AT12-003a

## 2009 - 2011 G37; SHIFT RESPONSIVENESS ISSUES

**APPLIED VEHICLES:** 2009 – 2011 G37 Sedan and Coupe (V36/CV36)  
(Convertible not included)

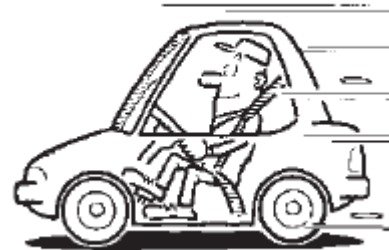
Figure A

- Take the vehicle for a 10 minute drive in order to meet the following Idle Air Volume Learn (IAVL) conditions:
  - Engine coolant temperature: 70 -100°C (158 - 212°F)
  - Battery voltage: More than 12.9V (At idle)
  - Transmission: Warmed up
