Technical Information Bulletin

E056

PACCAR MX RC2-RC11 Software Update Campaign

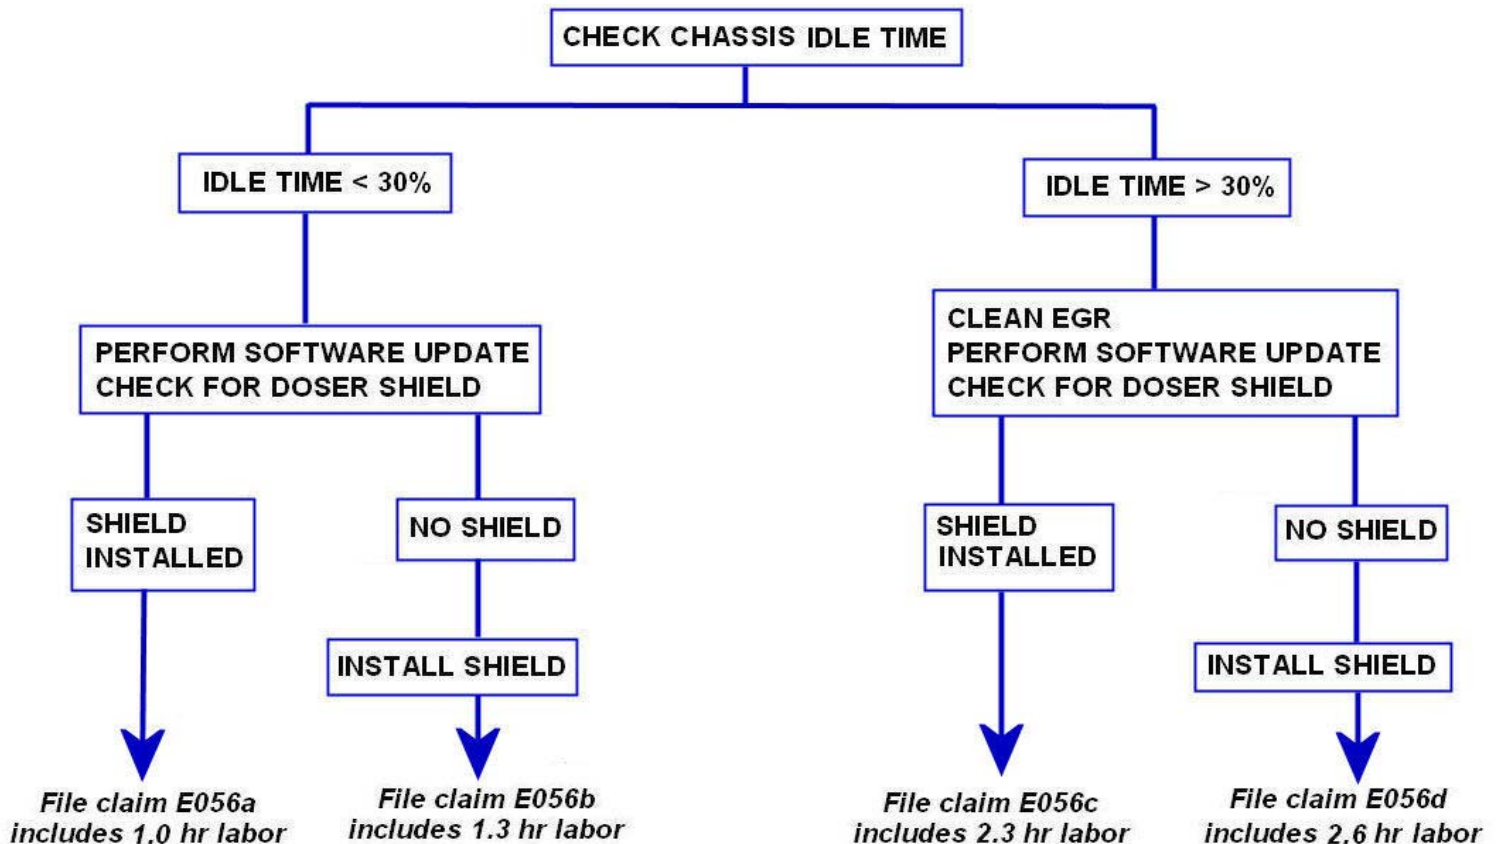
Procedure

General Instructions:

1. All chassis listed require a check of the chassis idle time history. Follow instructions of the attached Idle Time Check Procedure.
 - a. For chassis with 30% idle time or greater, skip to step 4.

3. Inspect the chassis for the presence of a doser shield. **All MX engines with updated software require a doser shield to be installed.**
 - a. For chassis already equipped with a doser shield, repairs are complete. File Quick Claim E056a.

- b. For chassis that do not have a doser shield, follow instructions of the Doser Shield Procedure. After installation, repairs are complete. File Quick Claim E056b.

- a. For chassis already equipped with a doser shield, repairs are complete. File Quick Claim E056c.
 - b. For chassis that do not have a doser shield, follow instructions of the Doser Shield Procedure. After installation, repairs are complete. File Quick Claim E056d.
-
