Date: June 2012
Subject: Customer Satisfaction Campaign 24U8
Engine Wiring Harness Overlay & ECM Programming
2011-2012 MY Audi R8/R8 Spyder

CAMPAIGN DATA SHEET

CAMPAIGN TYPE		CUSTOMER SATISFACTION CAMPAIGN	
SAGA CODE		24U8	
MARKET(S)		United States and Canada	
AFFECTED VEHICLES		2011-2012 MY Audi R8 & R8 Spyder	
TOPIC		Engine Wiring Harness Overlay & ECM Programming	
PROBLEM DESCRIPTION		Under certain driving conditions the MIL may come on even though the vehicle is operating correctly.	
CORRECTIVE ACTION		As applicable, installation of an engine wiring harness overlay and/or updated ECM programming.	
CUSTOMER NOTIFICATION DATE		July 2012	
ELSAWEB VISIBILITY DATE		June 20, 2012	
AIM VISIBILITY DATE		June 20, 2012	
CAMPAIGN VEHICLE COUNT	TOTAL AFFECTED	USA: 1,954	Canada: 206
	DEALER INVENTORY	USA: 181	Canada: 26
	CPO INVENTORY	USA: 0	Canada: 1
APPROXIMATE REPAIR TIME		50 – 290 TU	
SPECIAL TOOLS NEEDED?		YES – SEE CAMPAIGN CIRCULAR	
PARTS REQUIRED		CRITERION-SPECIFIC – SEE CAMPAIGN CIRCULAR	
INITIAL PARTS ALLOCATION DATE		On or about June 19, 2012	
TECHNICIAN TRAINING REQUIRED?		YES. Repair can only be performed by Audi R8 Authorized Dealers.

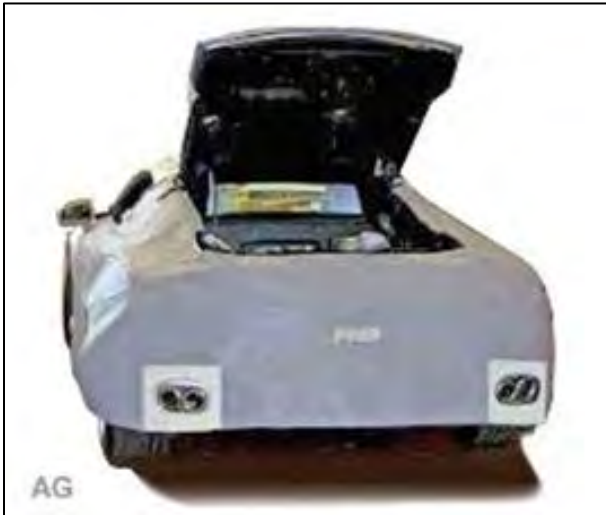
VAS 6411 – Coupe / Spyder Rear End Protector

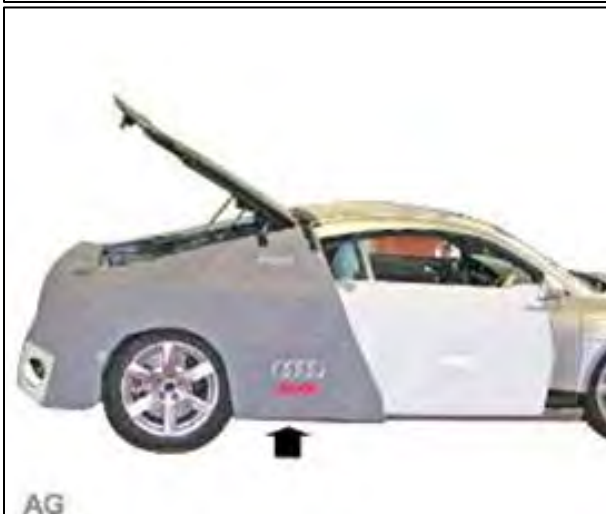
VAS 6412 – Coupe Side Panel Protector

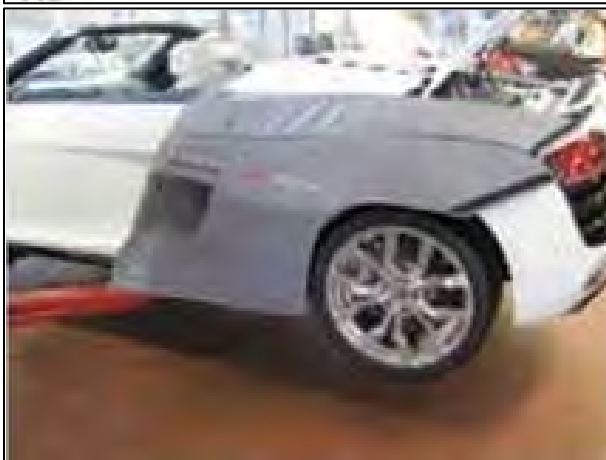
VAS 6428 – Spyder Side Panel Protector

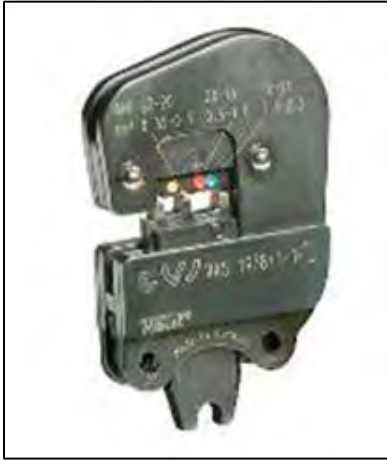
VAS 1978/1-1 – Exchangeable head, 0.35-.50 mm

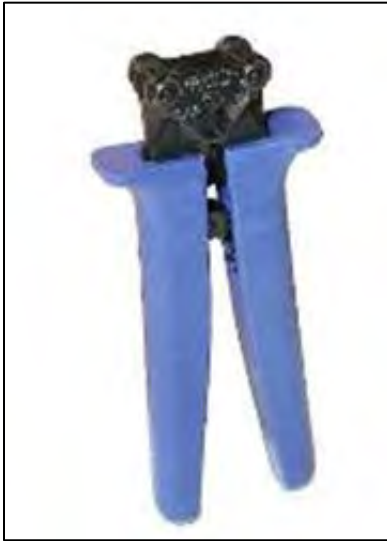
VAS 1978/1-2 – Crimping pliers (base tool)

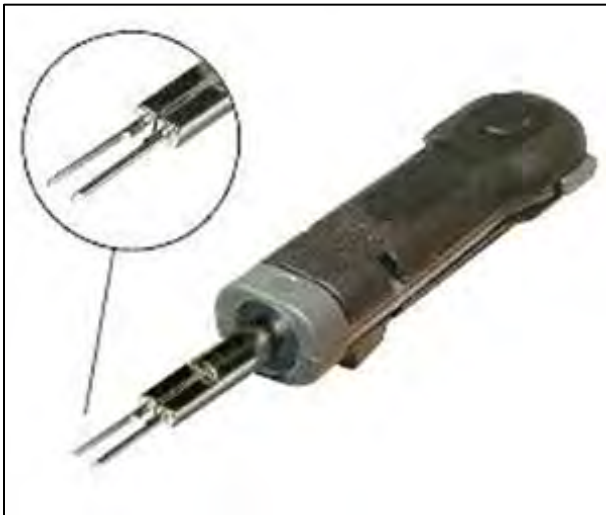
VAS 1978/7A – Terminal removal tool

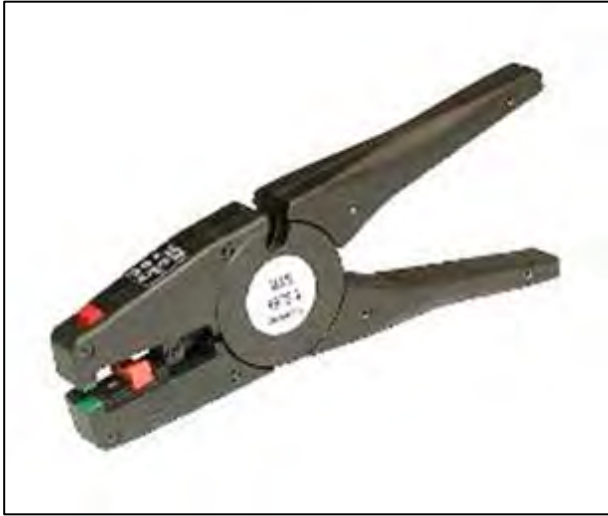
VAS 1978/3 – Wire stripping tool

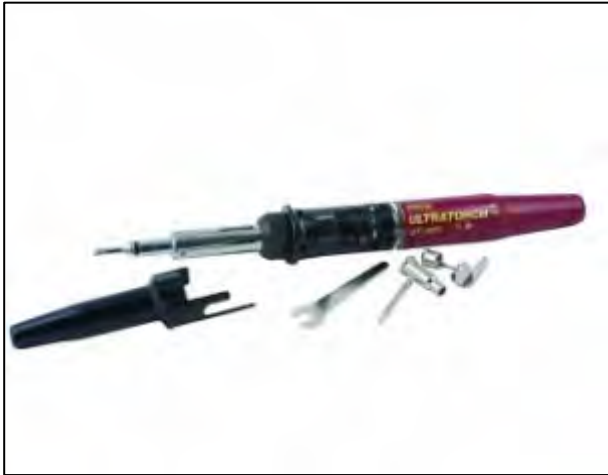
UT-100SI – Ultratorch in VAS 1978 B Tool kit
or suitable heat gun

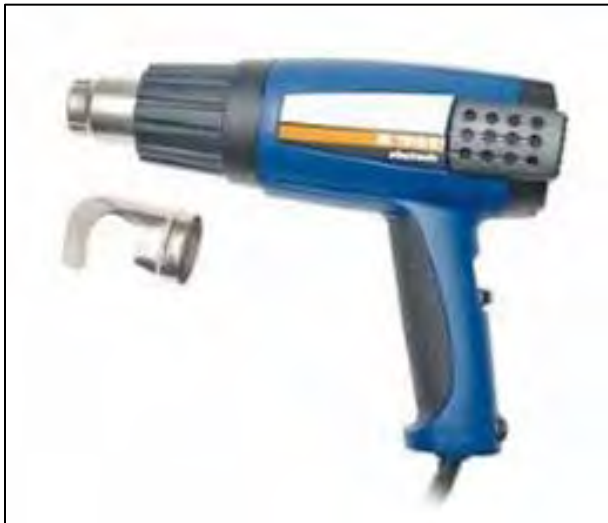
VAS 1978/14A – Hot air blower

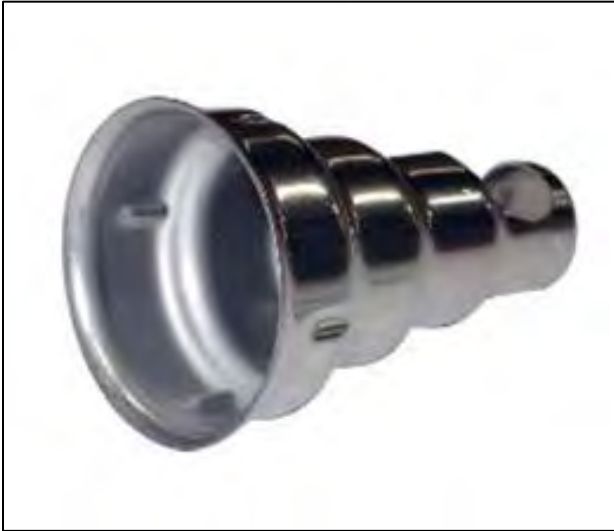
VAS 1978/15A – Shrink element for hot air blower

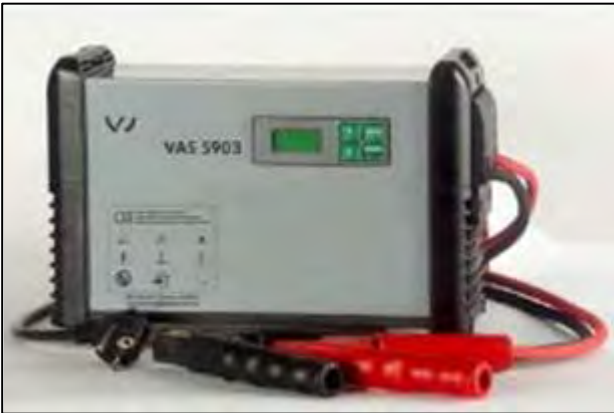
VAS 5903 Battery charger

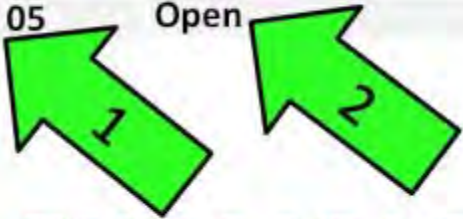
EXAMPLE

- Enter the VIN in ElsaWeb and proceed to the “Campaign/Action” screen.

- ⇐ Ensure that the Status is “Open” <arrow 2>.
- ⇐ Note the Applicable Criteria ID for use in determining the correct work to be done and corresponding parts associated <arrow 1>.

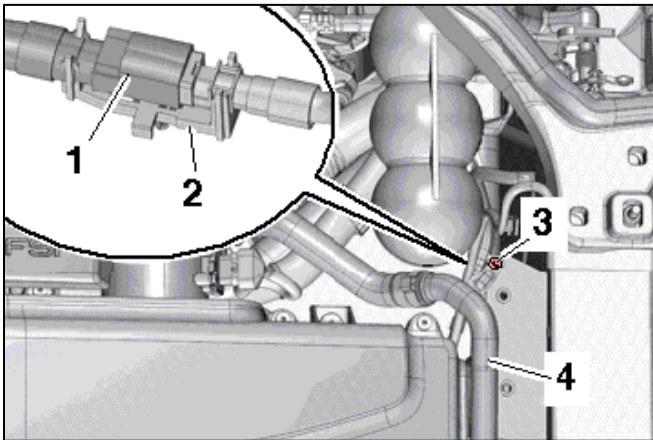
- ⇐ Remove the bolt <3> from the secondary air injection hose <4>.
- ⇐ Remove the connector <1> from the bracket <2> and disconnect it.

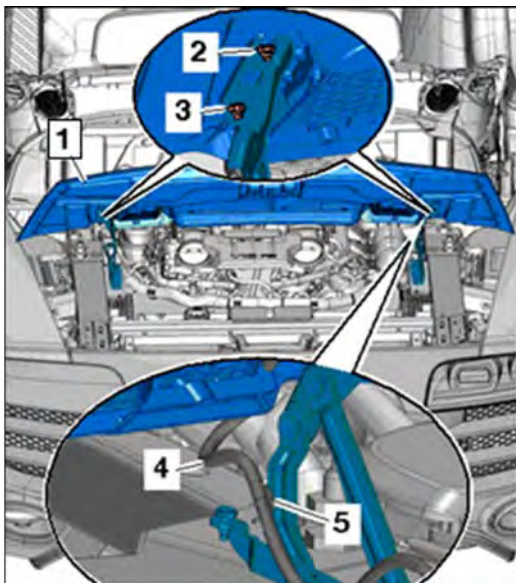
- ⇐ Free up the wiring harness <4> on the right hinge <5>.
- ⇐ Remove the nut <3>.
- ⇐ Loosen the nut <2> two turns.
- Repeat on other side.

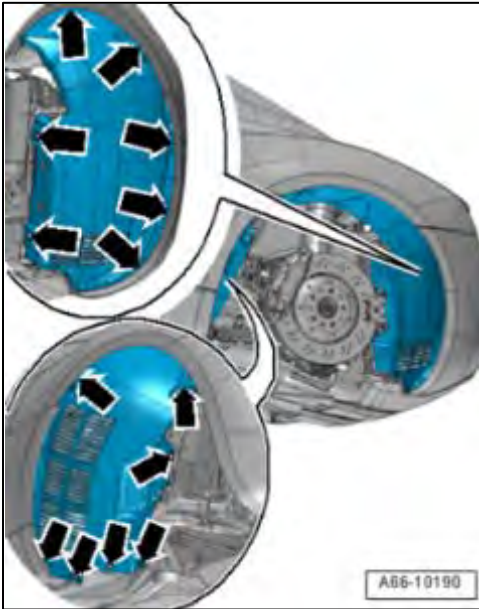
- Remove both rear wheels.
- ⇐ Remove both left and right rear wheel housing liners by removing screws <arrows>.

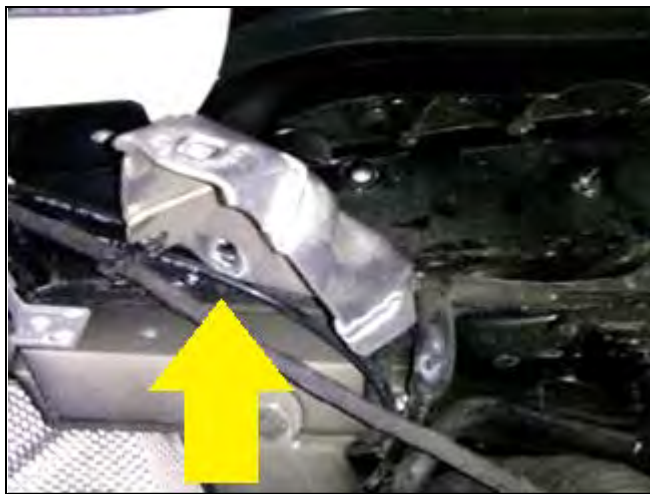
- Remove right side air intake snorkel.
- ⇐ Remove right fender support bracket <arrow>.

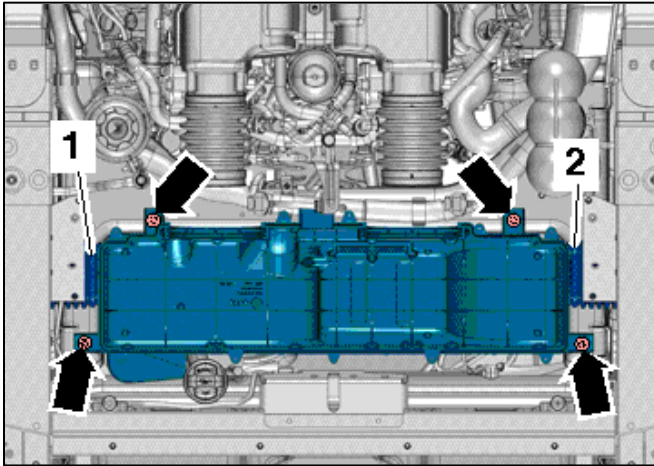
- ⇐ Remove the air filter housing bolts <arrows>.
- ⇐ Remove the boots <1 and 2> from the air filter housing.
- Remove air filter housing with the Mass Airflow (MAF) sensors.

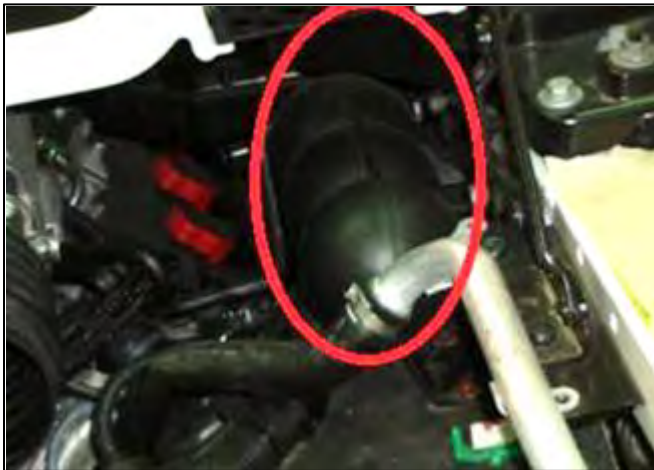
- ⇐ Remove vacuum reservoir <circle> hold-down bolts on right side of engine compartment to gain better access to wiring harness.

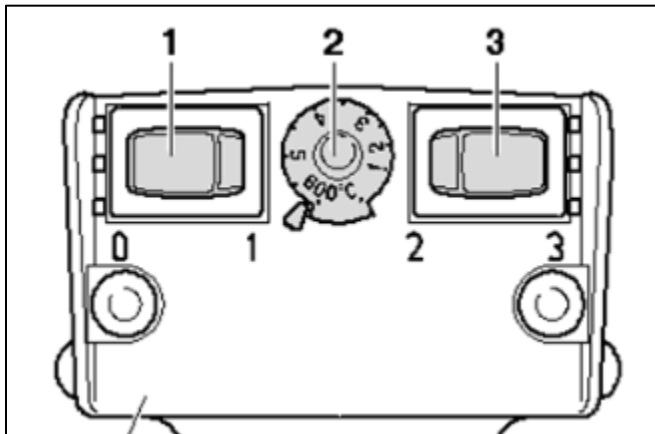
- ⇐ Adjust the settings on the hot air gun (VAS 1978/14A or equivalent) with the temperature control <2> at the maximum setting and the two-stage air flow switch <3> set to level 3.

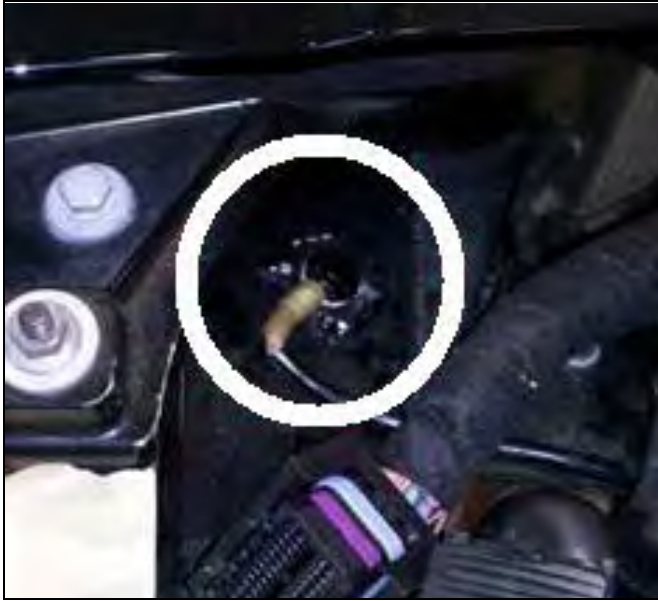
⇐ Remove ground wire <circle> at ECM 1 (J623, passenger's side).

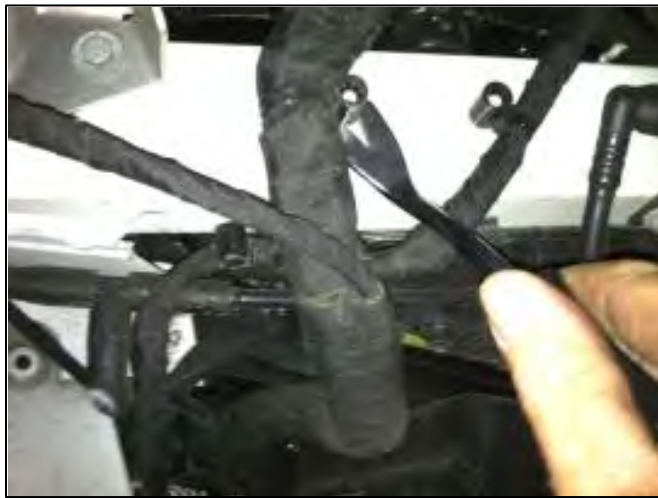
⇐ Release harness holder from frame in right fender well.

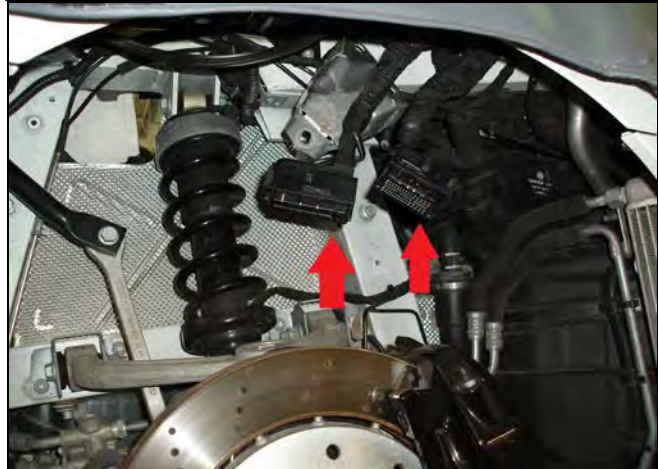
⇐ Pull the harness <arrows> down through the frame opening, into the wheel well, to provide working room for new harness installation.

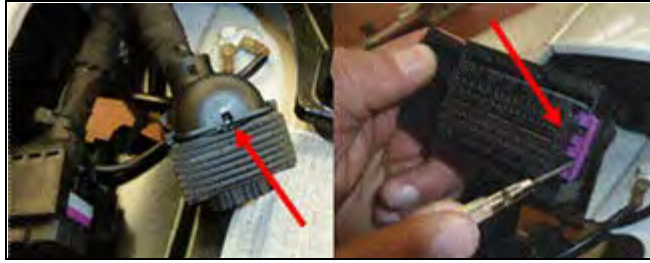
(Arrow 1) Lug.

(Arrow 2) Terminal lock.

- ⇐ Locate the smaller T60 connector from ECM 2 (J624, driver's side).
- ⇐ Remove the tie wrap and release the cover with a small screwdriver on the smaller T60 (push the lug upwards away from the front of the plug, <arrow 1>).
- ⇐ Pull out the terminal lock insert <arrow 2>.

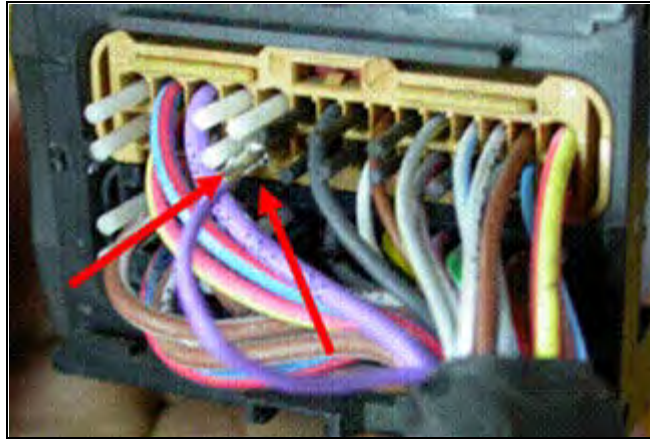
- ⇐ The terminal of the engine speed signal (purple wire) is in the brown housing element, located in **chamber 36**. Release the terminal using VAS1978/7A from the front side of the connector block, and gently remove wire.
- Repeat on the right side of vehicle: pull the purple wire from **chamber 36** of the T60 connector on ECM 1.

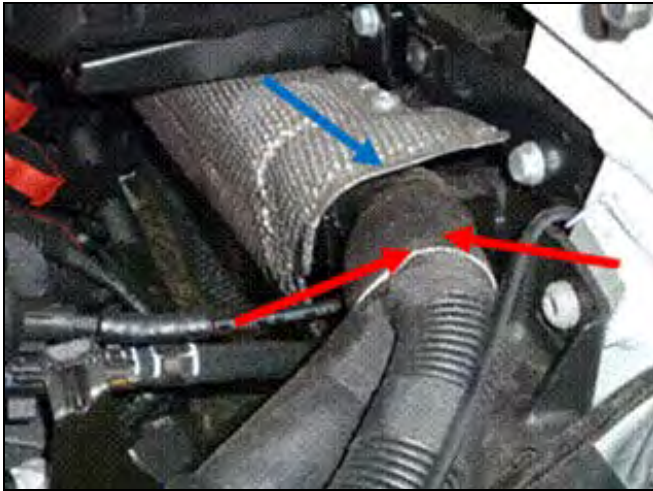
- ⇐ Mask the edge <blue arrow> of the heat shield with tape (risk of injury). Push back the protective hose <red arrows>.

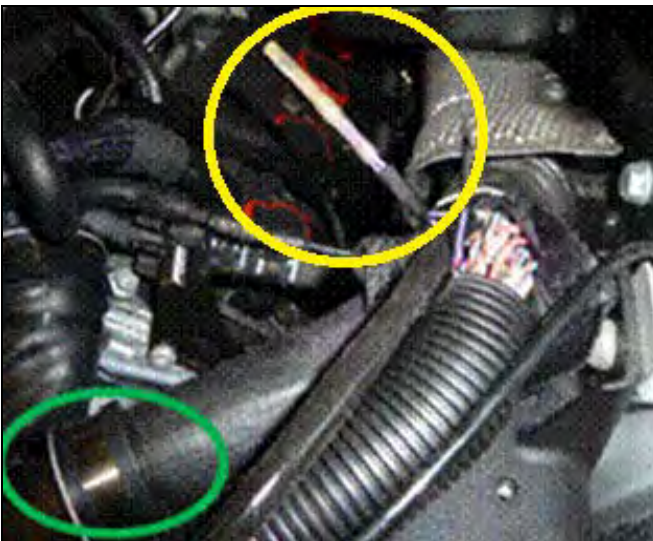
- ⇐ Remove hold down bolt for the harness holder <green circle>. Make sure that the other wires do *not* get damaged.
- ⇐ Locate purple overlay harness wire and cut it off 5 cm from D90 connection point <yellow circle>. Discard the overlay harness; it will no longer be used.

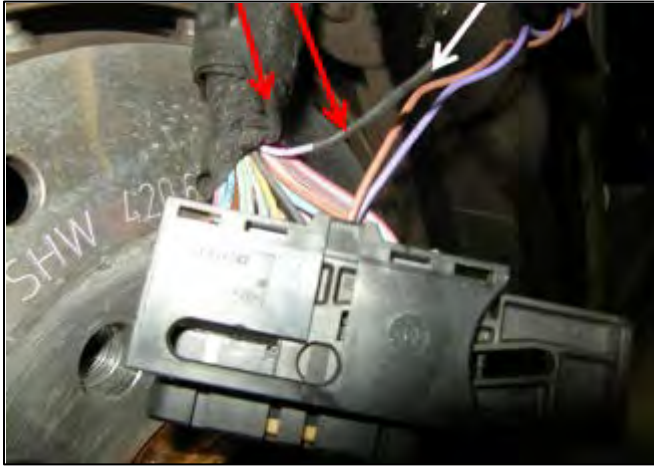
⇐ If the version 1 wiring harness was not installed: cut off wire terminal end and apply shrink tubing <red arrow> to wire from chamber 36 on both ECM1 & 2. Shrink tubing with UT-100SI Ultratorch (or equivalent). Pinch the end of the tubing closed <white arrow> and tape wire back in direction of the harness.

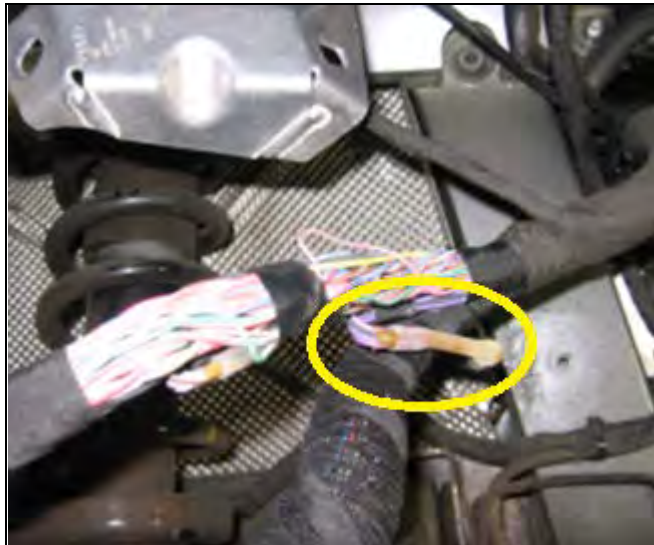
- Remove the brown wire for the G28 engine speed signal to the T60 connector on *ECM 1 (J623, passenger's side)* from **chamber 51** using VAS 1978/7A.
- ⇐ Cut off wire terminals and apply shrink tubing <red arrow> on each wire. Then, heat tubing with UT-100SI Ultratorch (or equivalent) and pinch the end of the tubing closed. Tape wires back in direction of the harness.
- ⇐ Strip the harness at the right side inside the wheel well, where the harness branches, and locate the D141 connection <yellow circle>.

- Locate the D141 connection in engine wiring harness near the harness junction where the harness branches to the T60 and T94 ECM connector plugs. The D141 connection has five lilac (purple) and one wire that is black or gray. Do not confuse with any other connection in harness.

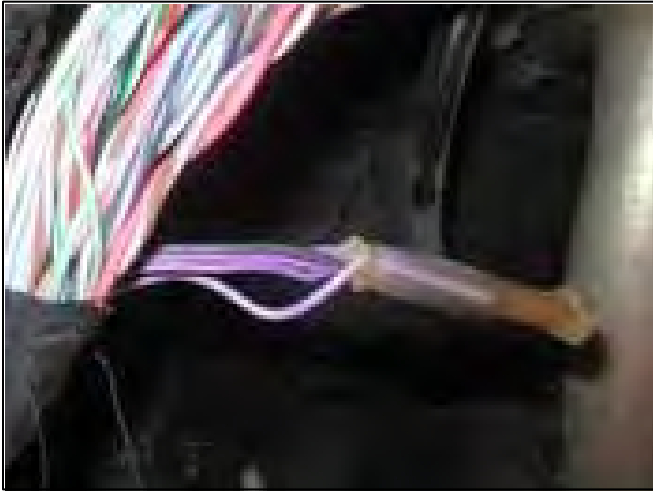
- ⇐ Cut off the wire that is black or gray about 5 cm behind the crimp. The new harness will be connected to the remaining section of black wire from the D141 connection. Apply shrink tubing to the harness section of the black wire and heat tubing with UT-100SI Ultratorch (or equivalent). Pinch the end of the tubing closed and tape back in direction of the harness.

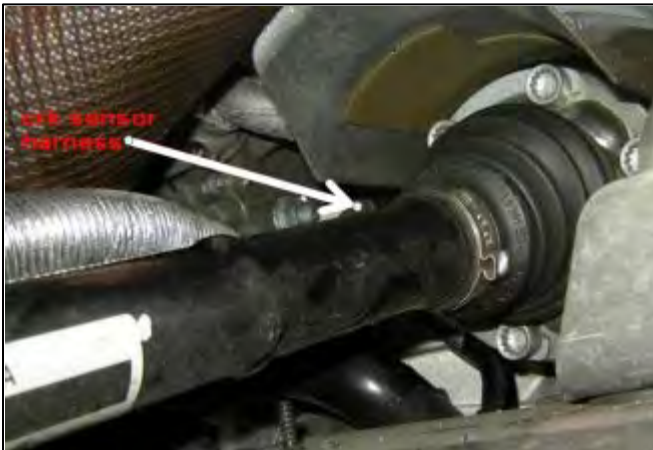
- ⇐ Disconnect the connector <arrow> to the G28 engine speed sensor on the left side of the transmission bell housing and cut off the connector end as straight as possible. The original wiring to the sensor is no longer required.

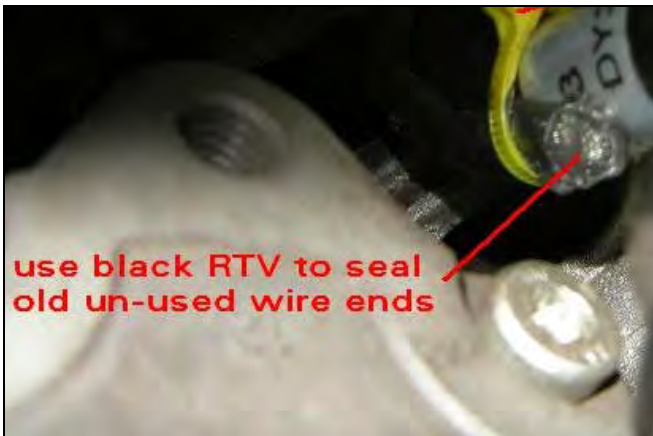
- ⇐ Seal the G28 cable opening with silicone sealant.

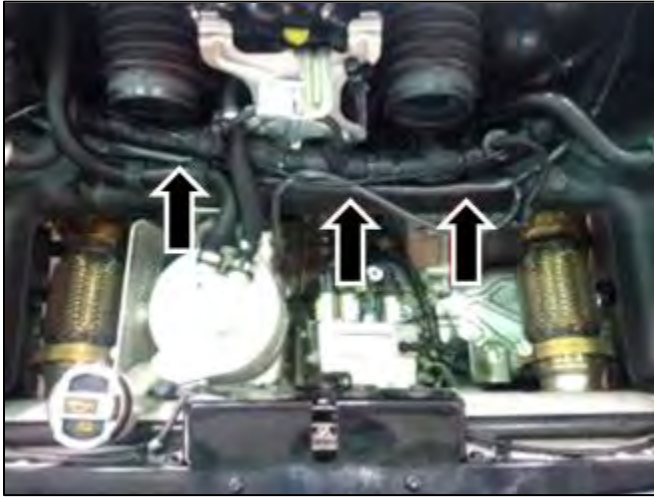
⇐ The overlay harness should be routed along the main engine harness <arrows>.

- Put the G28 plug of the repair harness on the engine speed sensor and tie wrap (N 909 377 02) following the original G28 harness. Keep harness away from sharp objects and the exhaust.
- The overlay harness should be routed along the main engine harness.

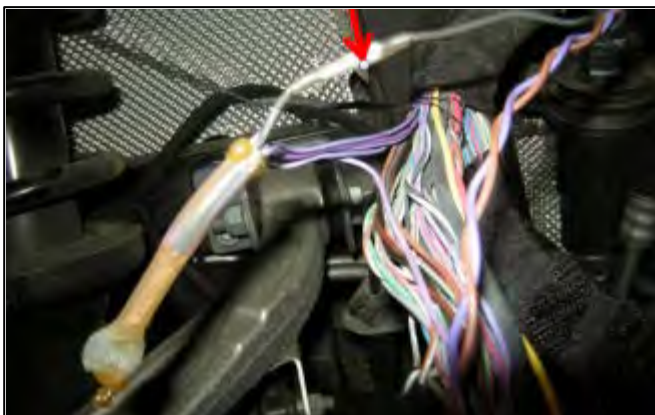
⇐ Crimp the black wire <arrow> from the D141 connection to the new wire from the overlay harness. Use crimping pliers VAS 1978/1-2 with exchangeable head VAS 1978/1-1. Use yellow crimping slot 0.35-2.5mm and crimp connector (000 979 940). Heat connector with UT-100SI Ultratorch (or equivalent).

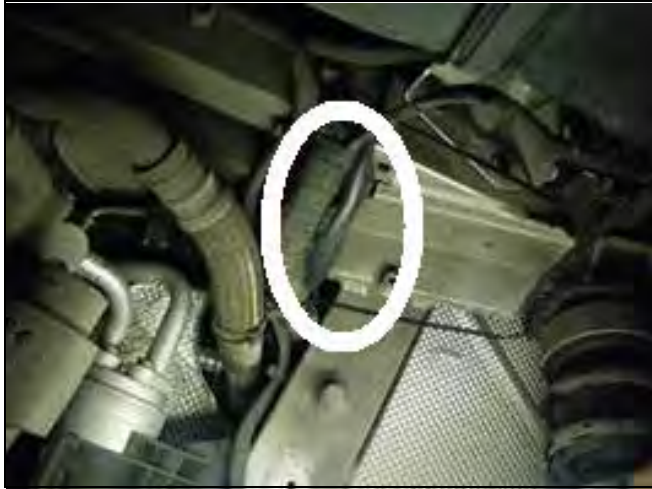
⇐ Route the overlay <circle> to ECM 2. Follow the harness through the splash shield into the wheel house.

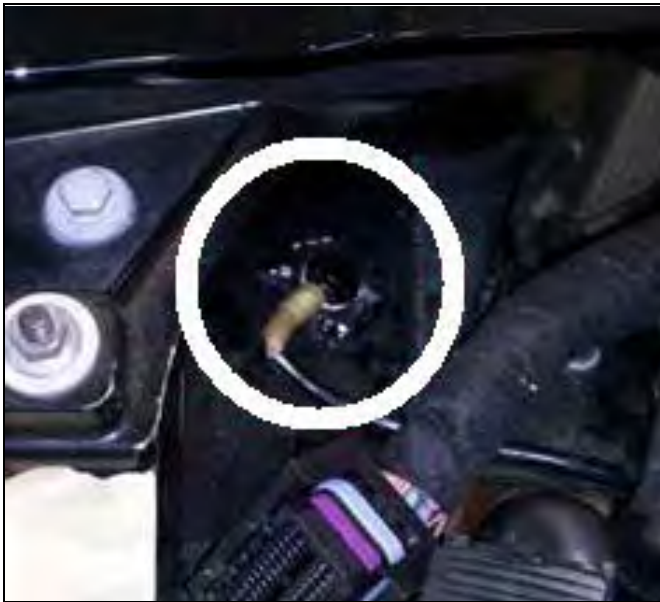
- Install tie wraps (N 909 377 02) every 8 inches following main engine harness. Do not overtighten.
- ⇐ Connect ECM 1 to both wiring harnesses. Reconnect ECM holders <2> and <5> with new shear bolts <3> (N 910 238 02) and <4> (N 909 803 04 with locking compound), then reinstall.

Be sure to install shear bolts <4> with locking compound into the correct position. Put the shear bolts <3> without locking compound into the ECM.

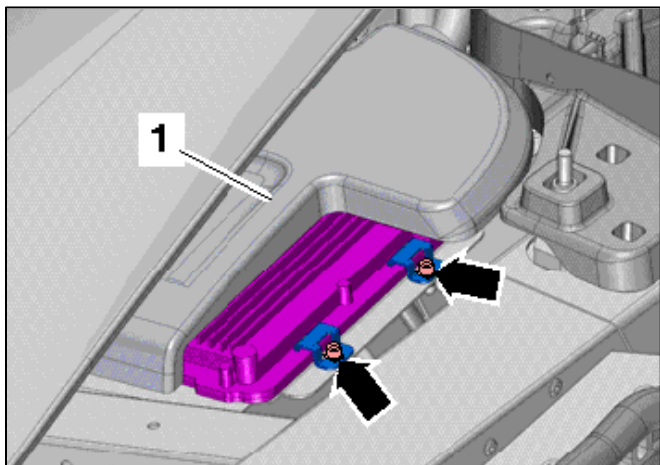
⇐ Reconnect ground <circle> from ECM 1.

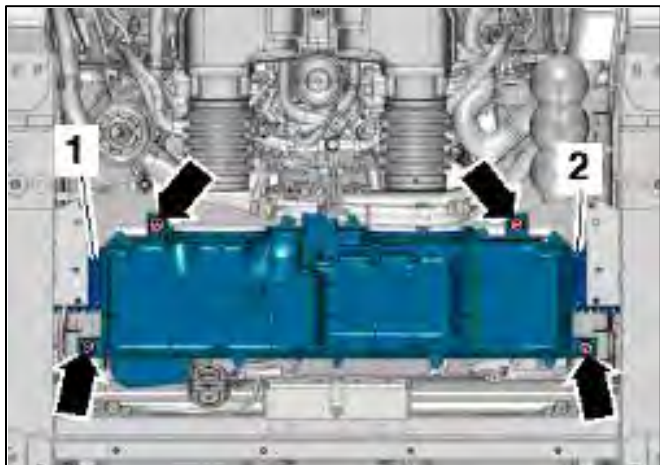
⇐ Secure ECM with locking tabs <arrows> and put cover <1> back in position on both sides of vehicle.

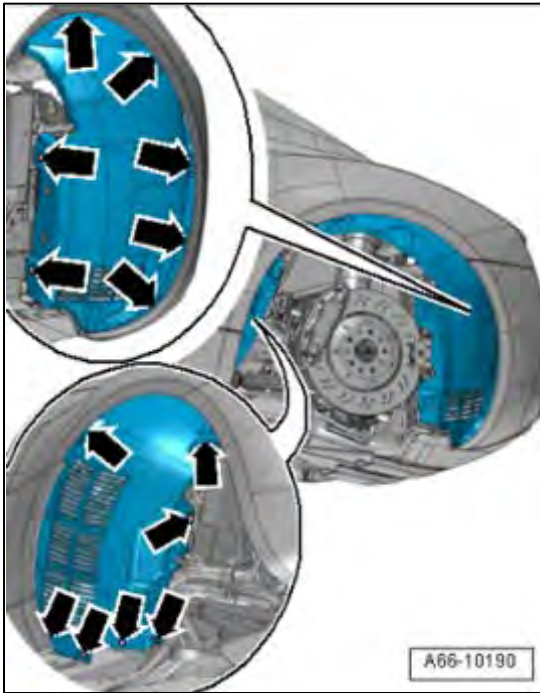
- Remove left rear wheel.

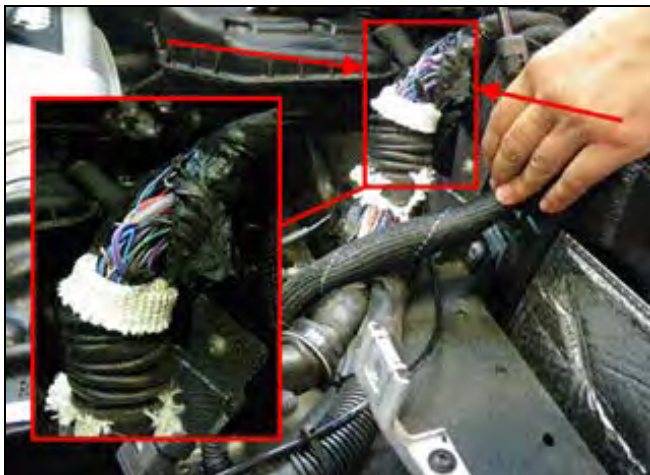
Tip: The D90 connection point of the engine speed signal wire is located on the right side of the engine compartment, just in front of the heat shield.

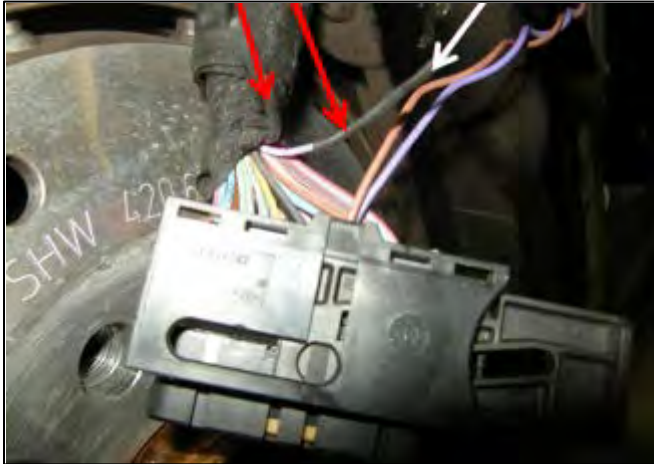
- ⇐ If the version 1 wiring harness was not installed: cut off wire terminal end and apply shrink tubing <red arrow> to wire from chamber 36 on both ECM1 & 2. Shrink tubing with UT-100SI Ultratorch (or equivalent). Pinch the end of the tubing closed <white arrow> and tape wire back in direction of the harness.

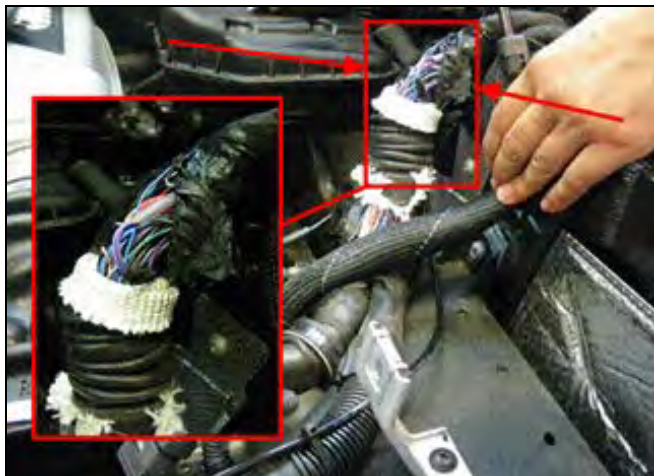
- Remove the brown wire for the G28 engine speed signal to the T60 connector on *ECM 1 (J623, passenger's side)* from **chamber 51** using VAS 1978/7A.
- ⇐ Cut off wire terminals and apply shrink tubing <red arrow> on each wire. Then, heat tubing with UT-100SI Ultratorch (or equivalent) and pinch the end of the tubing closed. Tape wires back in direction of the harness.
- ⇐ The D141 connection point <square> is on the right side of the compartment.

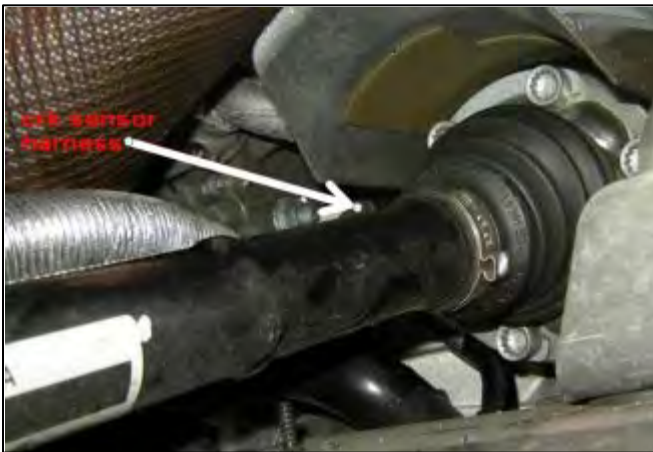
- ⇐ Cut off the wire that is black or gray about 5 cm behind the crimp. The new harness will be connected to the remaining section of black wire from the D141 connection. Apply shrink tubing to the harness section of the black wire and heat tubing with UT-100SI Ultratorch (or equivalent). Pinch the end of the tubing closed and tape back in direction of the harness.

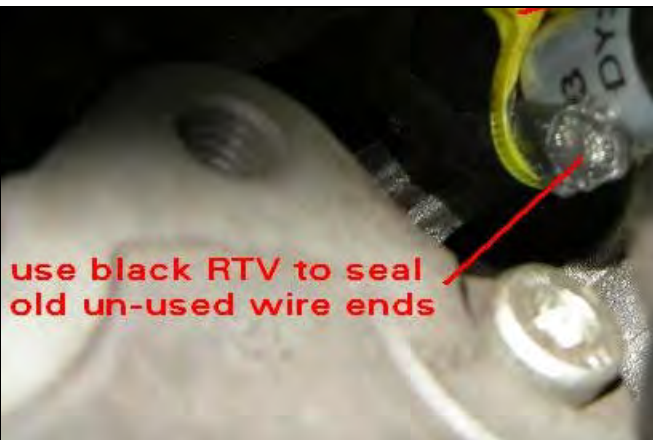
- ⇐ Disconnect the connector <arrow> to the G28 engine speed sensor on the left side of the transmission bell housing and cut off the connector end as straight as possible. The original wiring to the sensor is no longer required.

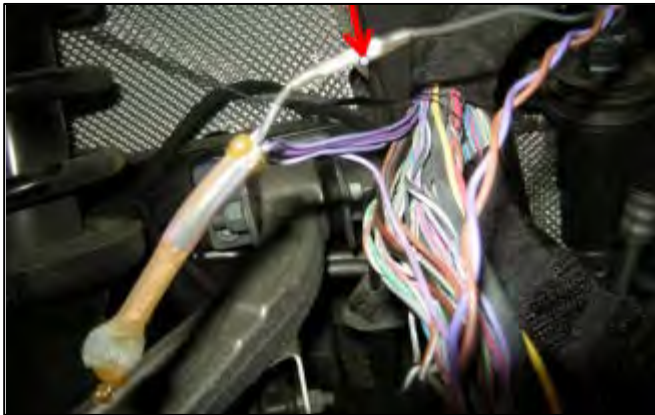
⇐ At ECM 1 (J623, passenger's side): plug the purple wire into chamber 36 and the brown wire into chamber 51 of the small plug (T60).

ⓘ Tip: Picture shows Spyder, but Coupe wiring harness should look the same.

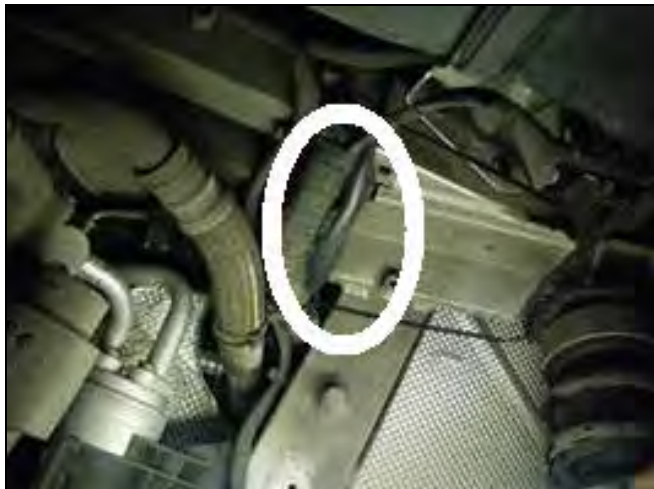
⇐ Crimp the black wire <arrow> from the D141 connection to the new wire from the overlay harness. Use crimping pliers VAS 1978/1-2 with exchangeable head VAS 1978/1-1. Use yellow crimping slot 0.35-2.5mm and crimp connector (000 979 940). Heat connector with UT-100SI Ultratorch (or equivalent).

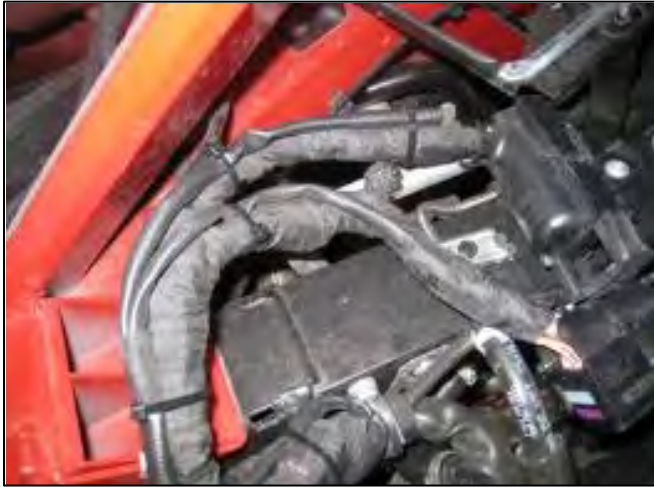
⇐ Route the overlay <circle> to ECM 2. Follow the harness through the splash shield into the wheel house.

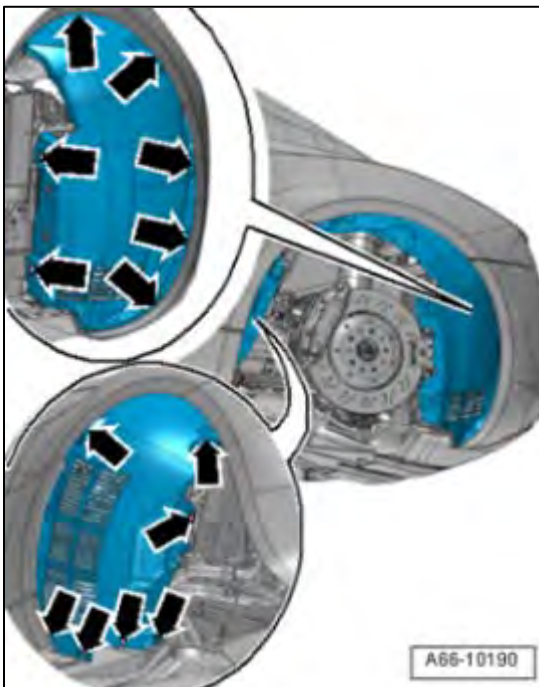
- ⇐ Carefully reinstall air filter housing with MAF. Secure with bolts <arrows> and torque to 8 Nm.
- ⇐ Reconnect air snorkels <1 and 6>.
- ⇐ Reconnect and tighten hose clamps <2 and 4>.
- ⇐ Make electrical connections to MAFs <3 and 5>.

- Uncover the oil fill opening and put the oil cap back into position.
- ⇐ Reinstall fender liner with bolts <arrows> torqued to 4 Nm.

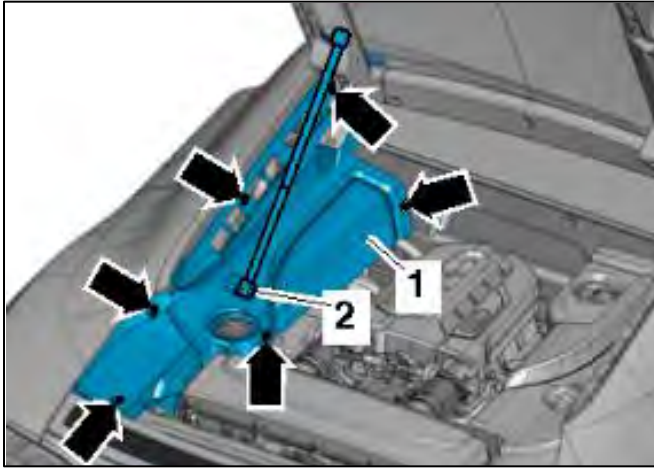
- ⇐ Remove cap from power steering fluid reservoir.
- ⇐ Release gas-filled strut <2> by pulling clip with small screwdriver while having a second technician support the lid.
- ⇐ Reinstall the engine compartment trim <1>.
 - Press the strut back onto the ball stud.
- ⇐ Put quick release fasteners <arrows> back in.
 - Repeat on other side.
