Audi

Customer Satisfaction Campaign

Code: 24U8

Subject: 2011 - 2012 Audi R8/R8 Spyder
Engine Wiring Harness Overlay & ECM Programming

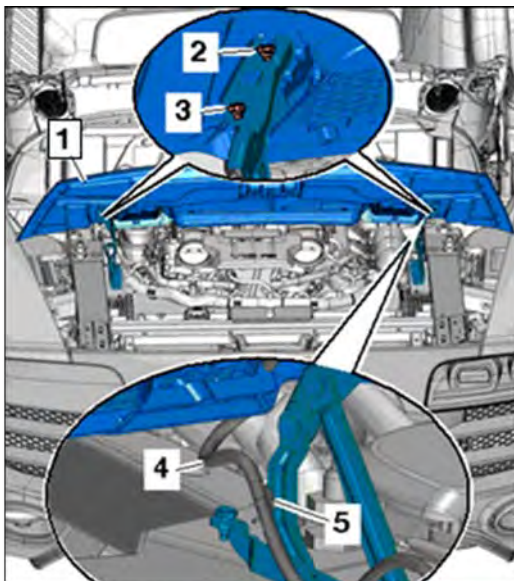
- ⇐ Free up the wiring harness <4> on the right hinge <5>.
- ⇐ Remove the nut <3>.
- ⇐ Loosen the nut <2> two turns.
- Repeat on other side.

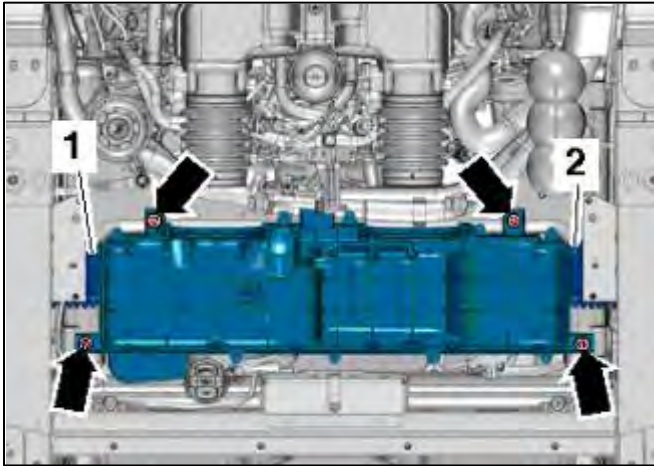
- ⇐ Remove the bolts <arrows> and press the left secondary air injection pipe <1> to the side.
- Repeat on right side of vehicle.

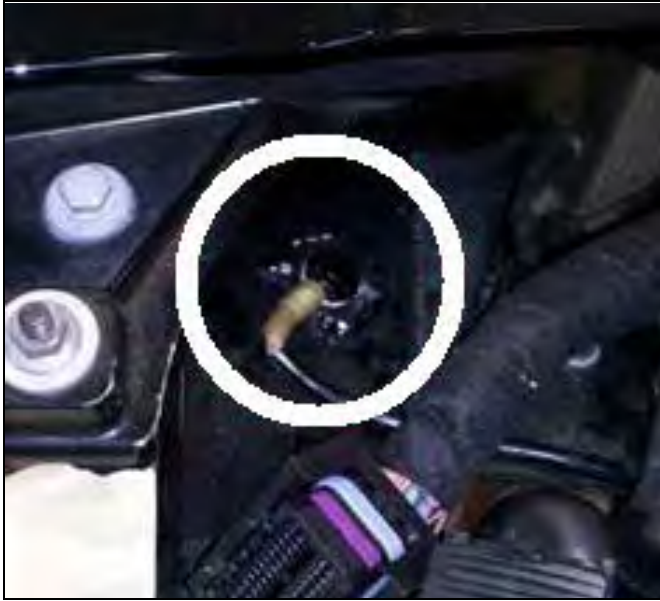
⇐ Remove shear bolts with locking pliers (see direction of <arrow>).

ⓘ Note: The shear bolts installed in the ECM do not need to be heated for removal. They should be removed without heat.

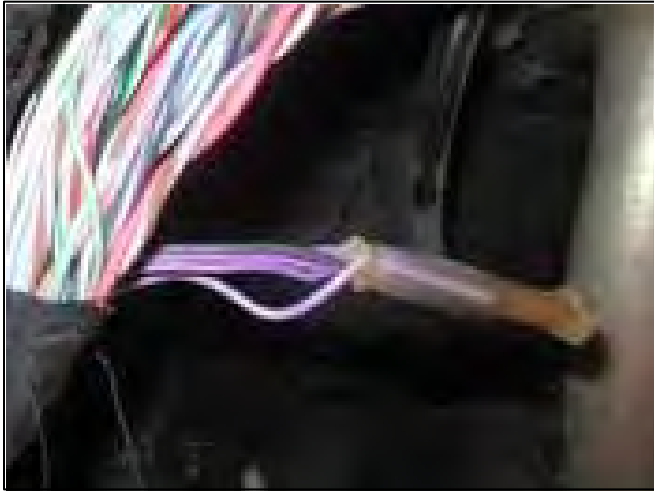
⇐ Strip the harness at the right side inside the wheel well, where the harness branches, and locate the D141 connection <yellow circle>.

- Locate the D141 connection in engine wiring harness near the harness junction where the harness branches to the T60 and T94 ECM connector plugs. The D141 connection has five lilac (purple) and one wire that is black or gray. Do not confuse with any other connection in harness.

ℹ Tip: The D141 connection can be in slightly different locations on each wiring harness. In many cases, you can locate it by squeezing the harness before removing any tape.

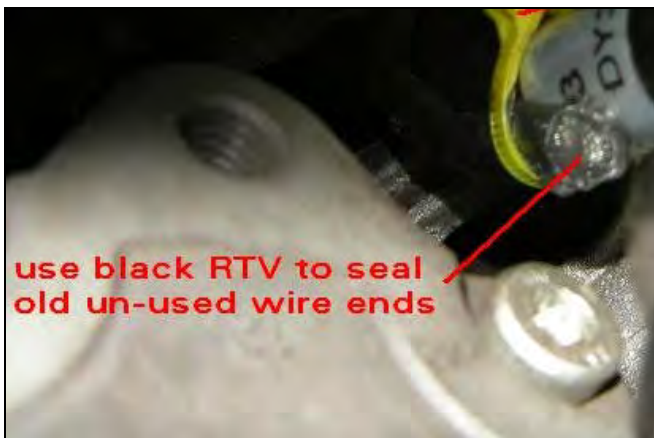
- ⇐ Disconnect the connector <arrow> to the G28 engine speed sensor on the left side of the transmission bell housing and cut off the connector end as straight as possible. The original wiring to the sensor is no longer required.

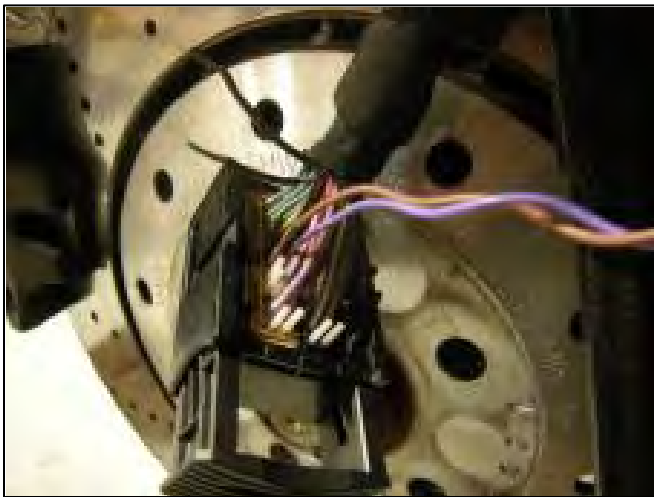
⇐ The overlay harness should be routed along the main engine harness <arrows>.

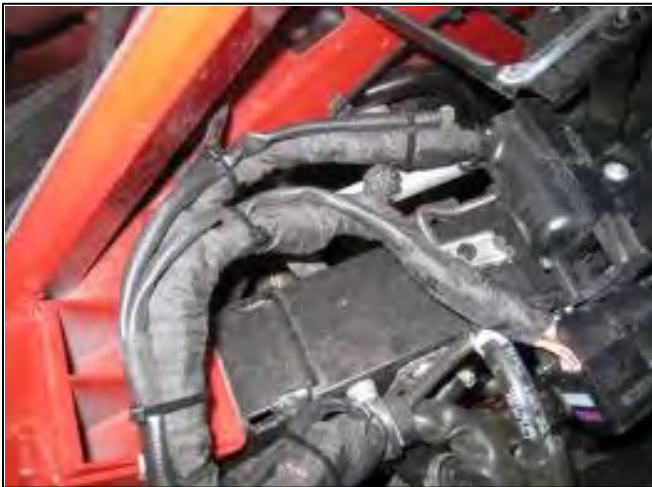
⇐ Route the overlay <circle> to ECM 2. Follow the harness through the splash shield into the wheel house.

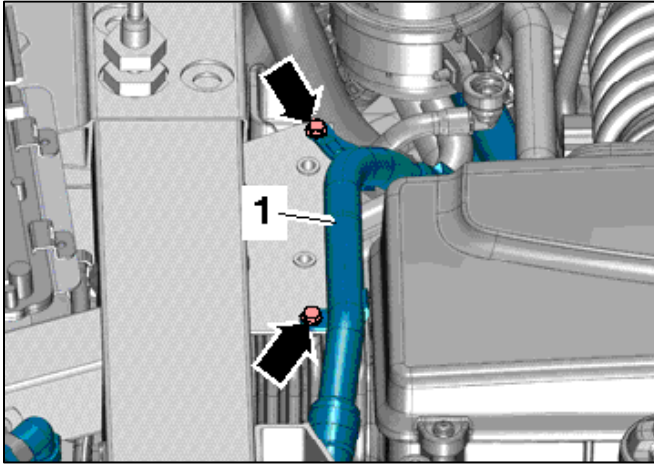
⇐ Reconnect the left secondary air injection tube <1> with 2 bolts <arrows>.

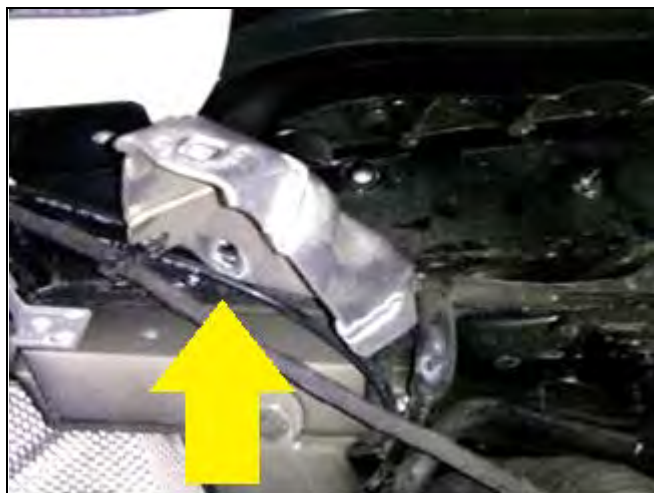
- Reinstall fender support bracket <arrow>
-
- Reinstall the air snorkel on the right side.

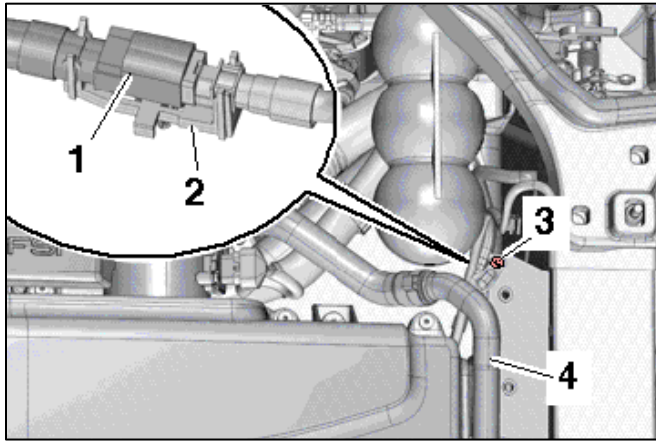
- ⇐ Reconnect connector <1>, then put back into bracket <2> ensuring that it is clipped into place.
- ⇐ Secure secondary air hose <4> with nut <3>.

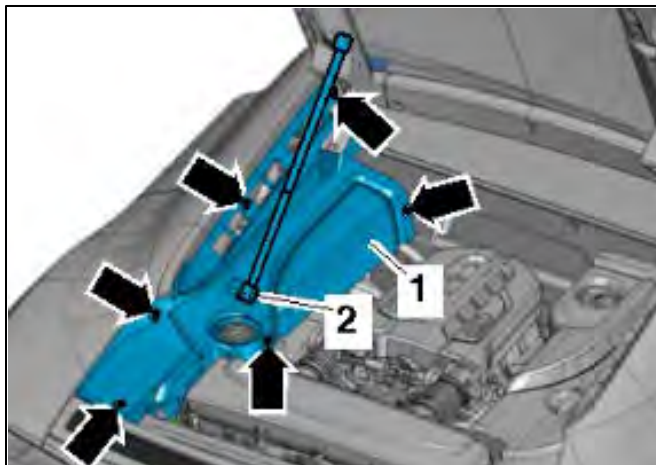
- ⇐ Remove quick release fasteners <arrows> and cap from power steering fluid reservoir.
- ⇐ Release gas-filled strut <2> by pulling clip with small screwdriver while having a second technician support the lid.
- ⇐ Raise the back of the engine compartment trim <1> and guide the front of it out at the lid hinge.
- Press the strut back onto the ball stud.
- Put cap from power steering fluid reservoir back into position.
- Repeat on other side.

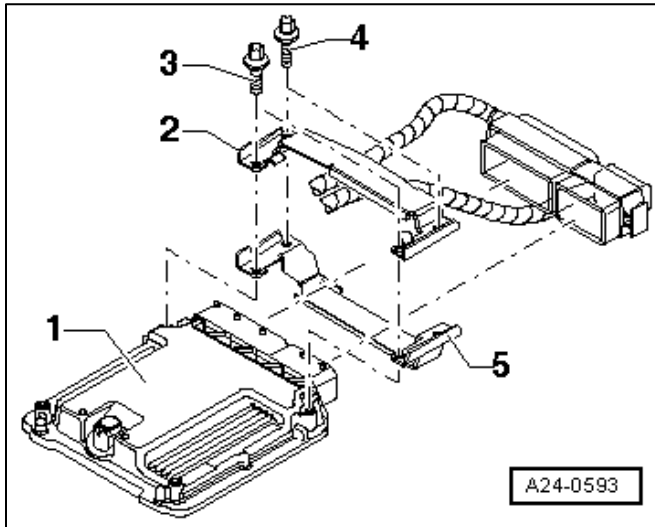
- ⇐ The ECM <1> is secured in a protective housing <5> and shear bolts <3 and 4> to make it more difficult to access.
- ⇐ The threads of the shear bolts <4> (that are not installed in ECM) are coated with locking compound and must be heated to remove.

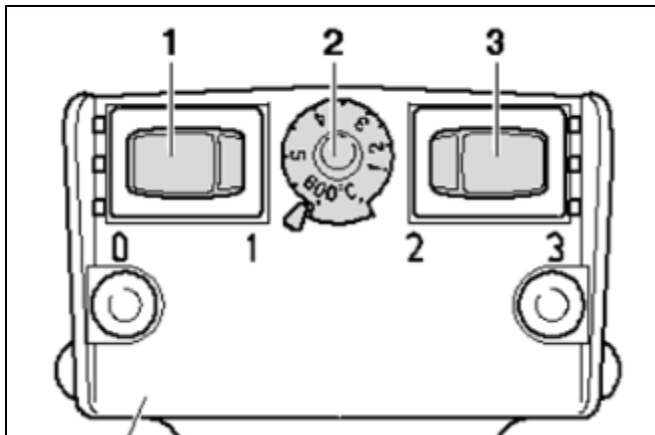
- ⇐ Adjust the settings on the hot air gun (VAS 1978/14A or equivalent) with the temperature control <2> at the maximum setting and the two-stage air flow switch <3> set to level 3.

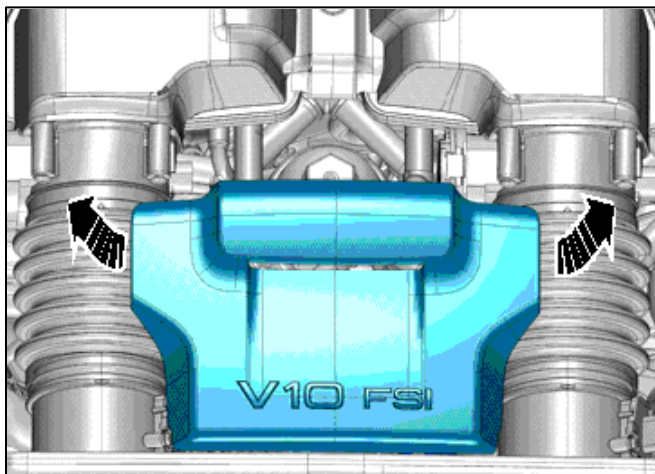
⇐ Remove the engine cover <arrows>. Do not jerk or pull it to one side.

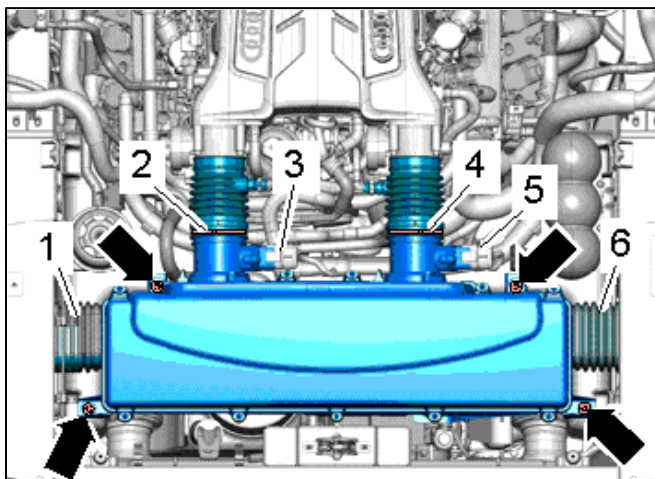
- ⇐ Disconnect electrical connection from Mass Airflow (MAF) sensors <3 and 5>.
- ⇐ Loosen hose clamps <2 and 4>.
- ⇐ Remove bolts <arrows>.
- Remove the air filter housing with MAF sensors.

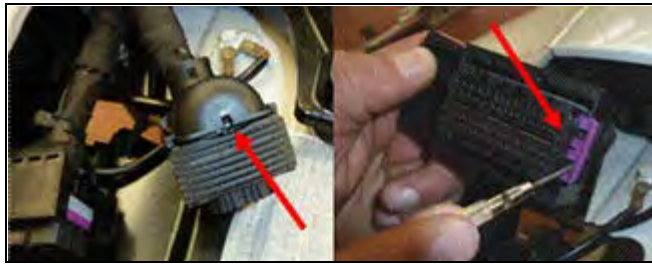
(Arrow 1) Lug.

(Arrow 2) Terminal lock.

- ⇐ Locate the smaller T60 connector from ECM 2 (J624, driver's side).
- ⇐ Remove the tie wrap and release the cover with a small screwdriver on the smaller T60 (push the lug upwards away from the front of the plug, <arrow 1>).
- ⇐ Pull out the terminal lock insert <arrow 2>.

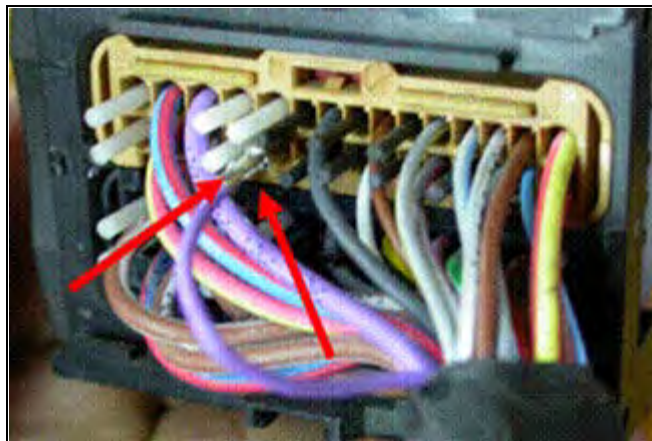
- ⇐ The terminal of the engine speed signal (purple wire) is in the brown housing element, located in **chamber 36**. Release the terminal using VAS1978/7A from the front side of the connector block, and gently remove wire.
- Repeat on the right side of vehicle: pull the purple wire from **chamber 36** of the T60 connector on ECM 1.

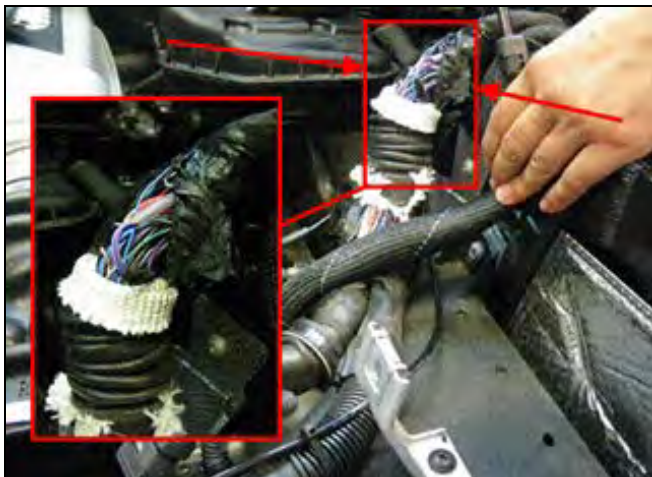
- ⇐ Locate purple overlay harness wire <square> and cut 5 cm from connection point. Discard the overlay harness; it will no longer be used.

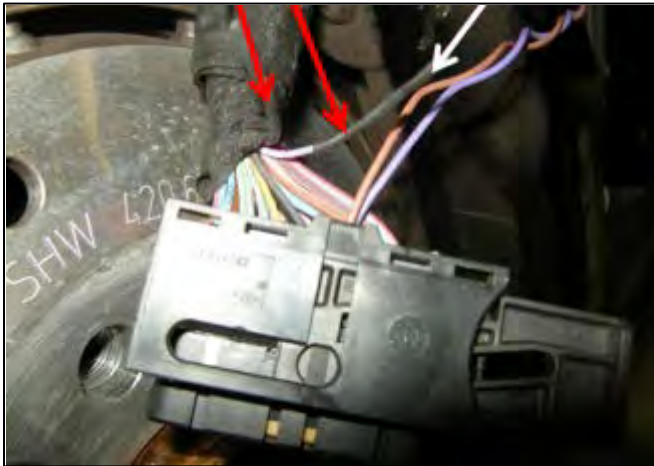
- ⇐ If the version 1 wiring harness was not installed: cut off wire terminal end and apply shrink tubing <red arrow> to wire from chamber 36 on both ECM1 & 2. Shrink tubing with UT-100SI Ultratorch (or equivalent). Pinch the end of the tubing closed <white arrow> and tape wire back in direction of the harness.

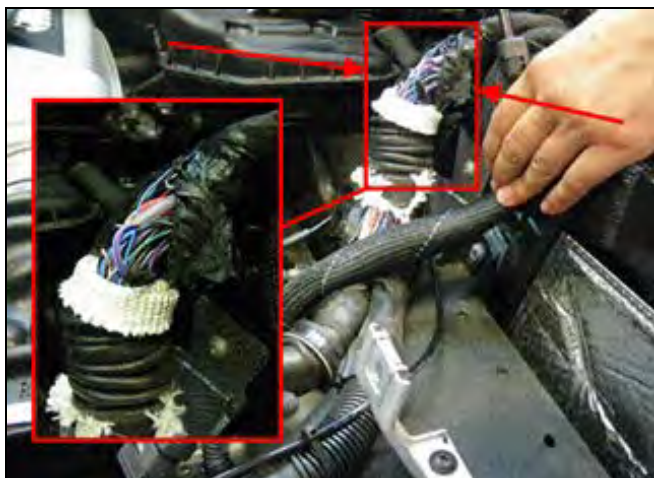
- ⇐ Locate the D141 connection in the engine wiring harness near the harness junction where the harness branches to the T60 and T94 ECM connector plugs. The D141 connection has five lilac (purple) and one wire that is black or gray.

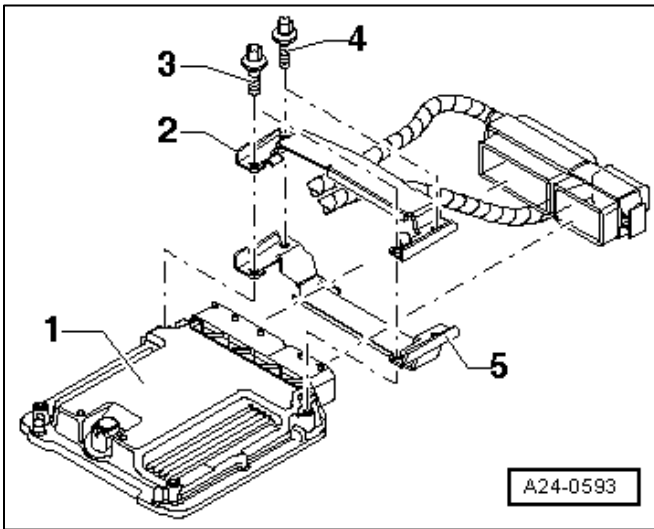
- Install tie wraps (N 909 377 02) every 8 inches following main engine harness. Do not overtighten.
- ⇐ Connect ECM 1 to both wiring harnesses. Reinstall ECM holders <2> and <5> with new shear bolts <3> (N 910 238 02) and <4> (N 909 803 04 with locking compound), then reinstall.

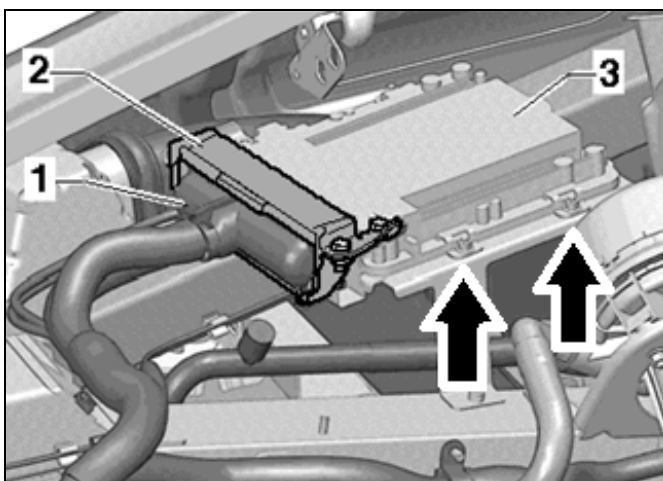
- ⇐ Secure ECM with retaining clips <arrows>.
