Customer Satisfaction Campaign

Code: 91i9

**Subject: 2012 Model Year Volkswagen Vehicles with
RNS 510 Radio w/Navigation System
Radio Software Update**

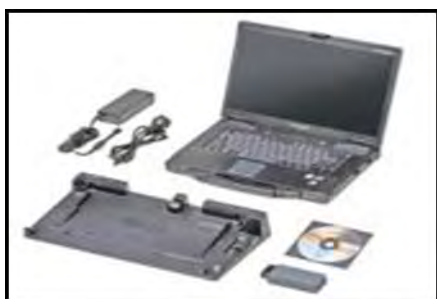
- VAS 6150 Laptop Diagnostic Unit, VAS 5051B, or VAS 5052/A

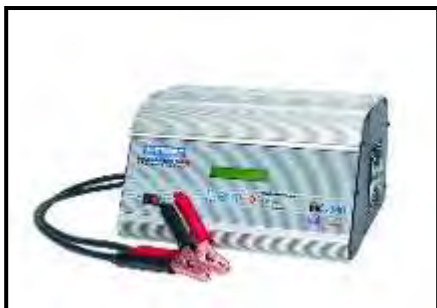
- INC-940 – Battery Charger or equivalent

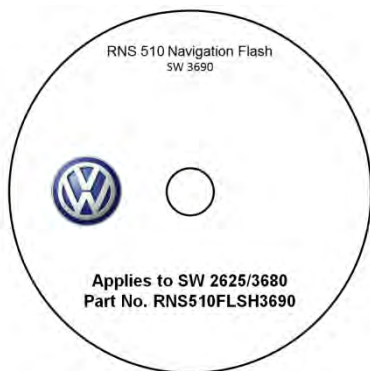
- RNS510FLSH3690 – Navigation Flash CD

Tip: This flash CD was previously shipped to support Technical Bulletin 2027965. Additional copies of the Update - Programming CD may be ordered from Volkswagen Technical Literature Ordering Center at www.vw.techliterature.com.

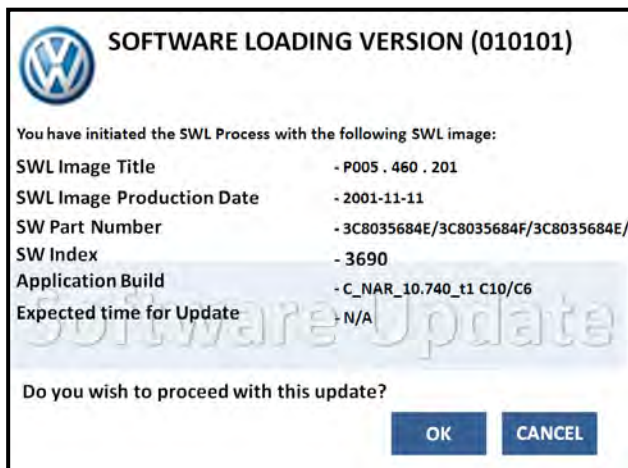
⇐ Read information, then touch “OK” to begin the update

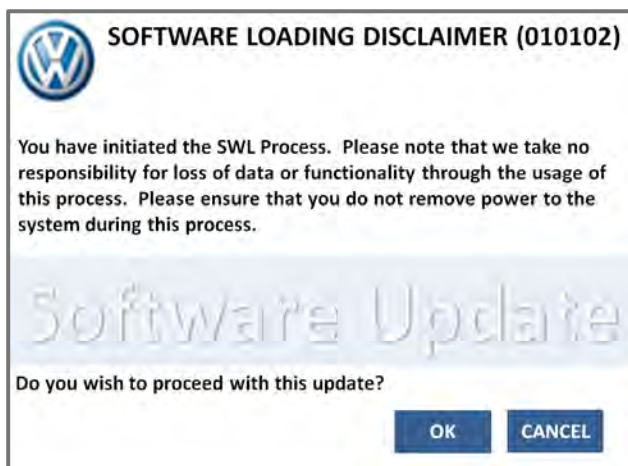
⇐ Read information, then touch “OK” to proceed with the update

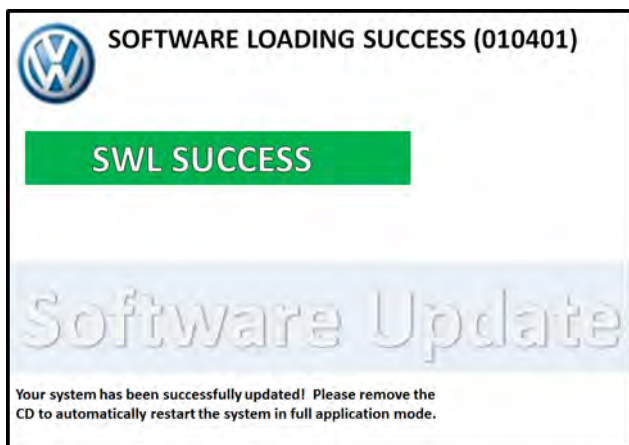
⇐ Allow software update to continue until “SWL SUCCESS” appears, then follow on-screen instructions

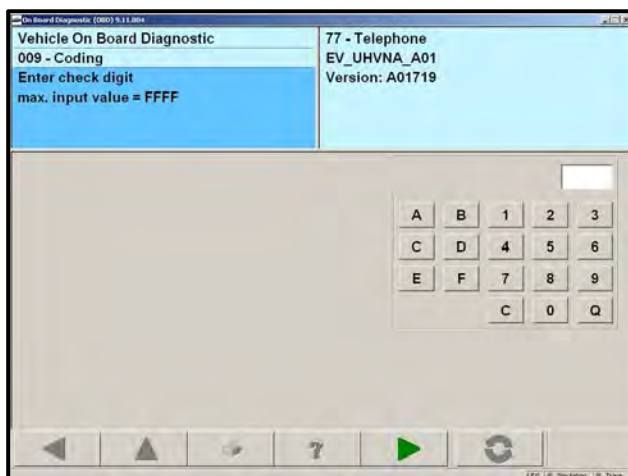
- Select the Forward arrow as a check digit is not required

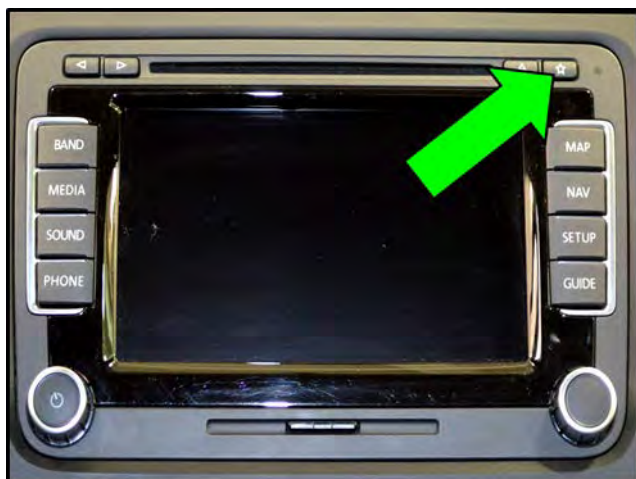
- ◀ Verify the repair by turning the radio on and selecting the “Star” button
<arrow>
 - A message that “Route Guidance not Active” should appear if changes were accepted
- Select the “Push-to-talk” button on the steering wheel or overhead assembly
 - Voice recognition for telephone should activate if changes were accepted
- Repeat any necessary steps if changes were not accepted
