Technical Service Bulletin

94 Adaptive light: Headlight range control warning displayed in instrument cluster - DTC 0014 Control Unit Faulty

94 12 76 2024877/2 April 27, 2012. Supersedes Technical Service Bulletin Group 94 number 10 – 39 dated December 2, 2010 for reasons listed below.

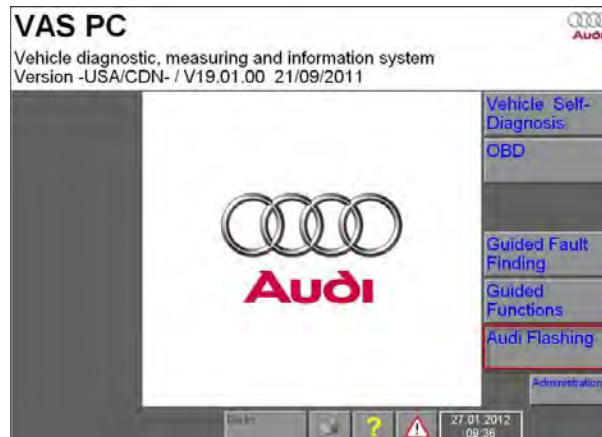
Figure 2. Audi Flashing.

- Turn off any appliances with high electromagnetic radiation (such as mobile phones).
 - If communication with a module cannot be properly established, appropriate repairs must be made before attempting SVM. If the tester cannot communicate with a module, the tester cannot flash software onto the module.
5. Enter the SVM code into the User Test Plan by selecting the **Audi Flashing** option at the main tester screen, unless otherwise directed by the TSB or TAC Helpline.
