SI M11 05 12
EngineSeptember 2012
Technical Service

Service Action: N18 Timing Chain Tensioner Oil Leakage Inspection and/or Seal (Gasket) Ring Replacement

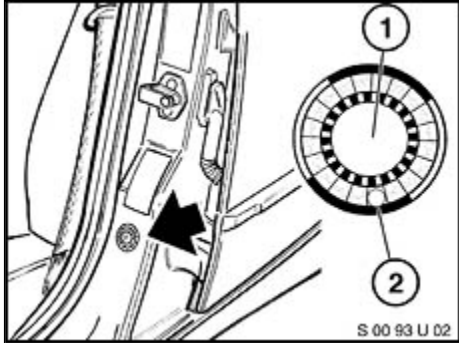
LABEL INSTRUCTIONS

This Service Action has been assigned code number **54**. After the vehicle has been checked and/or corrected, obtain a label (MD20-040) and:

- A. Emboss your MINI dealer warranty number in the middle of the label (1);
- B. Punch out code number **54** (2), printed on the label; and
- C. Affix the label to the B-pillar as shown.

In order to determine whether a specific vehicle has had this Service Action completed or is affected by this Service Action, first check the B-pillar label for code number **54**. If code number **54** has been punched out, the campaign has already been performed. If code number **54** has not been punched out, it will be necessary to utilize the "Service Menu" of DCSnet (Dealer Communication System) or the Key Reader. Based on the response of the system, either proceed with the corrective action or take no further action.
