Technical Service Bulletin

96 False warning by lane change assistant (Audi Side Assist)

96 13 56 2030583/2 May 2, 2013. Supersedes Technical Service Bulletin Group 96 number 12-42 dated September 5, 2012 for reasons listed below.

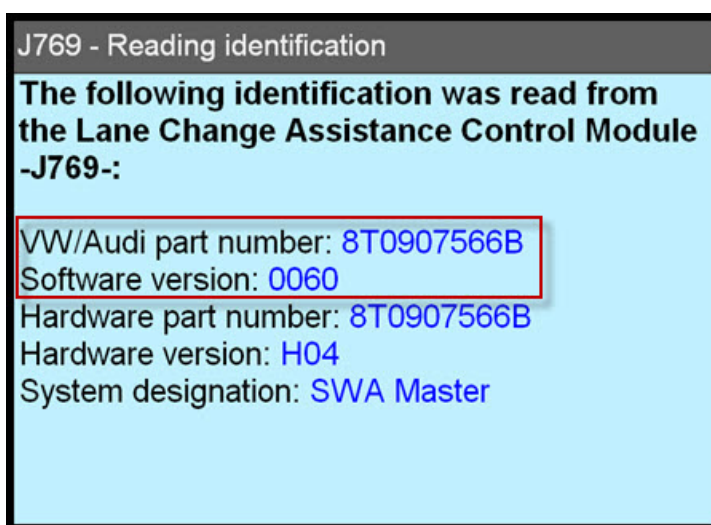
Figure 1. Software part number is identified as “VW/Audi part number” using VAS_PC

Guided Functions -> Selecting Vehicle System or Function -> 3C - Lane Change Assistance Control Module| J769 -> J769-Lane Change Assist. Ctrl. Mo., version (RG.96) -> Display identification services Lane Change Assistance Control Module -J768- (and -J770-) (Figure 1).
