## Technical Service Bulletin

**12-01-027**

**SANTA FE (AN)****SUBJECT: ECM UPDATE – 2.4L GDI/2.0L T-GDI CHECK FUEL CAP LOGIC IMPROVEMENT  
(SERVICE CAMPAIGN TL8)****\* IMPORTANT****\*\*\* Dealer Stock and Retail Vehicles \*\*\***

## ECU Update

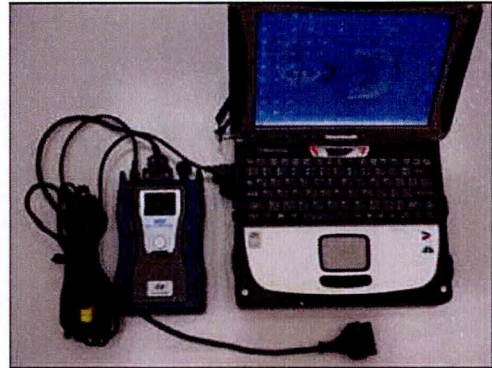
- Connect the USB cable between the GDS and the VCI.
- Connect the 16-pin DLC connector from the VCI into the DLC located under the driver's side dash.

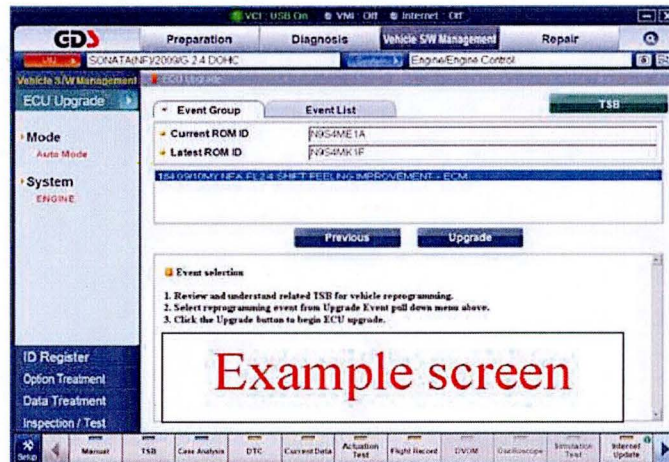
- Select update event as listed on the **GDS Event list of page-1**. Select **Upgrade**.

- If the screen indicates “**Voltage is OK**” (voltage > 12volts), select **OK**. If not, select **CANCEL** and charge the vehicle battery by running the engine for 10 minutes.
- Updating will continue until 100% is reached on the bar graph. At the prompt, turn the ignition key OFF for 10 seconds, then turn it ON and select **OK**.
- The GDS will confirm that ECM reprogramming had successfully finished. Select **OK**.
- If the ECM update was not successful, go to **GDS MANUAL MODE ECM UPDATE PROCEDURE**.
- Check for DTC in all systems and Erase All DTC that stored due to loss of CAN communication during the ECM Update.
- Turn **ignition OFF for 10 seconds** then turn back **ON** before starting the engine.
- Start the engine to confirm proper operation.
- Clear DTC in the BlueLink system per instructions of TSB 12-BE-005-2.
