<b>HYUNDAI</b>   NEW THINKING. NEW POSSIBILITIES.  <b>Technical Service Bulletin</b>	GROUP	MODEL
	FUEL SYSTEM	SANTA FE (CM)
	DATE	NUMBER
	NOVEMBER 2012	12-FL-008
<b>SUBJECT: ECM UPDATE – MIL ON WITH CYLINDER CONTRIBUTION/BALANCE</b> <b>DTC(s): P0263, P0266, P0269, P0272, P0275, P0278</b>

## **ECU Update**

This bulletin provides information for an ECM software update of some Santa Fe (CM) vehicles with 3.5L engine that may experience any of the following DTC(s):

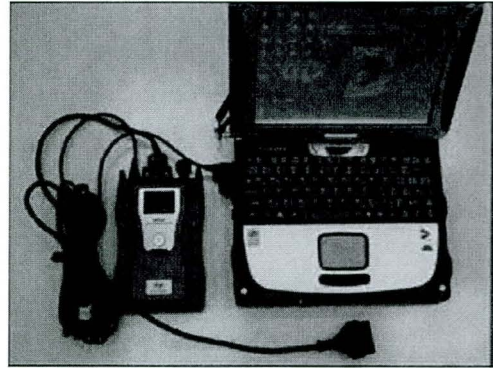
- Connect the USB cable between the GDS and the VCI.
- Connect the 16-pin DLC connector from the VCI into the DLC located under the driver's side dash.

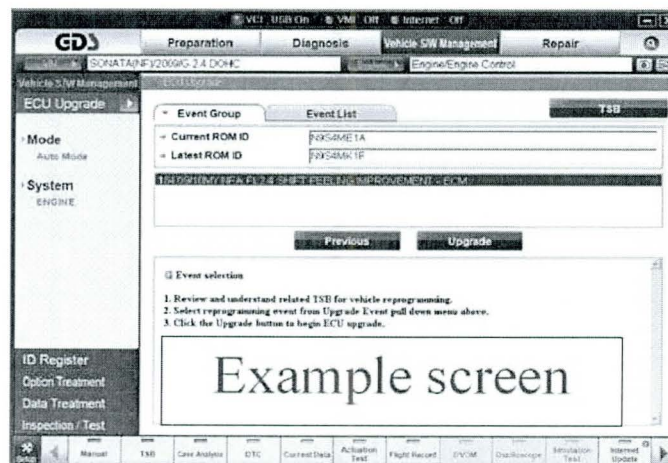
5. Select update event as listed on the **GDS Event list of page-1**. Select **Upgrade**.
