## Technical Service Bulletin

GROUP <b>CAMPAIGN</b>	NUMBER <b>12-01-049</b>
DATE <b>DECEMBER 2012</b>	MODEL <b>SANTA FE (AN)</b>

**SUBJECT: CLUSTER SOFTWARE UPDATE (SERVICE CAMPAIGN TN6)**

**Description:** This bulletin provides the service procedure to update the instrument cluster software.

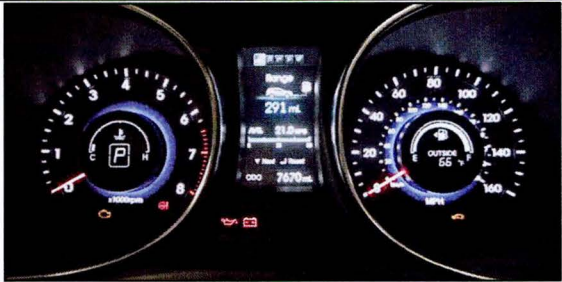
Model	Type	Cluster P/N	ROM ID	
			Previous	New
SANTA FE w/ Super Vision Cluster

94011-4Z000 94011-4Z010 94011-4Z020	-	B0 AD
SANTA FE w/ Conventional Cluster

Verify the ECM ROM ID before updating the vehicle's software. Refer to the table below.

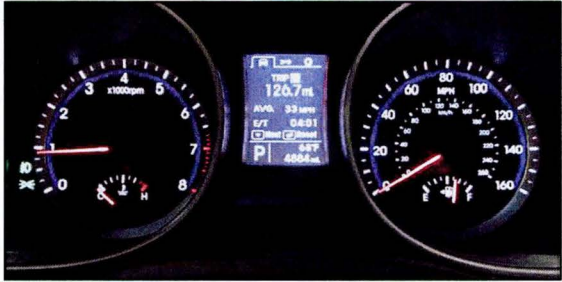
94001-4Z000 94001-4Z010 94001-4Z020	-	78 A2

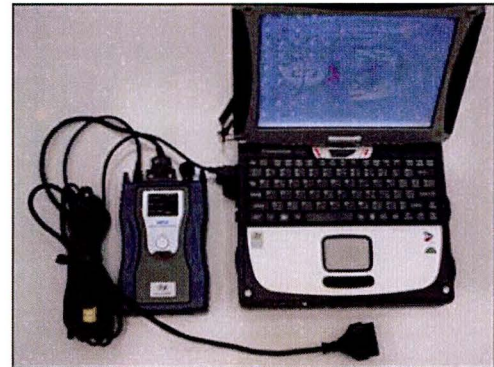
- Connect the USB cable between the GDS and the VCI.
- Connect the 16-pin DLC connector from the VCI into the DLC located under the driver's side dash.
