**NUMBER:** 08-065-12

**GROUP:** Electrical

RHR Navigation Map Enhancements

This bulletin involves updating the RHR radios navigation map database software.

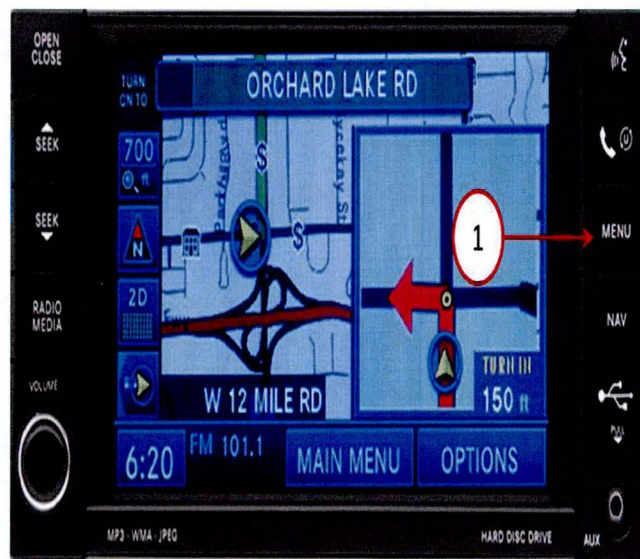
**Fig. 1 Radio Face Plate**

1 - MENU Key

1. Turn ignition to the RUN position
2. Turn the Radio on.
3. Press the MENU key (Fig. 1).

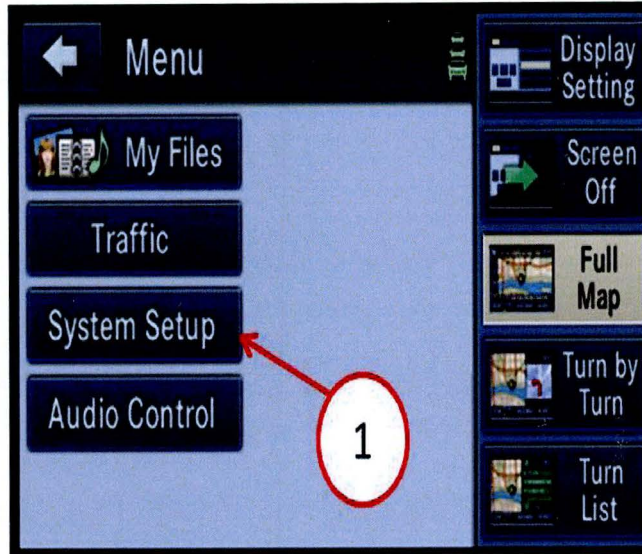
**Fig. 2 Radio Face Plate**

1 - System Setup

- 
4. Press System Setup (Fig. 2).

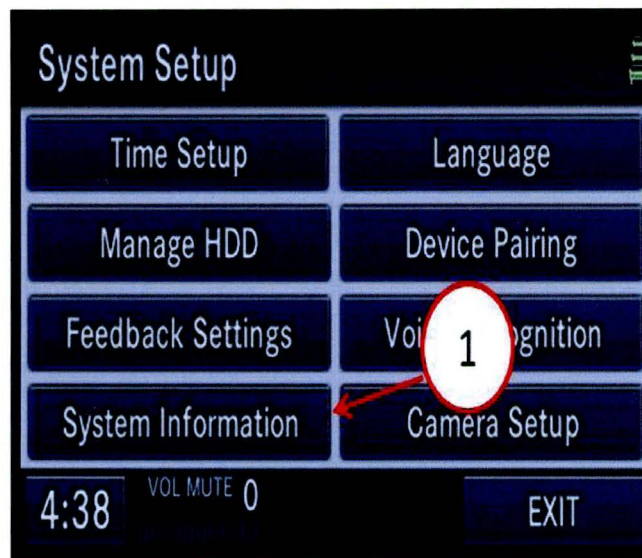
**Fig. 3 Radio Face Plate**

1 - System Information

5. Press System Information (Fig. 3).

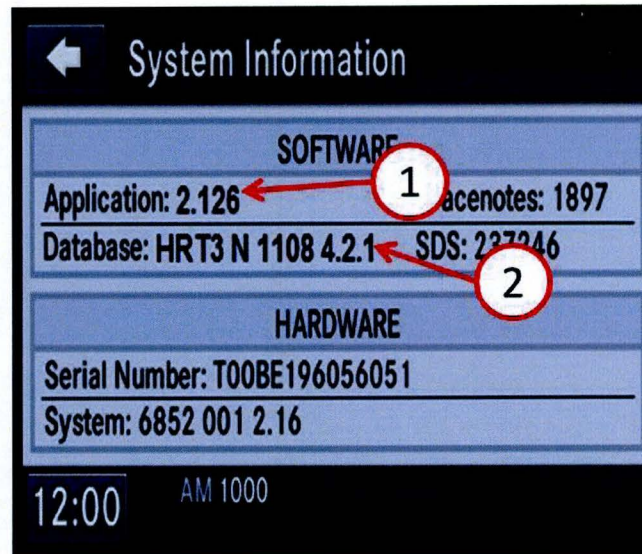
**Fig. 4 Software Versions**

- 1 - Application Version
- 2 - Database Software Version

6. Is the application software level at 2.126? (Fig. 4).  
a. No >>> Perform service bulletin 08-053-12 first, before proceeding with this bulletin.  
b. Yes >>> proceed to [Step #7](#).

- 
7. Is the Database software level at 4.3.1 or higher? (Fig. 4).
- a. Yes >>> This service bulletin doesn't pertain, normal diagnostic should be performed.
  - b. No >>> Proceed to [Step #8](#).

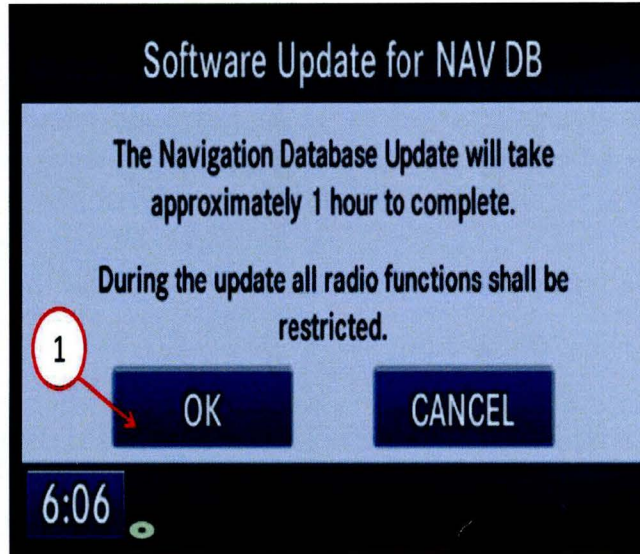
**Fig. 5 Radio Face Plate**

1 - Press OK

9. Insert the Navigation Map Update disc into the radio by pressing OPEN/CLOSE and inserting the update disc.
10. The radio will read the contents of disc and will prompt the user to select "OK" or "CANCEL" as shown in the screen below. It may take approximately 2 minutes for this prompt to display (Fig. 5).

- 
11. Press "OK"(Fig. 5).
  12. The next screen will display the current and new version of the Navigation Map database software (Fig. 6).
  13. Press YES to continue.

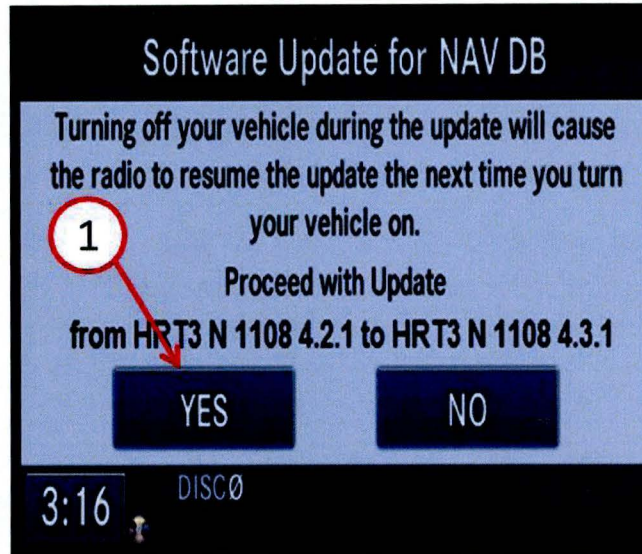
**Fig. 6 Current and Update Software Level**

1 - To Proceed Select "YES"

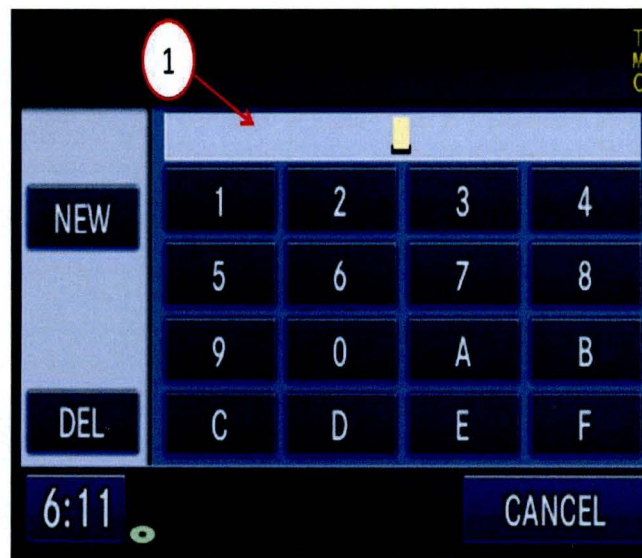
**Fig. 7 Radio Face Plate**

1 - Activation Key

14. When prompted by the radio enter the activation key obtained in [Step #8](#).

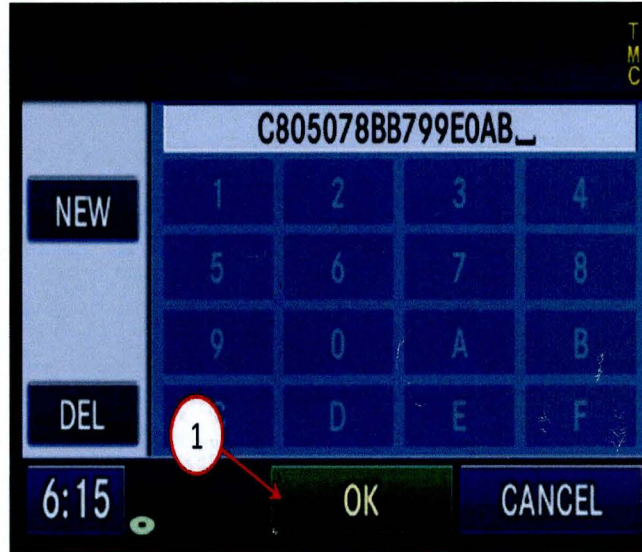
**Fig. 8 Radio Face Plate**

1 - Press OK

15. After successful entry of the activation key, the following screen will be displayed ([Fig. 8](#)).

- 16. Press "OK" and the update process will begin.
- 17. The following screen will be displayed (Fig. 9).

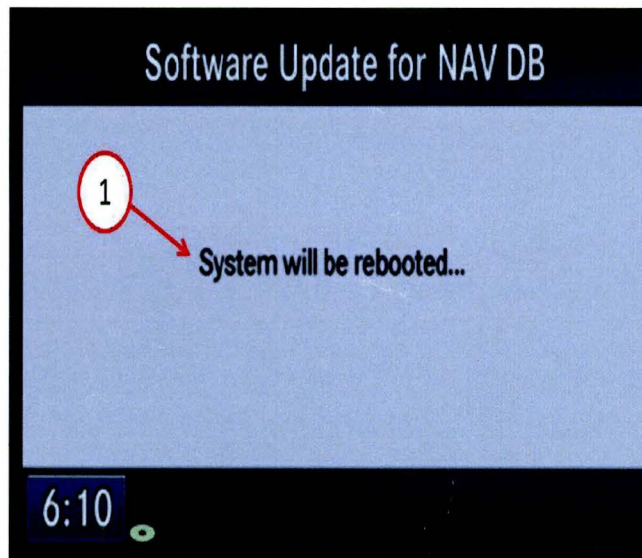
**Fig. 9 Radio Face Plate**

1 - System Reboot

**NOTE:** The update may take up to 1 hour to be completed. Once the update has been started no other action is needed from the technician. The tech can perform other duties while the navigation system is being updated.

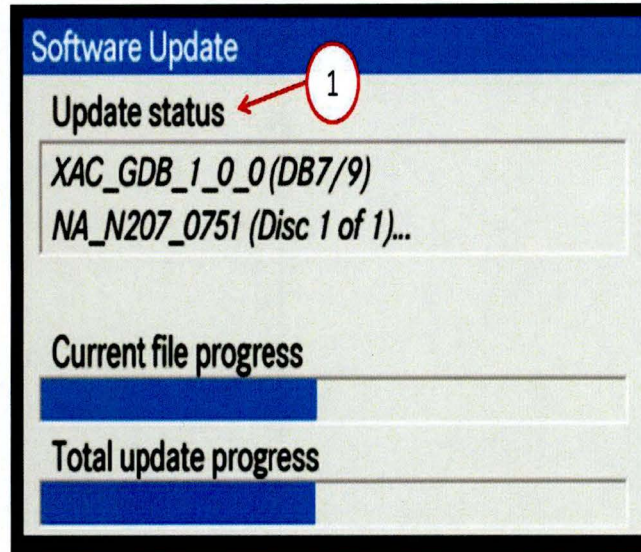
**Fig. 10 Radio Face Plate**

1 - Status

18. After the radio resets, the following screen will be displayed (Fig. 10)

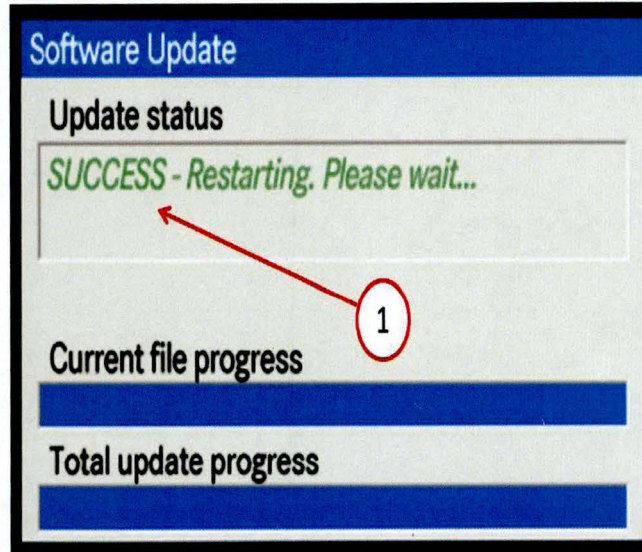
**Fig. 11 Radio Face Plate**

1 - Success

19. After successful update, the following screen will be displayed (Fig. 11)
