Technical Service Bulletin

24V2 UPDATE – ECM Software Update (FED_EMS)

Model(s)	Year	VIN Range	Vehicle-Specific Equipment
A6	2012	0009333 - 024032	3.0 TFSI Engine
A7

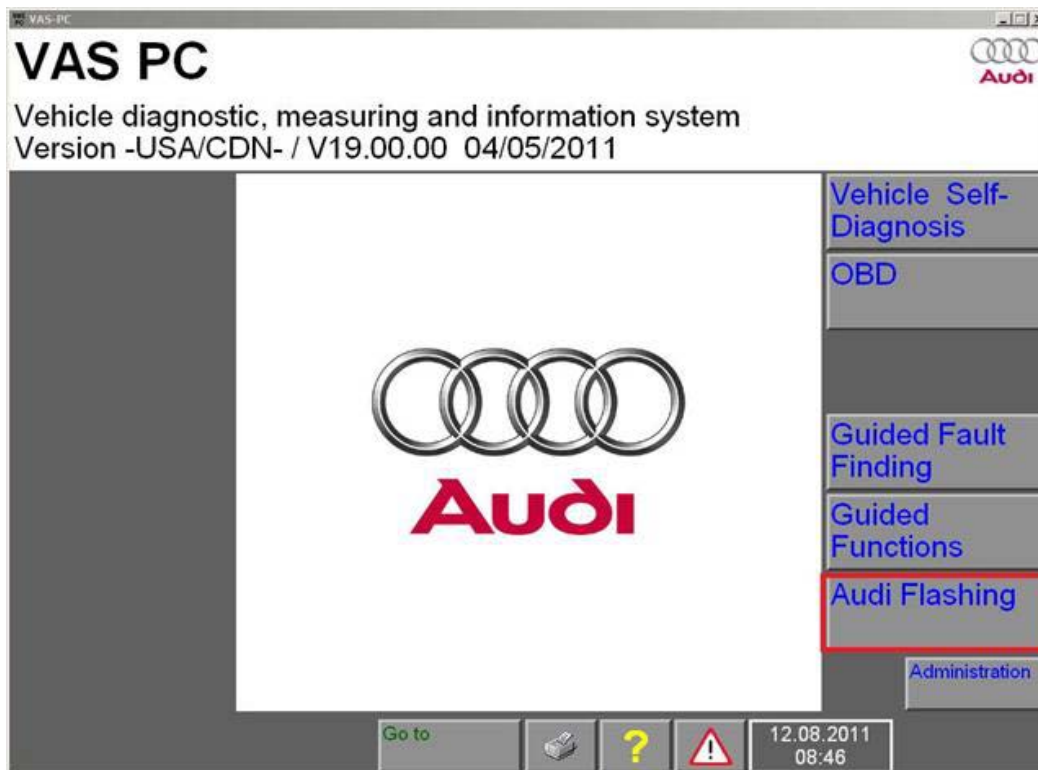
3. Connect diagnostic tester to vehicle.
4. Select "Audi Flashing" mode (Figure 1).

Figure 1. Audi Flashing.
