GROUP Electrical	MODEL Sorento (XMa) 2013MY
	NUMBER 047	DATE November 2012
TECHNICAL SERVICE BULLETIN		
SUBJECT: SERVICE ACTION: SORENTO UVO SOFTWARE UPGRADE (SA138)

This bulletin provides the procedure for upgrading the 2013MY Sorento UVO system. Kia is requesting the completion of this Service Action on all affected 2013MY Sorento vehicles prior to delivery. Before conducting the procedure, verify that the vehicle is included in the list of the affected VINs.

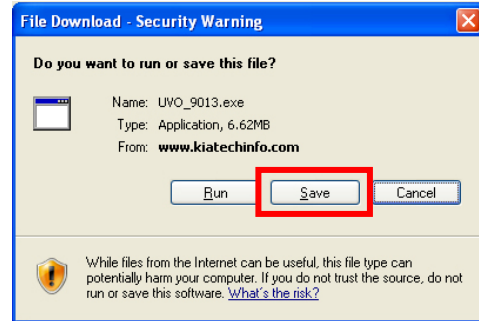
3. Click "Save File."

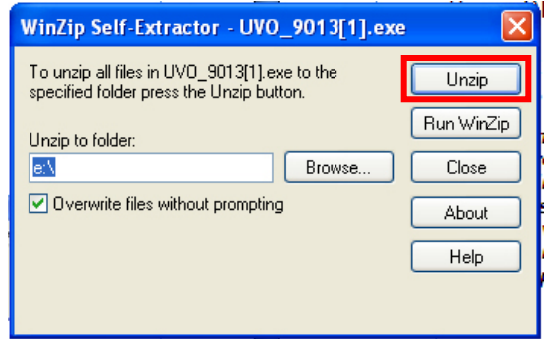
- 7. Insert a flash drive into USB port on your computer; click "Unzip" and the files will be downloaded to the USB flash drive.

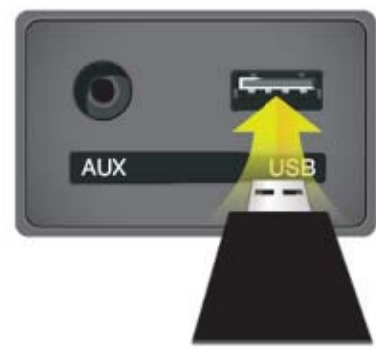
- 8b. Power UVO system ON.
- 8c. Connect USB flash drive to UVO system's USB socket.

The system will display "Reading Media" on the screen after USB is inserted. This is normal, since the unit is searching for music files. Then the system may display a "No File Available" pop-up after system music search is complete, wait until new screen appears and continue with the upgrade. Do not power off at any point while the system is being upgraded.

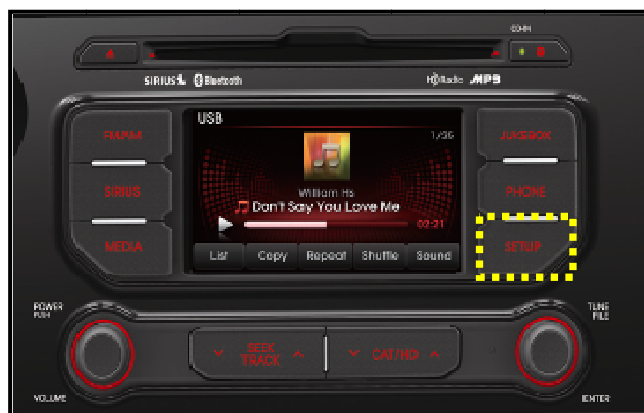
9. Press **“SETUP”** button on the head unit.

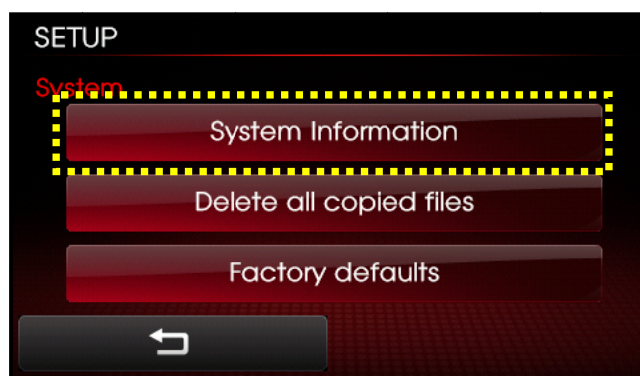
11. Touch **“System Information”** button on the screen.

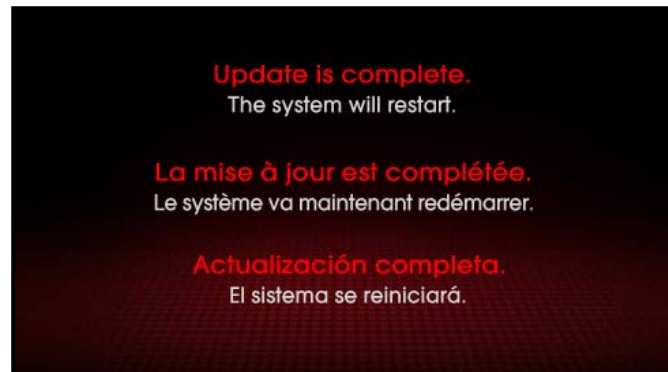
15. After the update is complete, the display shown on the right will appear for a few moments; then the UVO system will reboot again.

Repeat steps 2~4 and check whether UVO system version has been updated correctly (1.MP.9.013).
