MODEL  
Sportage (SL)  
2013MY

NUMBER  
048 (Rev 1, 12/13/2012)

SUBJECT: SERVICE ACTION: UVO SOFTWARE UPGRADE (SA139A)

This bulletin provides the procedure for upgrading the 2013MY Sportage UVO system. Kia is requesting the completion of this Service Action on all affected 2013MY Sportage vehicles prior to delivery. Before conducting the procedure, verify that the vehicle is included in the list of the affected VINs.

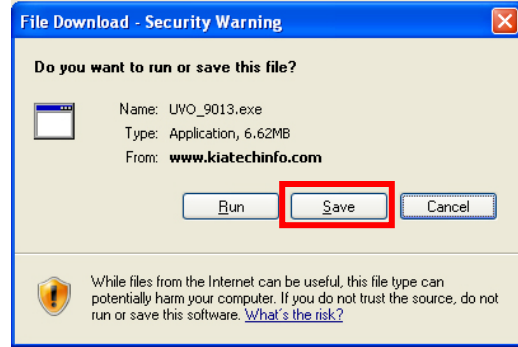
3. Click "Save File."

The UVO file download screens are for demonstrative purposes only. Actual screen content may differ.

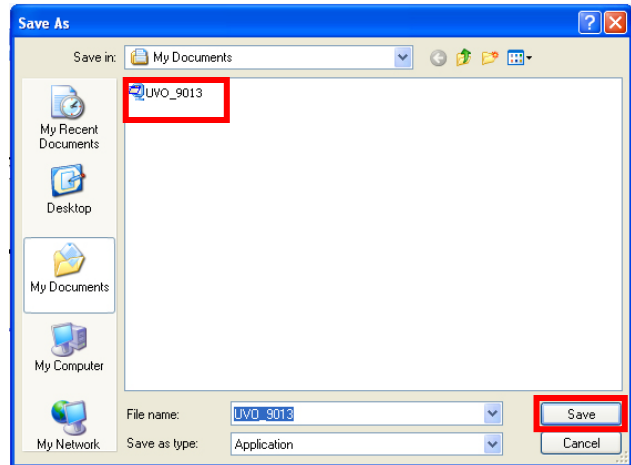
4. Click "Save".

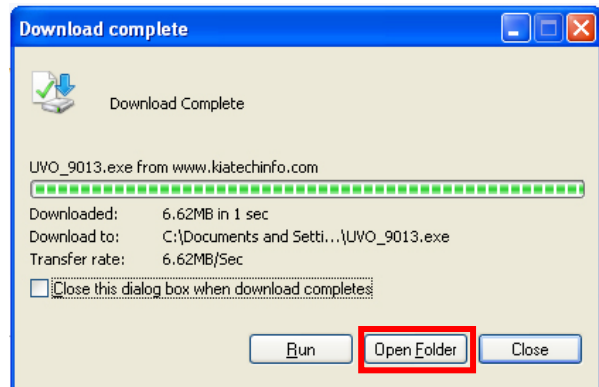
5. Click "Open Folder."

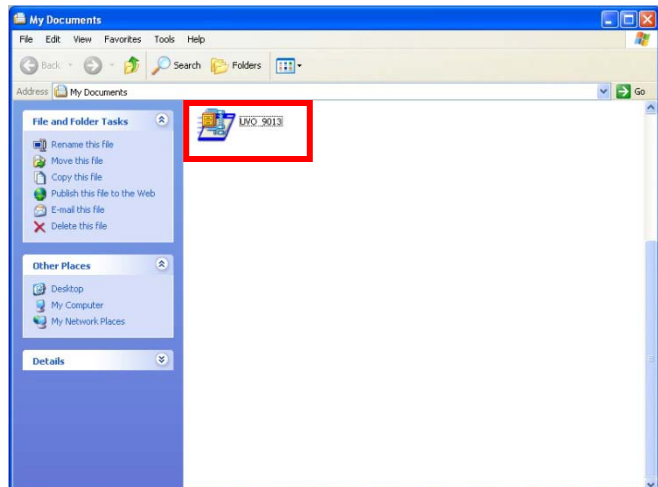
6. Click on update file to open it. The file name is "UVO\_9013".

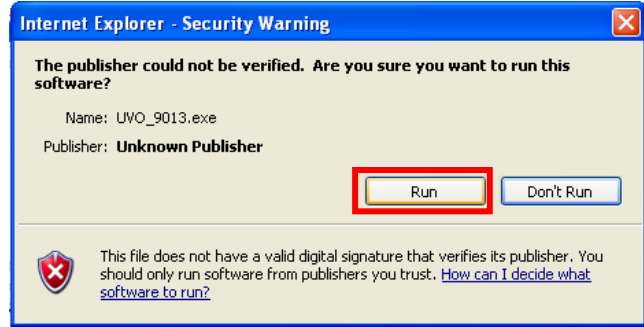
7. Click "Run."

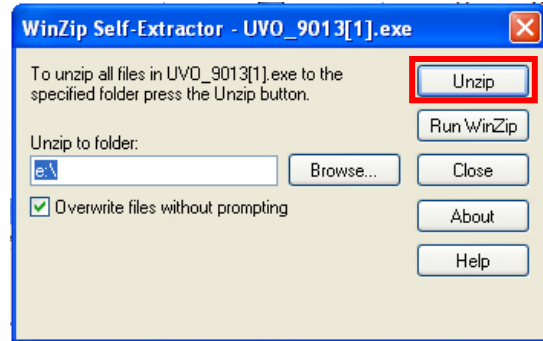
8. Insert a flash drive into USB slot on your computer; click Unzip and the files will be downloaded to the flash drive.

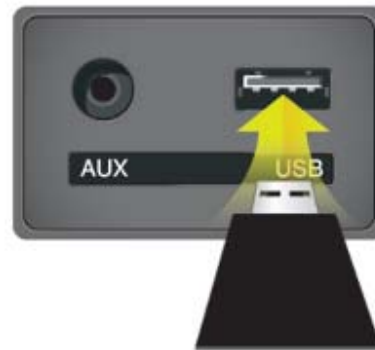
9. Unzip the downloaded file directly to the root directory of the USB being used for the update.

Unzipping the attached or downloaded file and copying the folder to the USB or unzipping to any folder other than the root folder will result in the upload not executing.

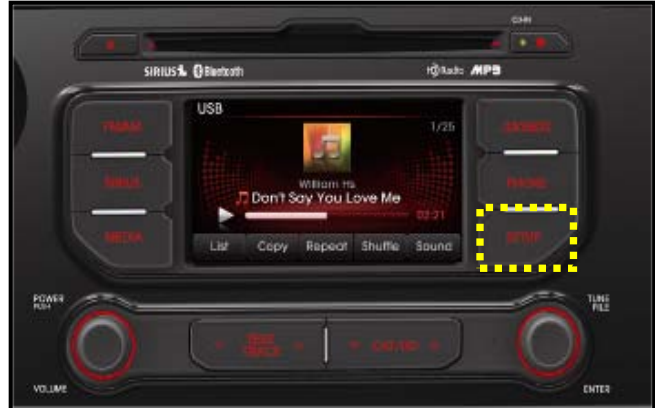
10. Press **“SETUP”** button on the head unit.

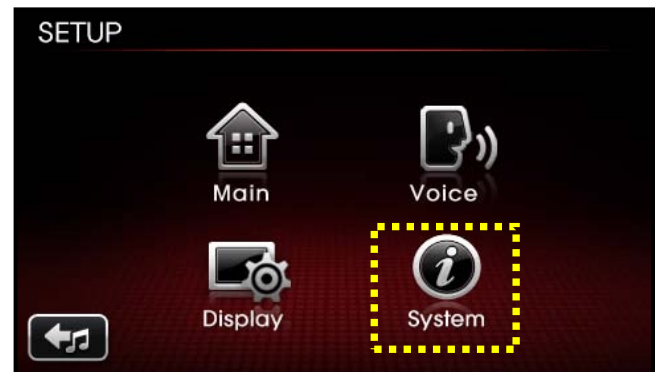
11. Touch **“System”** icon on the screen.

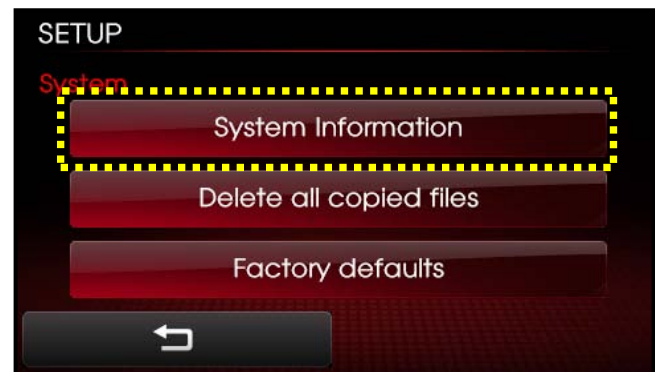
12. Touch **“System Information”** button on the screen.

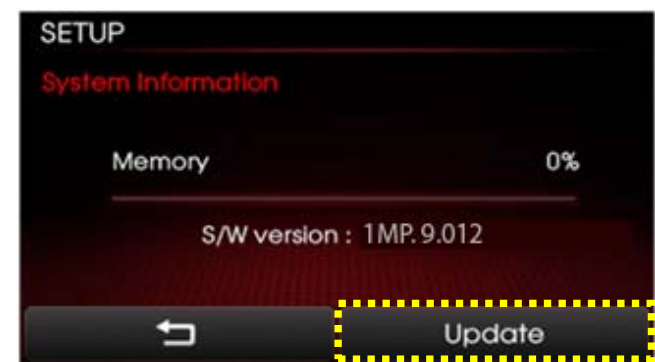
- 13a. Verify the current S/W version (1.MP.9.011) as shown in the image.

- 13b. Touch **“Update”** button on screen.

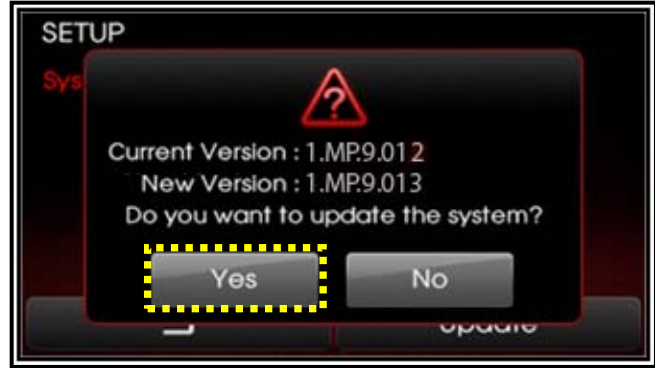
14. Check that “**New Version**” is correct for this Service Action (New version is 1.MP.9.013); if version is correct, then touch “**Yes**” button on screen.

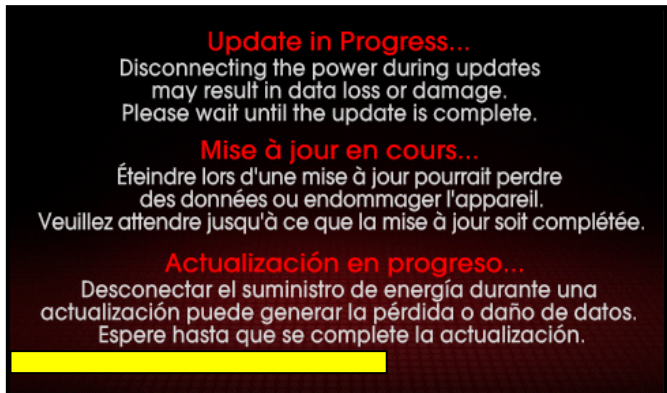
15. The UVO system will automatically reboot and the update will proceed.

When rebooting, screen will go dark for approximately 20 to 40 seconds, this is normal. System will reboot 2 times to perform the update.

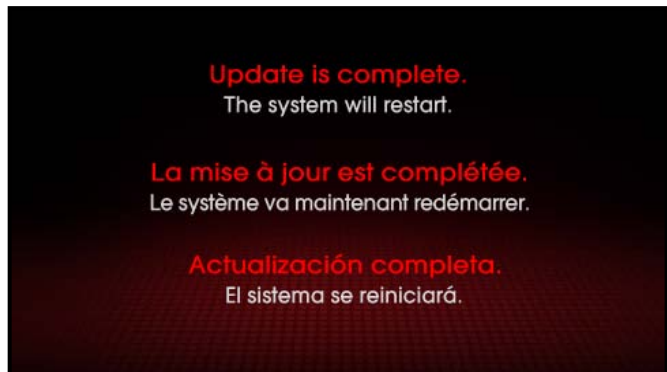
16. After the update is complete, the display shown on the right will appear for a few moments; then the UVO system will reboot again.

Repeat steps 2~4 and verify whether UVO system version has been updated to version 1.MP.9.013.
