GROUP Engine	MODEL 2013MY Sorento (XM) w/2.4L GDI
NUMBER 122	DATE August 2012

TECHNICAL SERVICE BULLETIN

SUBJECT: SERVICE ACTION: ECM UPGRADE –
2.4L GDI IDLE RPM STABILITY IMPROVEMENT (SA128)

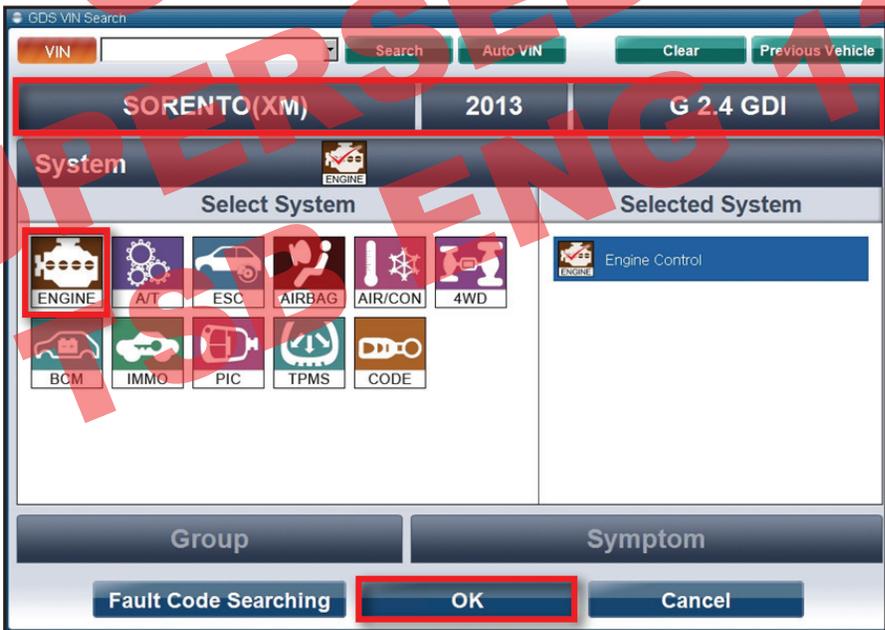
- 5. With the ignition key ON, turn ON the VCI and GDS tool. Access the GDS vehicle identification number (VIN) screen and configure the vehicle using the VIN Auto Detect function.

- 6. Once back at the GDS Main Screen, select ECU Upgrade from the bottom right-hand corner. Next select Auto Mode, and then Engine. Perform the ECM upgrade in accordance with normal GDS tool ECM upgrade procedures.
