## WC34 - Re-programming Front-end Electronics Control Unit and Rear-end Electronics Control Unit (Workshop Campaign)

| Vehicle Type: | <b>Cayenne (92A)/Cayenne Diesel (92A)/Cayenne S Hybrid (92A)<br/>Cayenne S (92A)/Cayenne Turbo (92A)</b> |
| Concerns: | <p><b>Front-end electronics control unit</b></p> <p><b>Rear-end electronics control unit</b> (only for model year 2012 vehicles)</p> |

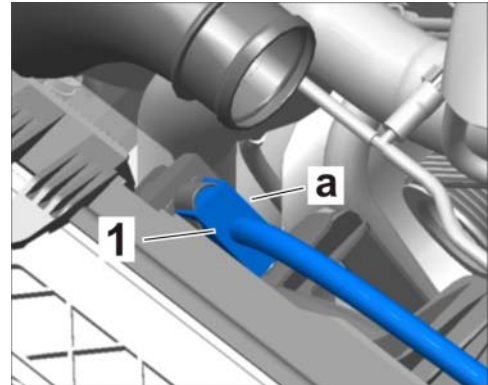
*Electric plug connection for fan blower*

- 1 Disconnect electric plug connection for the fan blower ⇒ *Electric plug connection for fan blower -1-* (⇒ *Electric plug connection for fan blower -a-*) to prevent the fan blower from coming on during control unit programming.  
Having the fan on and the associated increased current draw can cause a drop in voltage, which can result in abnormal termination of control unit programming.

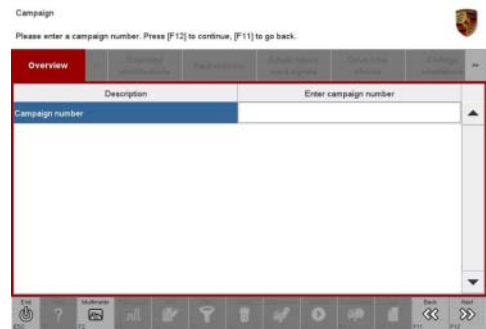
*Programming number input field*

- 6 To enter the programming number, click in the relevant text box so that the cursor starts to flash  
⇒ *Programming number input field.*

- 7 Enter the programming number **WC34\_92A** and press  
•Enter “ to confirm.
