WC34 - Re-programming Front-end Electronics Control Unit and Rear-end Electronics Control Unit (Workshop Campaign)

**Vehicle Type: Panamera/Panamera 4/Panamera S Hybrid
Panamera S/Panamera 4 S/Panamera Turbo/Panamera Turbo S**

**Concerns: Front-end electronics control unit
Rear-end electronics control unit (only for model year 2012 vehicles)**

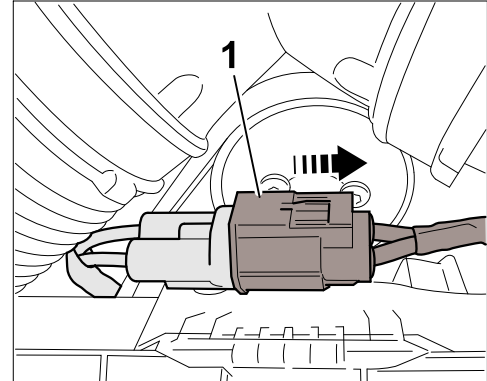
Disconnecting electric plug connection

- 1 Disconnect electric plug connection for the fan blower ⇒ *Disconnecting electric plug connection -1-* (⇒ *Disconnecting electric plug connection -arrow-*) to prevent the blower from coming on during control unit programming. Having the fan on and the associated increased current draw can cause a drop in voltage, which can result in abnormal termination of control unit programming.

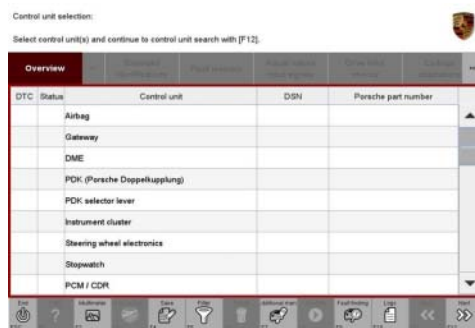
Control unit selection

- 2 In the control unit selection screen (⇒ **'Overview'** menu), press **•F7** to call up the ⇒ **'Additional menu'** (⇒ *Control unit selection*).

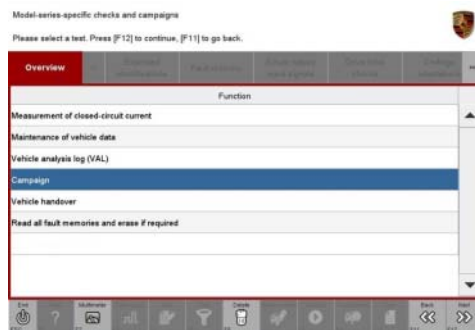
Additional menu – Campaign

- 3 When the question "Create Vehicle Analysis Log (VAL)?" appears, either press **•F12** to create a VAL or press **•F11** if you do not want to create a VAL.
- 4 Press **•>>** to acknowledge the message informing you that campaigns for the vehicle are stored in the PIWIS information system.
- 5 Select the ⇒ **'Campaign'** function and press **•>>** to confirm your selection ⇒ *Additional menu – Campaign*.

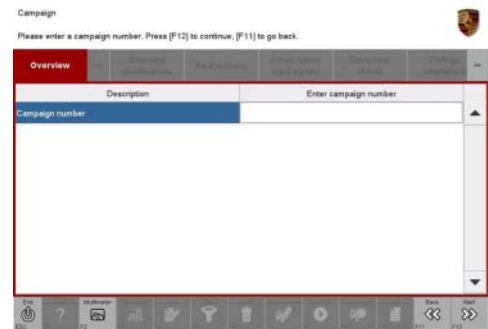
Programming number input field

- 6 To enter the programming number, click in the relevant text box so that the cursor starts to flash ⇒ *Programming number input field.*
