2012-2013MY Rio (UB)  
2012-2013MY Soul (AM)

118 (REV 2, 10/08/2013)

## TECHNICAL SERVICE BULLETIN

SUBJECT: COMBINED TSB/SERVICE ACTION – RIO, SOUL 1.6 GDI MIL ON WITH DTCS P0456/P0461/P050A/P2188/P2192/P0128 (SA152)

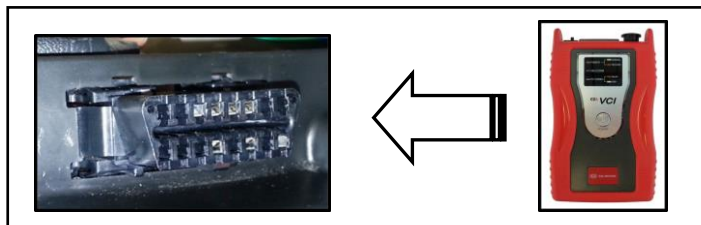
3. Connect the Main 16-pin DLC cable (GHDM – 241000) to the VCI.

4. Connect the Main 16-pin DLC cable (GHDM – 241000) to the OBD-II connector, located under the driver's side of the instrument panel.

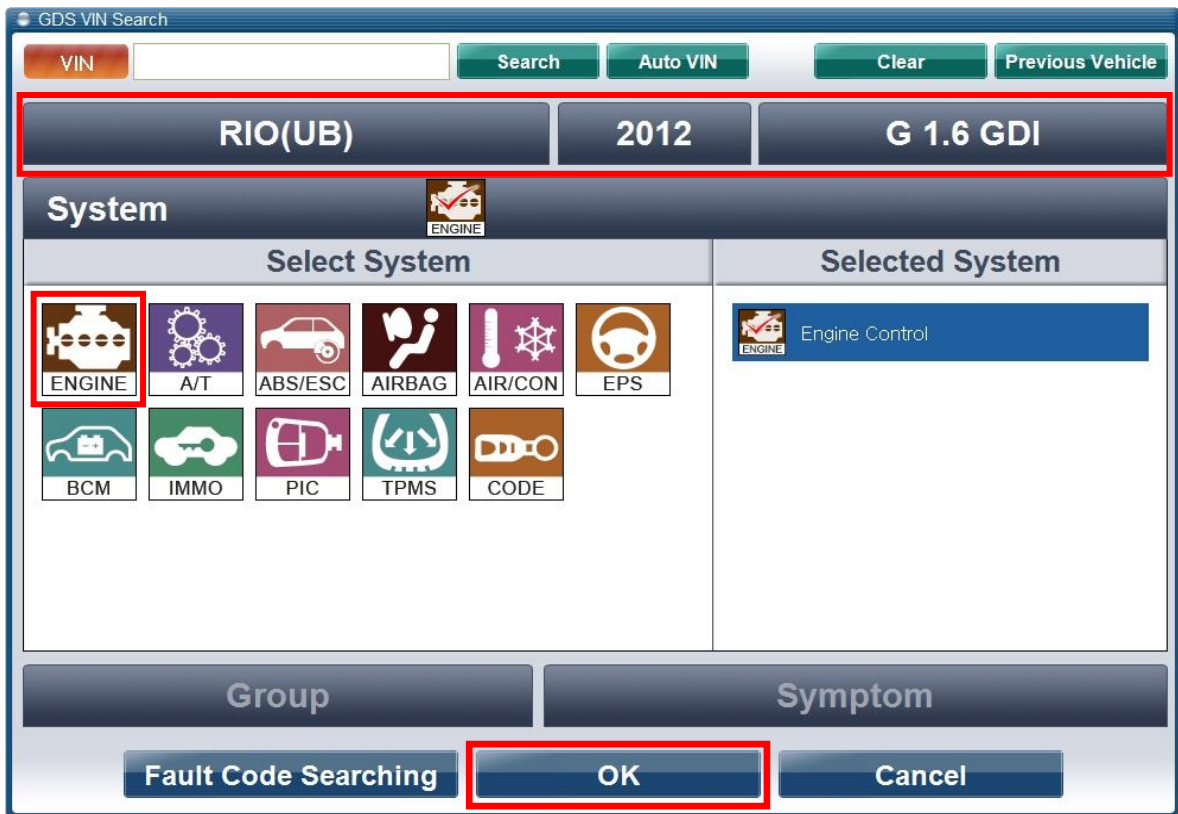
*Display screen above is for demonstration purposes only and will vary depending on model.*

7. Select **ECU Upgrade** from the bottom right-hand corner. Next select **Auto Mode**, and then **Engine**. Perform the ECM upgrade in accordance with normal GDS tool ECM upgrade procedures.
