GROUP Engine	MODEL 2011-2013MY Sorento (XM), 2011, 2012 & 2014MY Sedona (VQ)
NUMBER 133 (REV 2, 11/27/2013)	DATE September 2013

## TECHNICAL SERVICE BULLETIN

SUBJECT: SERVICE ACTION: ECM UPGRADE – MIL ON WITH DTC  
P0638 AND ETC MOTOR CLEANING (SA153)

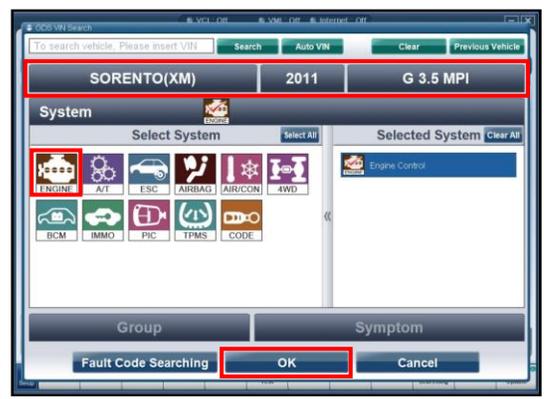
1. Select **ENGINE** System and click the **ETC Motor Cleaning**.

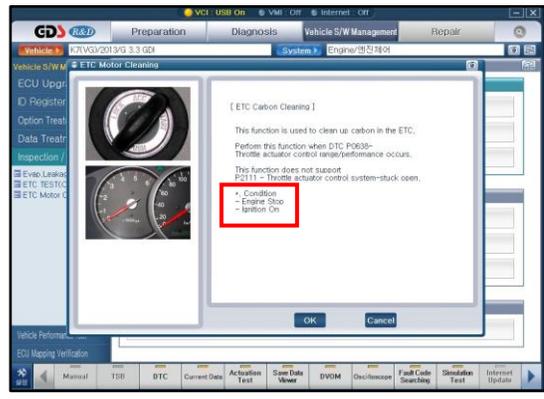
2. Click **OK** on the screen with the engine **OFF** and ignition in the **ON** position.

**The purpose of the cleaning procedure:**  
 “ETC Motor Cleaning” can be easily misunderstood and maybe assumed to be cleaning the throttle bore due to carbon build up. The cleaning procedure is designed to clean the electric motor brushes at the commutator located within the throttle body. Failure to perform this procedure may result in vehicle returning back to the dealer for the same issue and chargeback. The screen print should be attached to R/O.

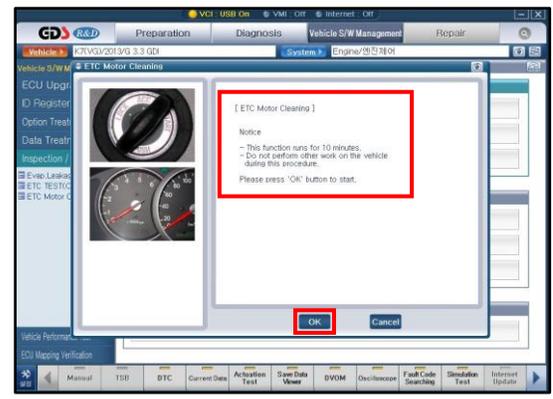
3. Click **OK** after reading the on-screen notice.

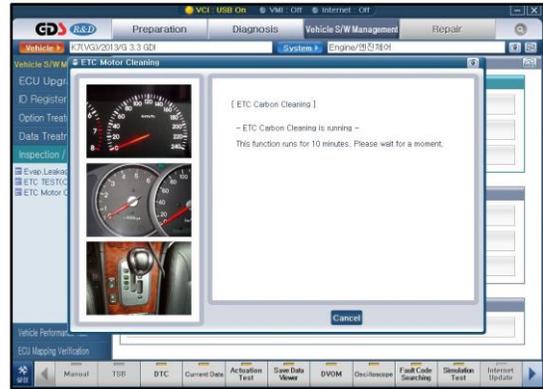
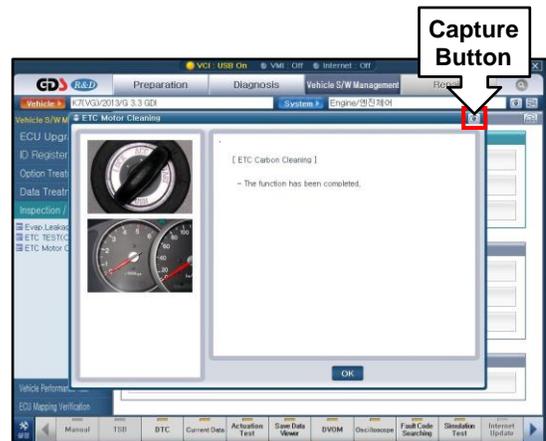
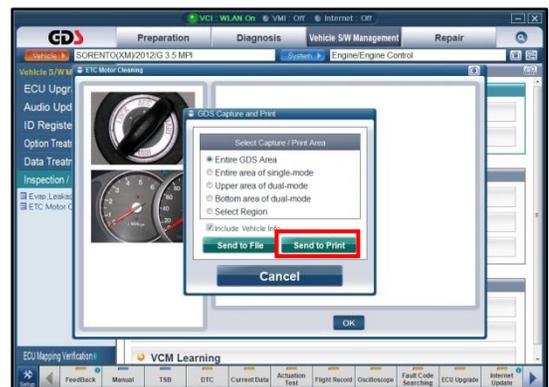
4. It will take, approximately, 10 minutes to complete the motor cleaning function.

5. Once the motor cleaning function has been completed, click on the capture button, as shown.

6. Make sure to capture the entire GDS area and click on the “Send to Print” button.

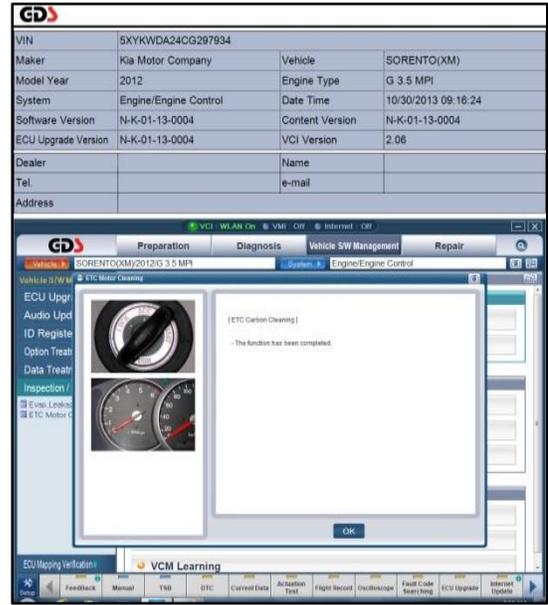
A paper copy of the screen capture **MUST** be attached to the R/O for verification that the procedure was completed.

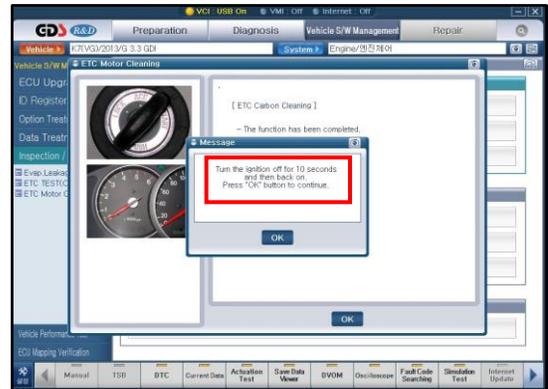
7. Cycle the ignition once, as directed.

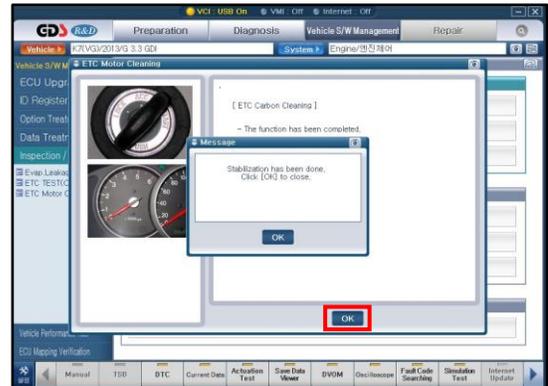
8. Click on OK to close.

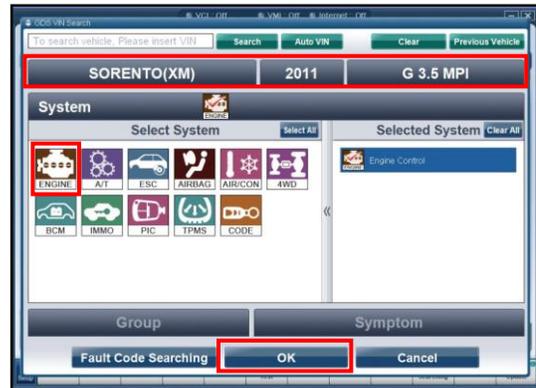
6. Select **ENGINE** system and click **OK**.

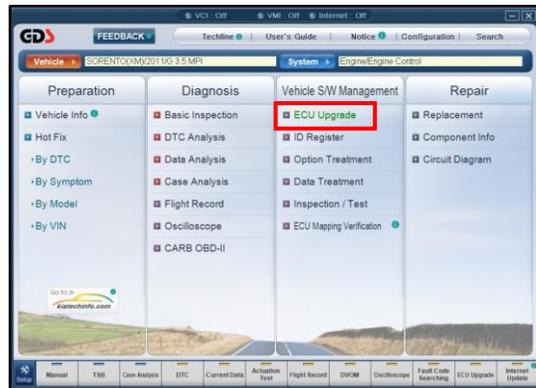
7. Select **ECU Upgrade**.

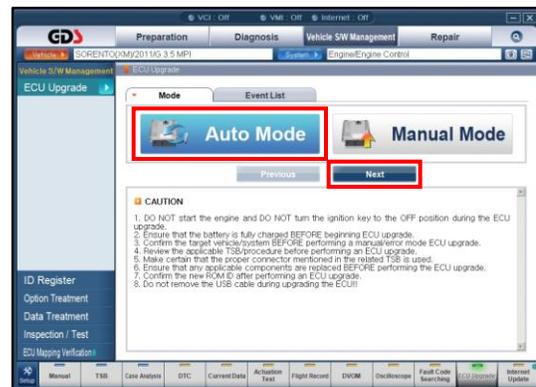
8. Select **Auto Mode**, and then **Next**.

Do NOT attempt to perform a Manual Mode upgrade unless Auto Mode fails. Always follow the instructions given on the GDS tool in either Auto or Manual mode. See table for Manual Mode passwords.

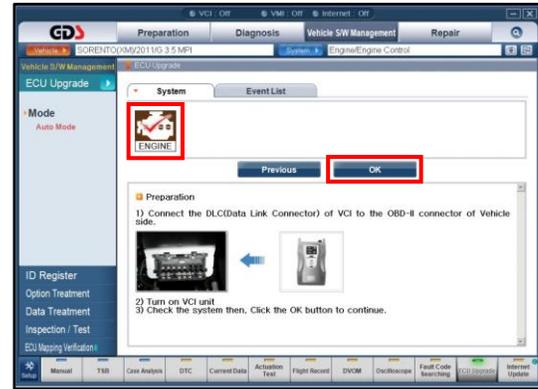
9. Select **Engine** and click **OK**.

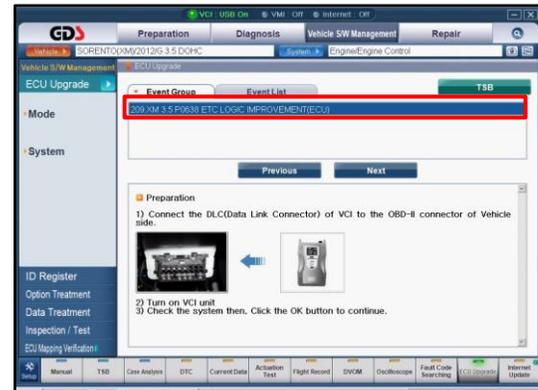
10. Select Upgrade Event: **208.VQ 3.5 P0638 ETC LOGIC IMPROVEMENT (ECU)** or **209.XM 3.5 P0638 ETC LOGIC IMPROVEMENT(ECU)**, then click **Upgrade** button and **OK** on battery voltage check screen.

UPGRADE EVENT NAME
208.VQ P0638 ETC LOGIC IMPROVEMENT
209.XM P0638 ETC LOGIC IMPROVEMENT

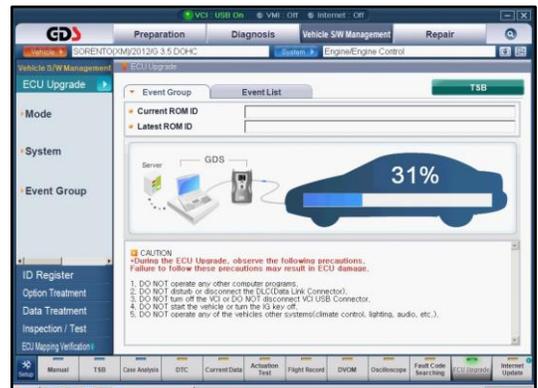
11. Upgrade will begin and the progress of the upgrade will appear on the bar graph.

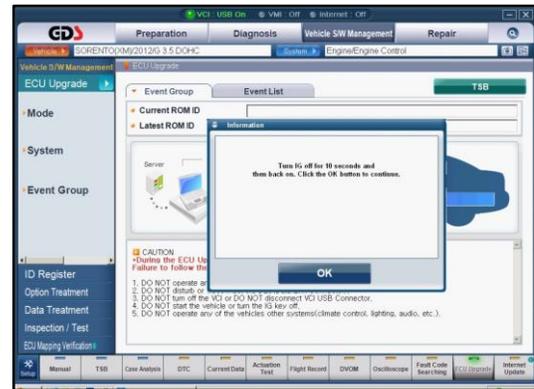
12. Follow the guidelines displayed on the screen during upgrade procedure and make sure to cycle the ignition **OFF** ↔ **ON** once.

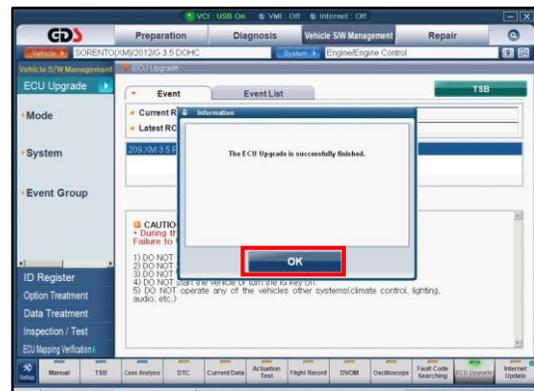
13. Click OK on the final screen. Upgrade events 208 or 209 are now complete.
