Subject: *****MAZDA SERVICE PROGRAM (MSP41) - MAZDA CONNECT INFOTAINMENT GMGTEM UPDATE	Bulletin No: 09-034/13
	Last Issued: 11/25/2013

2014 Mazda3 vehicles (with MAZDA CONNECT Infotainment System) after June 11, 2013

An updated version of the software for the Connectivity Master Unit (CMU) has become available. Under this MSP41, the CMU of applicable Mazda3 vehicles will be reprogrammed to the updated version using a USB memory stick. This software update includes some fixes for the Infotainment System as described below as well as some additional minor fixes.

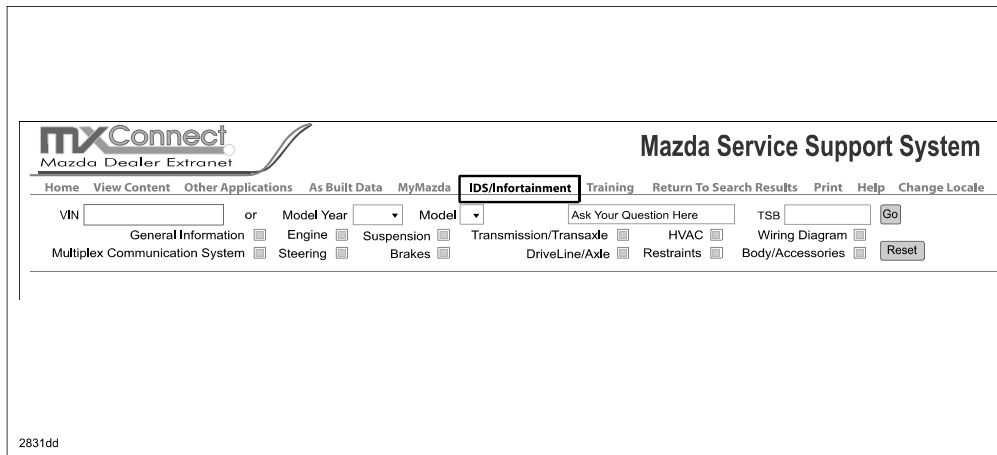
5. Log on to MS3 and select “IDS/Infotainment.”

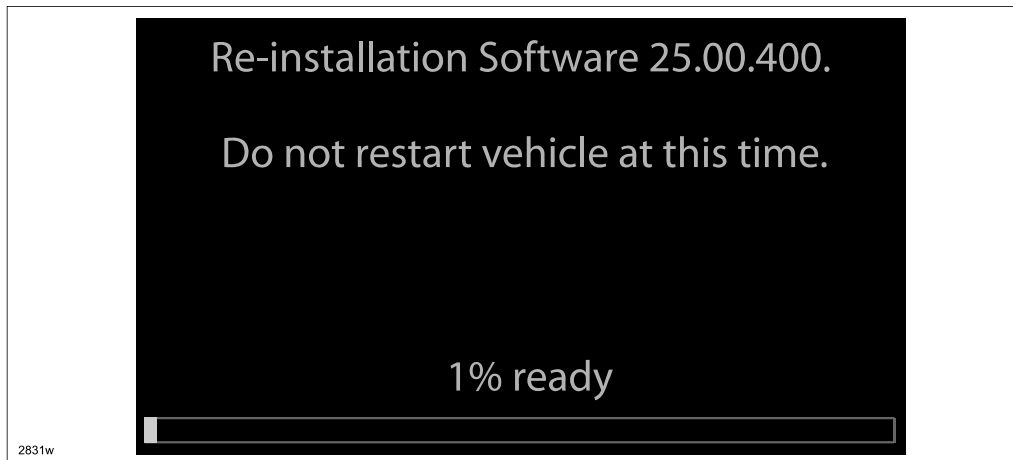
25. Reinstallation will start from 0% and as the reflashing process takes place, the progress bar will gradually increase to 100%.

NOTE: It may be difficult to read the display at times as it becomes dark, but "Do not restart vehicle at this time" is displayed.

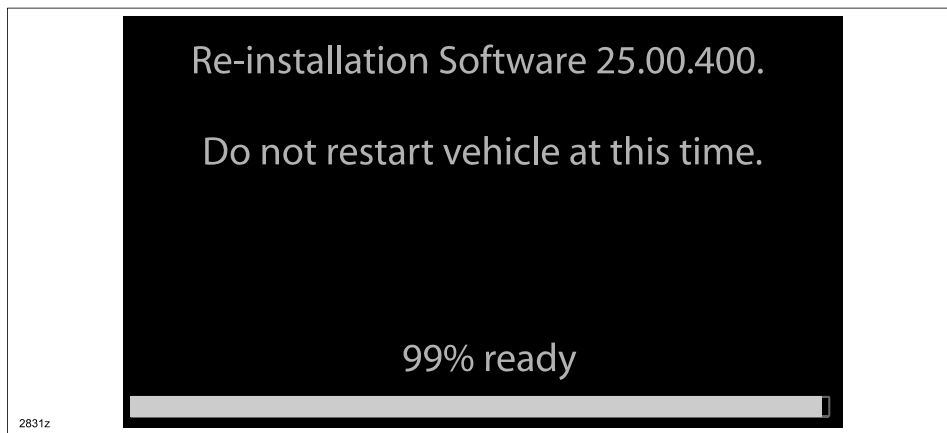
Type B: The ignition was turned “OFF” during the reflashing process. This screen will continue to be displayed until reflashing is completed. After the reflashing is completed, go to next step.
