MODEL
2011-2012MY Optima (TF/QF) Turbo
2011-2012MY Sportage (SL) Turbo

TECHNICAL SERVICE BULLETIN

SUBJECT: SERVICE ACTION: ECM UPGRADE – MIL ON WITH DTC P0300 AND/OR P0301, P0302, P0303 AND P0304 (SA151)

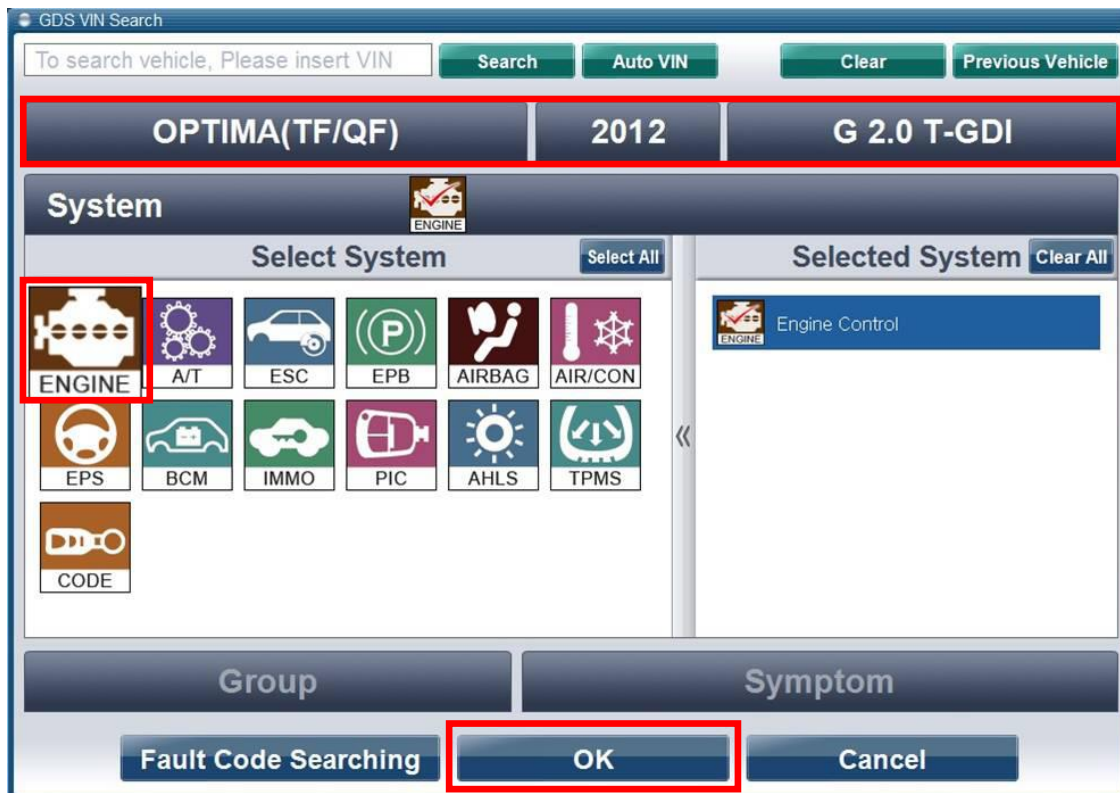
- With the ignition key ON, turn ON the VCI and GDS tool. Access the GDS vehicle identification number (VIN) screen and configure the vehicle using the VIN AUTO DETECT Function.
