# Technical Service Bulletin

## PSS 01 Mil on, fuel rail pressure low (P0087)

01 13 72 2033211/1 March 5, 2013.

Model(s)	Year	VIN Range	Vehicle-Specific Equipment
A4, allroad, A5, A5 cab, Q5, A6	MY13	000001 - 999999	2.0 TFSI

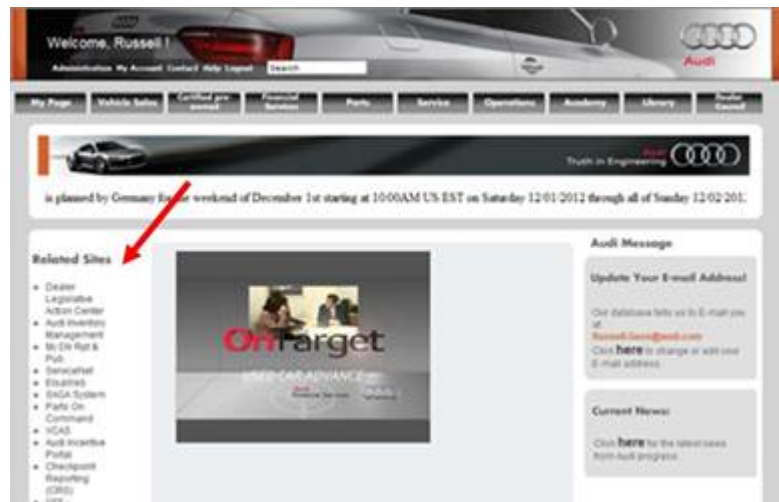
Figure 1. Related Sites section on Accessaudi.com landing page

3. Create a PSS record in the PSS application via the hyperlink in Accessaudi.com (Figure 1) or Technical Assistance page in Elsa (Figure 2).

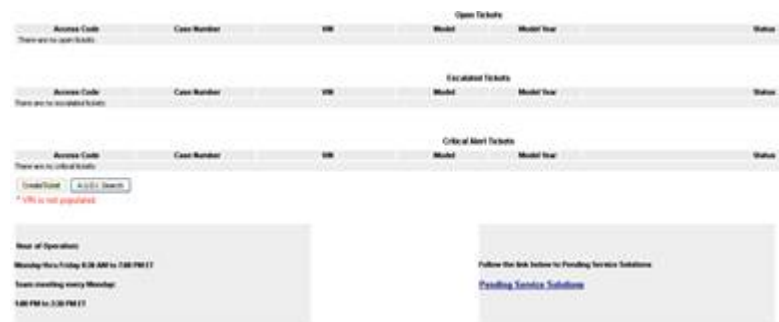
Figure 2. Technical Assistance page
