Navigation System Firmware Update

Service Category Audio/Visual/Telematics

Section Navigation/Multi Info Display

YEAR(S)	MODEL(S)	ADDITIONAL INFORMATION
2014	IS250	Drive Type(s): 2WD, 4WD VDS(s): BF1D2, CF1D2
2014	IS350	Drive Type(s): 2WD, 4WD VDS(s): BE1D2, CE1D2

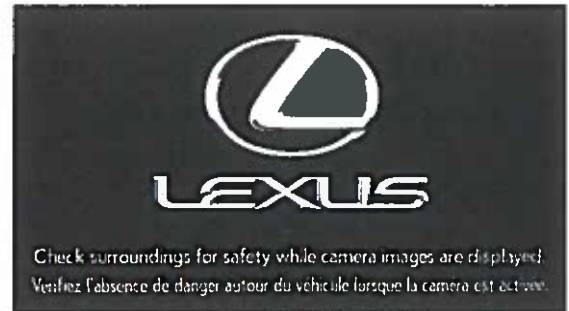
Figure 1.

1. Confirm the software version.
 - A. Cycle ignition to ACC. The *LEXUS* emblem will be displayed on the navigation screen.
 - B. Wait for the display to switch to the *Caution* screen, and then select *Continue*. The map screen will display.
 - C. Enter the *Service Menu* by cycling the headlight switch ON/OFF 3 times while holding down the MENU button.

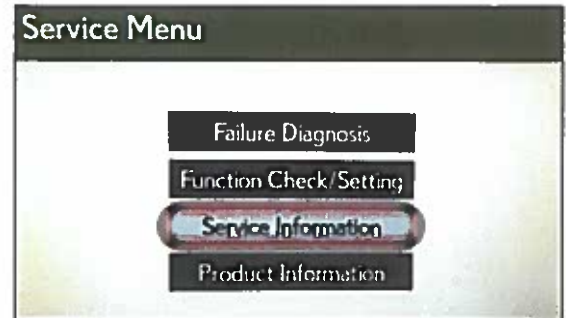
Figure 4.

D. Select *Service Information*.

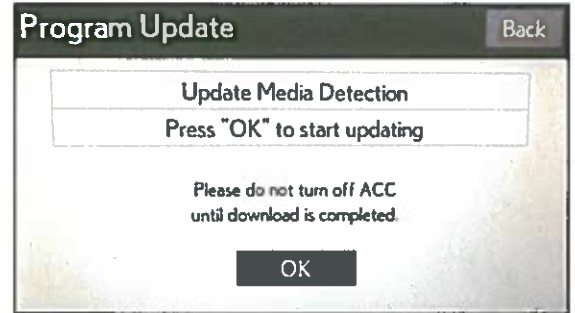
Figure 10.

D. Wait for the system to recognize the update media.

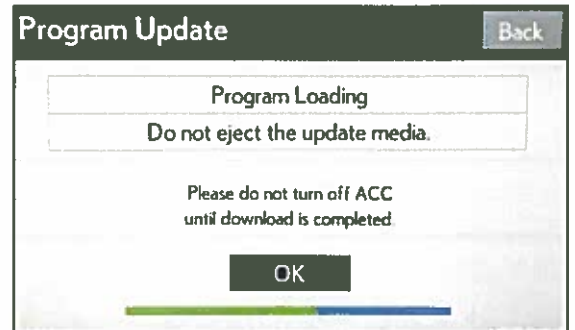
Figure 12.

F. Wait for the upload to finish. This should take about 2 – 3 minutes.

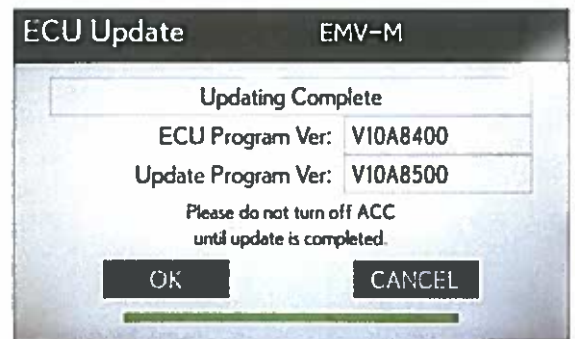
Figure 15.

- I. Wait until update is complete. This should take about 3 – 5 minutes.

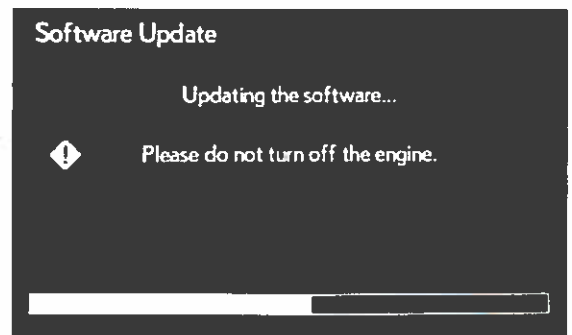
Figure 19.

- L. Cycle ignition to ACC and wait for the update to finish.
