# Navigation System Firmware Improvement

**Service Category** Audio/Visual/Telematics

**Section** Navigation/Multi Info Display

## Navigation System Firmware Improvement

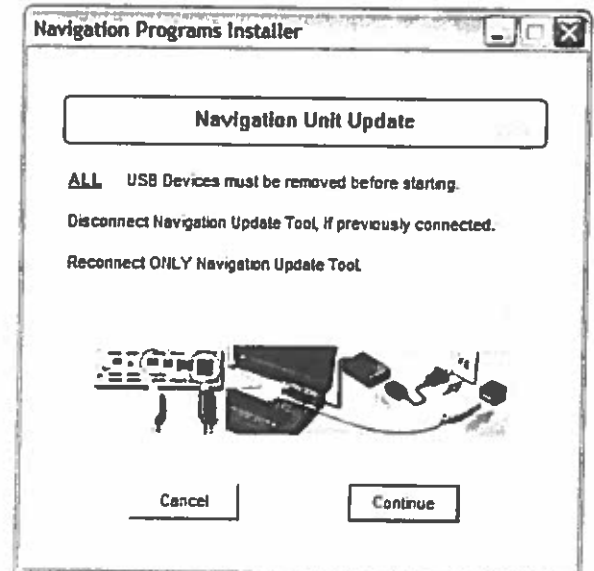
Figure 2.

6. Connect the Navigation Update Tool to the PC using the USB cable.
  - A. Make sure the USB cable is secured in both the PC and Navigation Update Tool USB ports.
  - B. Confirm the Navigation Update Tool is powered correctly.
  - C. Turn the power ON.
  - D. Click *Continue*.
7. Verify that both the Transfer Mode Display light (green) and Power Supply Display light (blue) are lit, then click *Continue*.

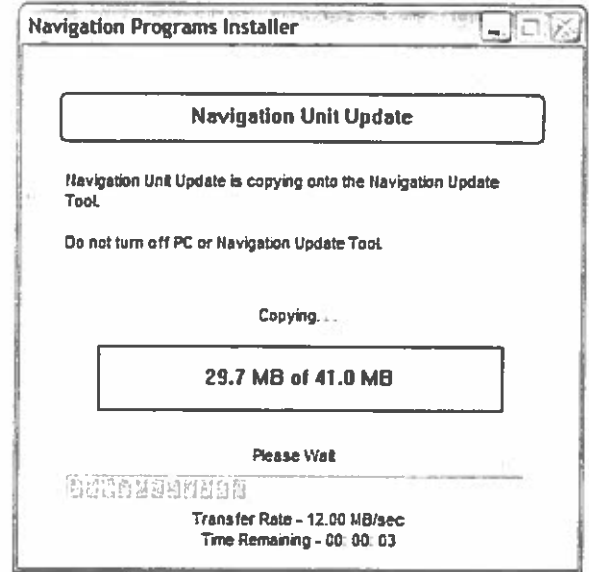
Figure 5.

- Navigation Firmware will now load onto the Navigation Update Tool.

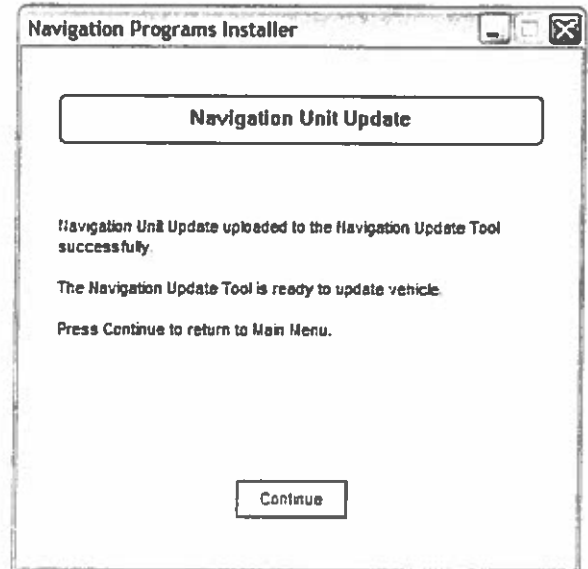
Figure 6.

- Once the Navigation Firmware is successfully loaded onto the Navigation Update Tool, click *Continue* to finish the installer.

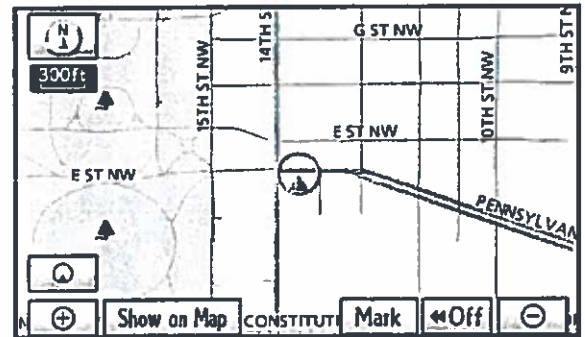
Figure 8.

4. Select *Show on Map*.
