**Service Action: Program Control Units**

F30 and F30H

With the N20, N55 engines and automatic transmission

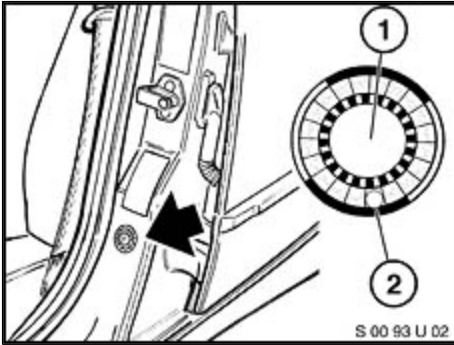
- A. Emboss your BMW center warranty number in the middle of the label (1);

- B. Punch out code number **638** (2), printed on the label; and
- C. Affix the label to the B-pillar as shown.

If the vehicle already has a label from a previous Service Action/Recall Campaign, affix the new label next to the old one. Do not affix one label on top of another one because a number from an underlying label could appear in the punched-out hole of the new label.
