SI M51 01 13  
Body Equipment

**Service Action: Replace Both Sun Visors**

R55

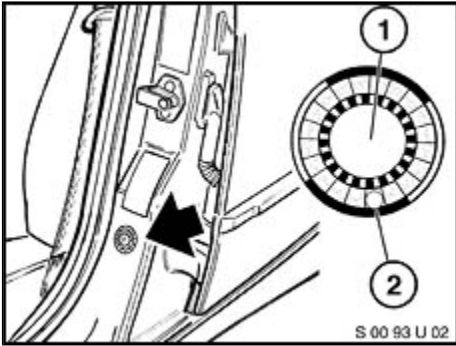
This Service Action has been assigned code number **57**. After the vehicle has been checked and/or corrected, obtain a label (MD20-040) and:

- A. Emboss your MINI dealer warranty number in the middle of the label (1);
- B. Punch out code number **57** (2), printed on the label; and
- C. Affix the label to the B-pillar as shown.
