SI B61 18 13
General Electrical Systems

Service Action: Program Control Units (CAS)

F12

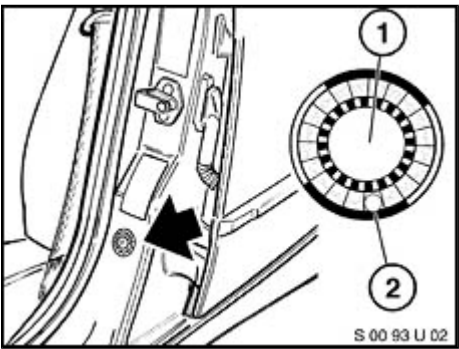
LABEL INSTRUCTIONS

<p>This Service Action has been assigned code number 655. After the vehicle has been checked and/or corrected, obtain a label (SD 92-420) and:</p> <ul style="list-style-type: none"> A. Emboss your BMW center warranty number in the middle of the label (1); B. Punch out code number 655 (2), printed on the label; and C. Affix the label to the B-pillar as shown.
---	---

If the vehicle already has a label from a previous Campaign, affix the new label next to the old one. Do not affix one label on top of another one because a number from an underlying label could appear in the punched-out hole of the new label.
