This Service Information bulletin supersedes SI B61 20 13 **dated November 2013.**

Service Action: Replace EMF Switch

MODEL

F15

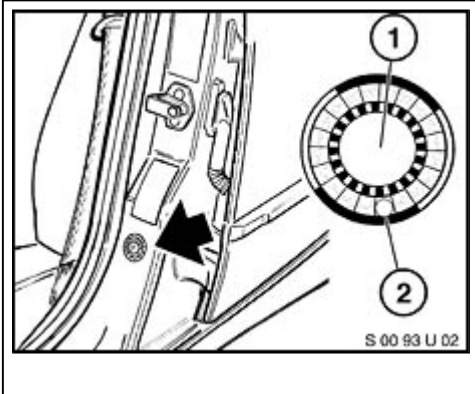
LABEL INSTRUCTIONS

<p>This Service Action has been assigned code number 658. After the vehicle has been checked and/or corrected, obtain a label (SD 92-420) and:</p> <ol style="list-style-type: none"> Emboss your BMW center warranty number in the middle of the label (1); Punch out code number 658 (2), printed on the label; and Affix the label to the B-pillar as shown.
---	--

If the vehicle already has a label from a previous Service Action/Recall Campaign, affix the new label next to the old one. Do not affix one label on top of another one because a number from an underlying label could appear in the punched-out hole of the new label.
