## Title: VT365 With Poor Performance- Low Power - Excessive Exhaust Backpressure

**Applies To:** 2004 - 2006 VT 365 Engines with VGT Turbocharger

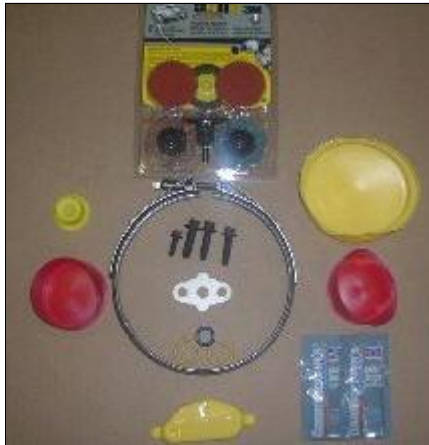
Part Number: 1870713C91 (Turbocharger Reconditioning Kit)

1. 3M Abrasive Kit (Includes Disc Hold and Abrasive Pads)
2. Plastic Protective Covers & Plugs
3. Mounting Bolt Kit
4. Anti-Seize
5. O-Ring & Gasket
6. Housing Ring
