Technical Service Bulletin

SUBJECT: ECM REPROGRAMMING FOR MIL ILLUMINATION, MIS-DETECTION OF DTC P0300			No: TSB-13-13-001
			DATE: January, 2013
			MODEL: See below
CIRCULATE TO:	<input type="checkbox"/> GENERAL MANAGER	<input type="checkbox"/> PARTS MANAGER	<input checked="" type="checkbox"/> TECHNICIAN
<input checked="" type="checkbox"/> SERVICE ADVISOR	<input checked="" type="checkbox"/> SERVICE MANAGER	<input checked="" type="checkbox"/> WARRANTY PROCESSOR	<input type="checkbox"/> SALES MANAGER

During cold engine start, rough or partial clutch operation may cause powertrain vibration similar to misfire conditions and cause false MIL illumination. New software revises improper Misfire Monitoring (P0300) threshold values to prevent these problems.

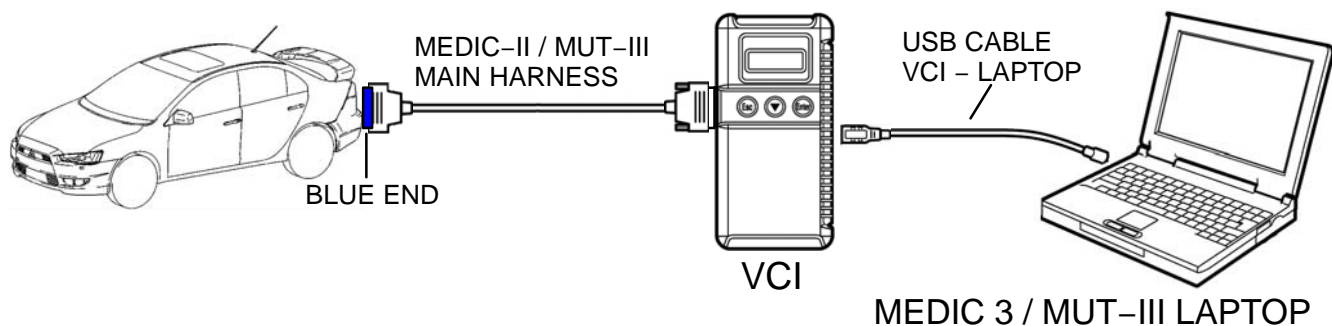
Connect the equipment as follows:

- Turn the laptop computer on. If you're running on battery power and the charge indicator in the lower right hand corner of the screen does not show a full charge, it is recommended that either the laptop battery be charged prior to beginning, or that reprogramming be completed with the A/C power adaptor connected to the laptop.
- Connect the USB cable to the VCI.
- When the laptop displays the MUT-III main screen, connect the USB cable to the laptop.
- Connect the MUT-III main harness with the blue DLC connection to the VCI.
- Connect the blue connector of the MUT-III main harness to the vehicle's data link connector.
- Turn the VCI power switch ON. Verify that the indicator lamp in the upper right corner of the screen is green.

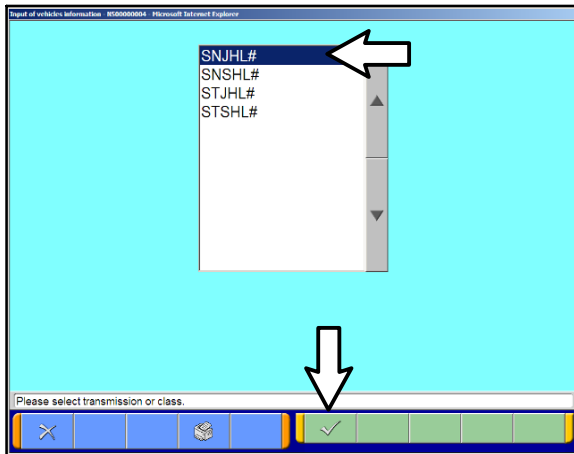
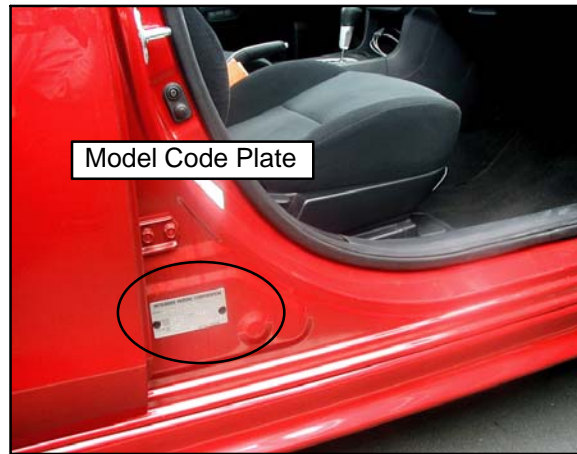
- i. A window may pop up asking you to select either the transmission type or vehicle class. Click the check mark to clear the window.
- j. Click on the CLASS button and make the appropriate selection from the menu, Then click the check mark at the bottom of the page.

NOTE: Vehicle class can be found on the Vehicle Information Code Plate attached to the base of the RH b-pillar (see photo below). Vehicle class is part of the model code.

Click the check mark to enter the class.

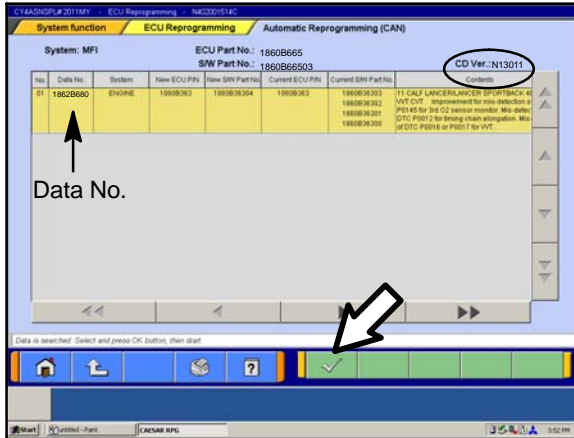
l. The CAN database screen will display.

Confirm the database number at the top right of the table is **N13011** or higher.

If more than one row is displayed in the table, refer to the ECM Reprogramming Chart on page 1 to select the proper Data No. for this procedure and select the appropriate row.

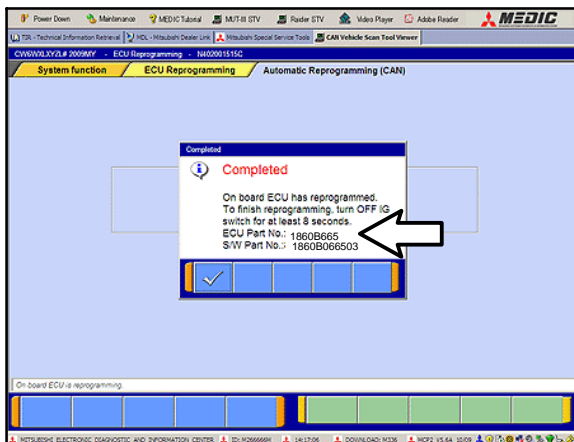
o. This message will display when ECM reprogramming is successfully completed. Confirm the “New S/W P/N” displayed matches the table on page 1 of this TSB.

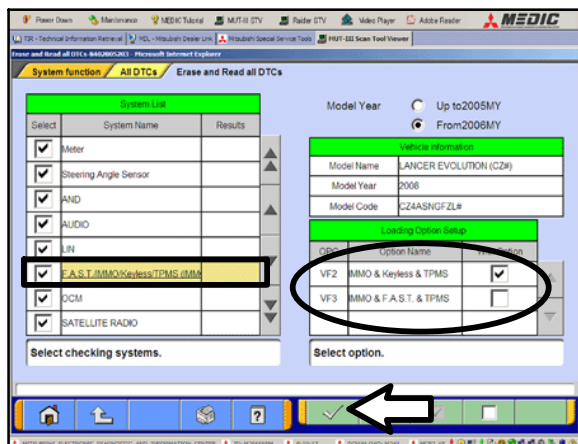
- d. In the left column, scroll to and click FAST/IMMOB/KEYLESS/TPMS. In the right column, check the correct option code (VF#) from the Loading Options Setup list. This will activate the check mark at the bottom of the page.
- Vehicles with regular keyless entry (buttons on a multi-function key), select VF2.
 - Vehicles with F.A.S.T. Key (including OSS), select VF3.
- Click the check mark to continue.
