Technical Service Bulletin

SUBJECT: ECM REPROGRAMMING FOR MIL ILLUMINATION, MIS-DETECTION OF DTC P0145			No: TSB-13-13-002
			DATE: January, 2013
			MODEL: 2011 Outlander Sport
CIRCULATE TO:	<input type="checkbox"/> GENERAL MANAGER	<input type="checkbox"/> PARTS MANAGER	<input checked="" type="checkbox"/> TECHNICIAN
<input checked="" type="checkbox"/> SERVICE ADVISOR	<input checked="" type="checkbox"/> SERVICE MANAGER	<input checked="" type="checkbox"/> WARRANTY PROCESSOR	<input type="checkbox"/> SALES MANAGER

This TSB provides a field fix procedure to address false MIL illumination with DTC P0145 (Heated oxygen sensor (3rd) circuit slow response) stored in the ECM. This software update optimizes the judgement criteria to minimize false MIL illumination.

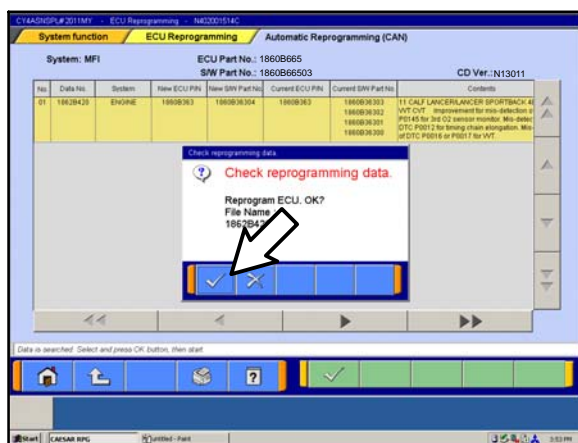
l. The CAN database screen will display.

Confirm the database number at the top right of the table is **N13011** or higher.

If more than one row is displayed in the table, refer to the ECM Reprogramming Chart on page 1 to select the proper Data No. for this procedure and select the appropriate row.

Click on the correct row to highlight it.

Click on the check mark to continue.
