Technical Service Bulletin

SUBJECT:		No: TSB-13-13-004	
PCM REPROGRAMMING FOR DTC P2181 – COOLING SYSTEM PERFORMANCE		DATE: February, 2013	
		MODEL: 2007 Raider	
CIRCULATE TO:	<input type="checkbox"/> GENERAL MANAGER	<input type="checkbox"/> PARTS MANAGER	<input checked="" type="checkbox"/> TECHNICIAN
<input checked="" type="checkbox"/> SERVICE ADVISOR	<input checked="" type="checkbox"/> SERVICE MANAGER	<input checked="" type="checkbox"/> WARRANTY PROCESSOR	<input type="checkbox"/> SALES MANAGER

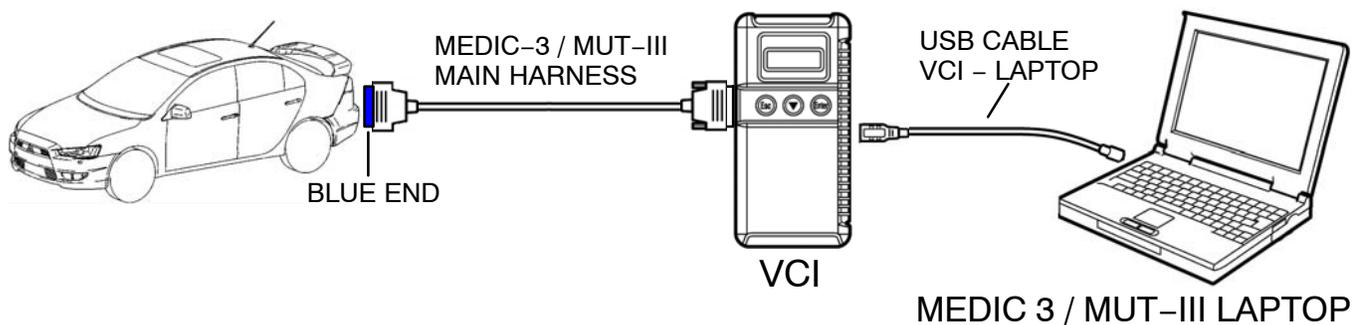
Connect the equipment as follows:

- Turn the laptop computer on. If you're running on battery power and the charge indicator in the lower right hand corner of the screen does not show a full charge, it is recommended that either the laptop battery be charged prior to beginning, or that reprogramming be completed with the A/C power adaptor connected to the laptop.
- Connect the USB cable to the VCI.
- When the laptop displays the MUT-III main screen, connect the USB cable to the laptop.
- Connect the MUT-III main harness with the blue DLC connection to the VCI.
- Connect the blue connector of the MUT-III main harness to the vehicle's data link connector.
- Turn the VCI power switch ON. Verify that the indicator lamp in the upper right corner of the screen is green.

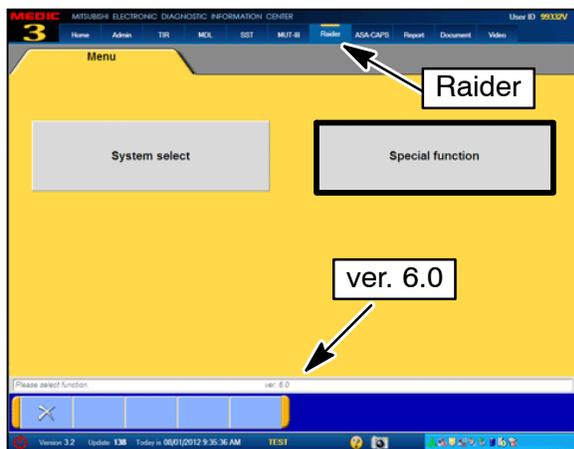
- b. If using MEDIC-3, from the main page, click the Raider tab at the top center of the screen.

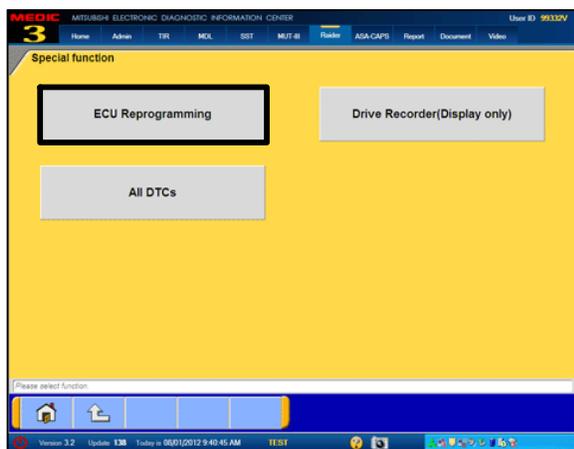
- c. In the Raider main menu, select **Special Function**.

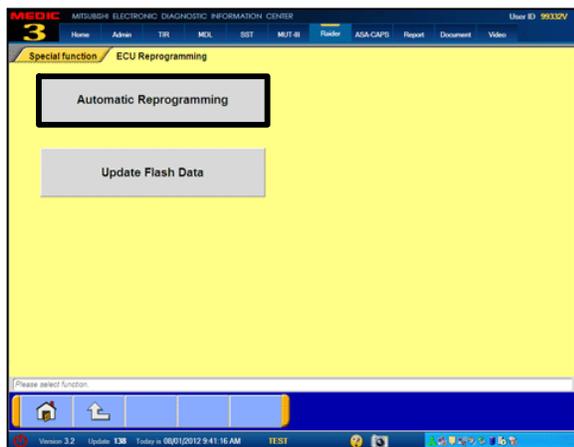
- d. Select **ECU Reprogramming**.

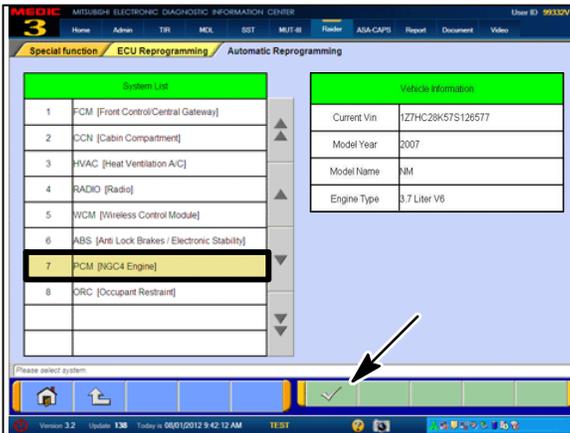
- e. Select **Automatic Reprogramming**.

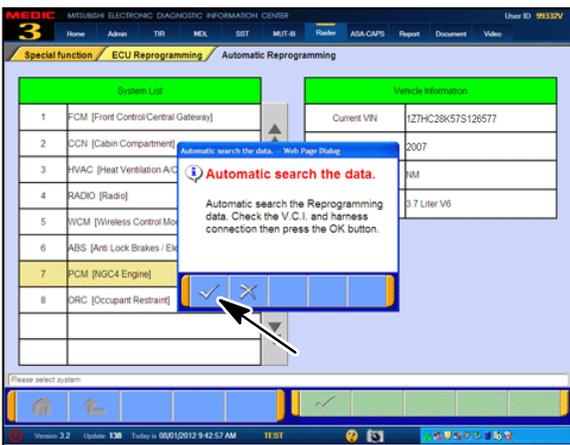
f. Select **PCM (NGC 4 Engine)**.

Click on the check mark at the bottom of the screen.

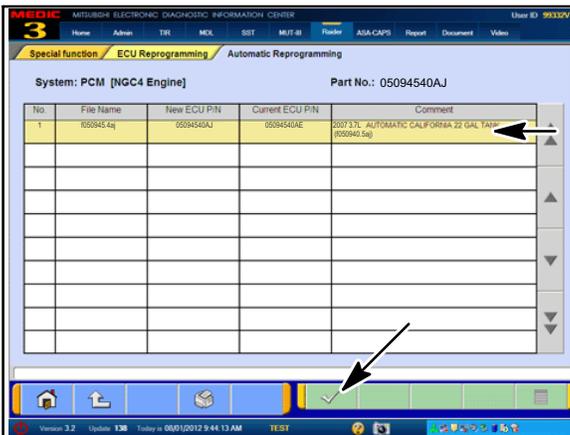
g. This window will pop up advising the program will “Automatic search the data.” Click on the check mark to continue.

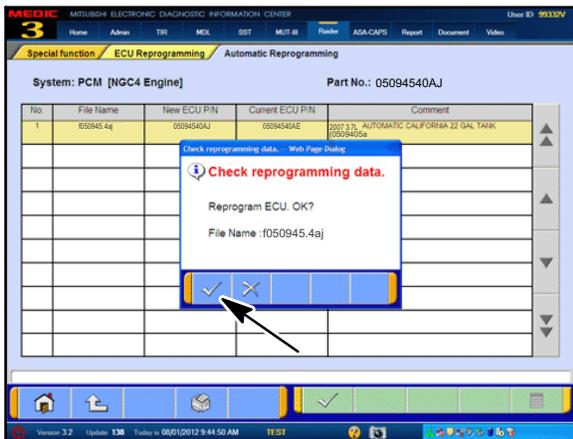
h. Select the programming database (calibration) listed in the “New ECU P/N” column that matches the “New S/W Part #” column from the chart on page 1 of this TSB.

Click on the check mark at the bottom of the screen.

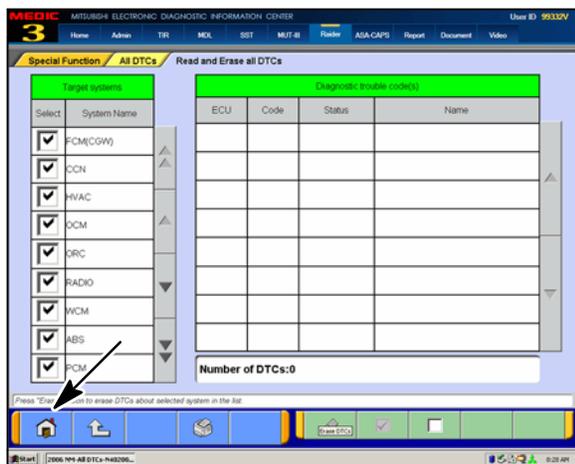
b. If DTCs are listed, click on the erase button at the bottom of the screen.

Any DTCs listed will be erased and rechecked to see if they return.
