Technical Service Bulletin

SUBJECT:			No: TSB-13-13-001REV
ECM REPROGRAMMING FOR MIL ILLUMINATION, MIS-DETECTION OF DTC P0300 – REVISED			DATE: March, 2013
			MODEL: See below
CIRCULATE TO:	<input type="checkbox"/> GENERAL MANAGER	<input type="checkbox"/> PARTS MANAGER	<input checked="" type="checkbox"/> TECHNICIAN
<input checked="" type="checkbox"/> SERVICE ADVISOR	<input checked="" type="checkbox"/> SERVICE MANAGER	<input checked="" type="checkbox"/> WARRANTY PROCESSOR	<input type="checkbox"/> SALES MANAGER

This TSB provides a field fix procedure to address false MIL illumination with DTC P0300 (Random/multiple cylinder misfire detected) stored in the ECM under the following conditions:

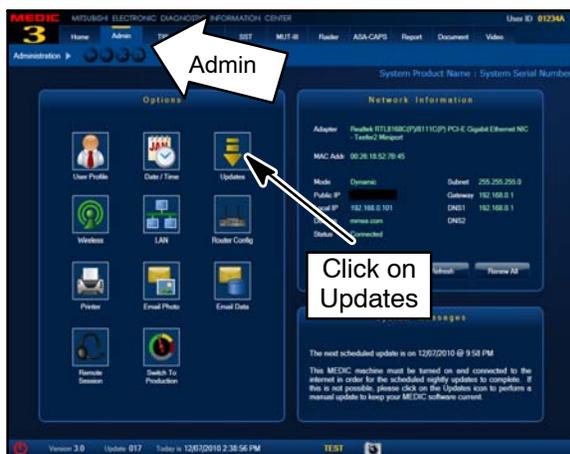
3. Select the MEDIC 3 Admin tab and click on “Updates.”

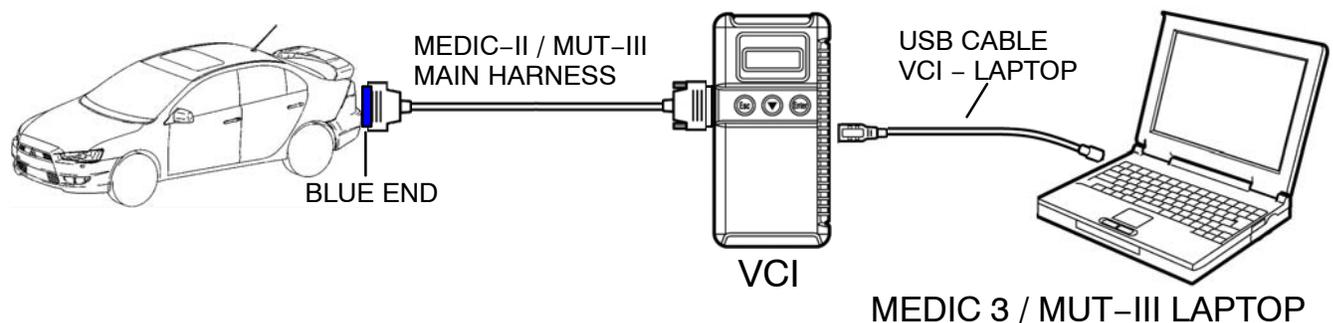
Connect the equipment as follows:

- Turn the laptop computer on. If you're running on battery power and the charge indicator in the lower right hand corner of the screen does not show a full charge, it is recommended that either the laptop battery be charged prior to beginning, or that reprogramming be completed with the A/C power adaptor connected to the laptop.
- Connect the USB cable to the VCI.
- When the laptop displays the MUT-III main screen, connect the USB cable to the laptop.
- Connect the MUT-III main harness with the blue DLC connection to the VCI.
- Connect the blue connector of the MUT-III main harness to the vehicle's data link connector.
- Turn the VCI power switch ON. Verify that the indicator lamp in the upper right corner of the screen is green.

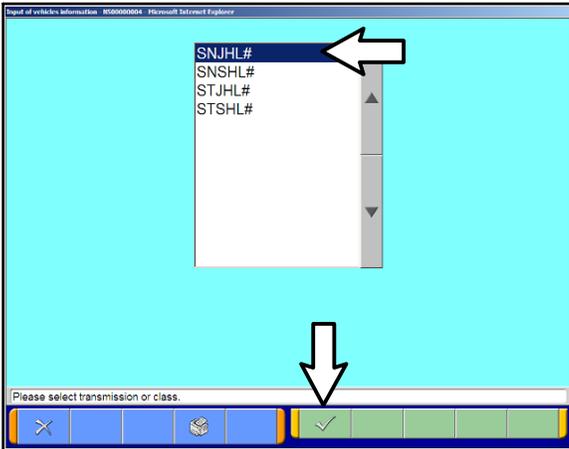
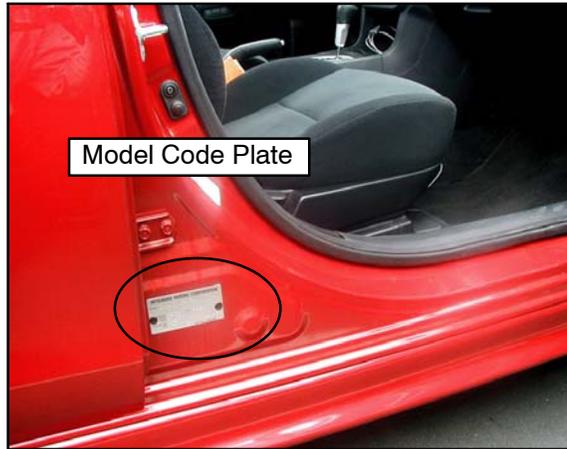
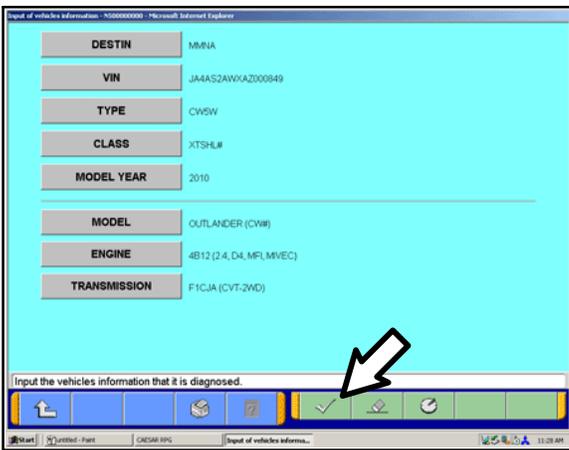
- i. A window may pop up asking you to select either the transmission type or vehicle class. Click the check mark to clear the window.
- j. Click on the CLASS button and make the appropriate selection from the menu, Then click the check mark at the bottom of the page.

NOTE: Vehicle class can be found on the Vehicle Information Code Plate attached to the base of the RH b-pillar (see photo below). Vehicle class is part of the model code.

Click the check mark to enter the class.

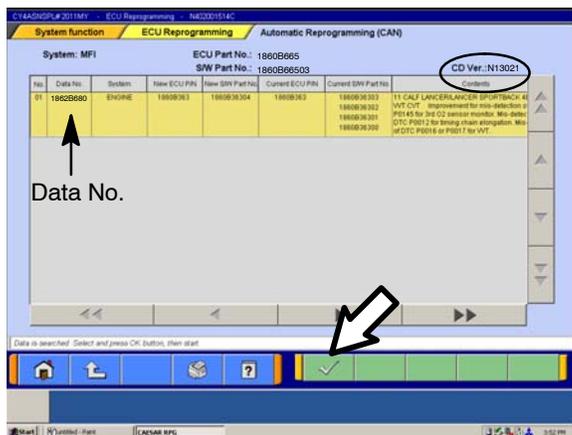
l. The CAN database screen will display.

Confirm the database number at the top right of the table is **N13021** or higher.

If more than one row is displayed in the table, refer to the ECM Reprogramming Chart on page 1 to select the proper Data No. for this procedure and select the appropriate row.

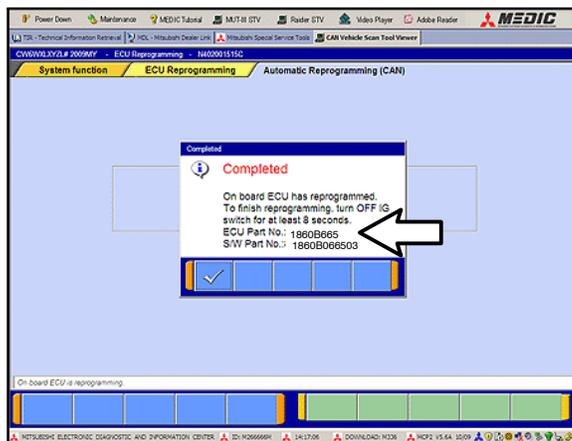
o. This message will display when ECM reprogramming is successfully completed. Confirm the “New S/W P/N” displayed matches the table on page 1 of this TSB.

p. You will be prompted to turn the ignition switch to the OFF position, wait at least 8 seconds, then turn it back on.

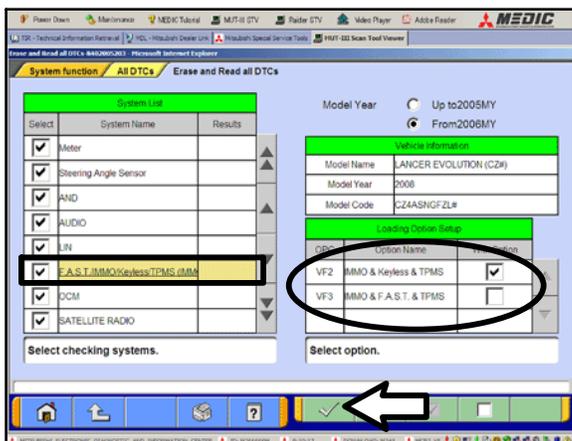
d. In the left column, scroll to and click FAST/IMMOB/KEYLESS/TPMS. In the right column, check the correct option code (VF#) from the Loading Options Setup list. This will activate the check mark at the bottom of the page.

- Vehicles with regular keyless entry (buttons on a multi-function key), select VF2.
- Vehicles with F.A.S.T. Key (including OSS), select VF3.

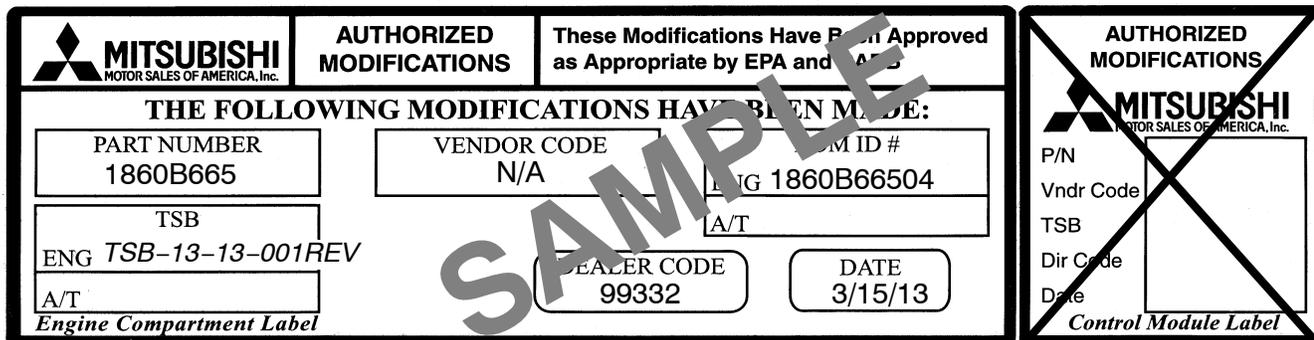
7. Using a ball-point pen, enter the appropriate Engine Control Module (ECM) part number, Software Part Number (ROM ID#), this Technical Service Bulletin number (TSB-13-13-001REV), your dealer code, and the current date on the Engine Compartment / Control Module Label (p/n MSSF024G00). The Vendor Code is not applicable. Labels are available from your facing PDC.

The information shown on this sample label is for 2011 Outlander Sport. Other model information is different.

The Control Module Label is NOT used for this reflash. It should be discarded.

- Carefully remove all dirt and oil from a vacant area near the VECI label on the underside of the hood, and affix the *Engine Compartment Label* (LH side, above) to that area.
- Test drive the vehicle to confirm the MIL does not illuminate and proper operation.
