# Technical Service Bulletin

SUBJECT:			No: <b>TSB-13-13-002REV</b>
<b>ECM REPROGRAMMING FOR MIL ILLUMINATION, MIS-DETECTION OF DTC P0145 – REVISED</b>			DATE: <b>March, 2013</b>
			MODEL: <b>See Below</b>
CIRCULATE TO:	<input type="checkbox"/> GENERAL MANAGER	<input type="checkbox"/> PARTS MANAGER	<input checked="" type="checkbox"/> TECHNICIAN
<input checked="" type="checkbox"/> SERVICE ADVISOR	<input checked="" type="checkbox"/> SERVICE MANAGER	<input checked="" type="checkbox"/> WARRANTY PROCESSOR	<input type="checkbox"/> SALES MANAGER

Improper Secondary Parameter judgement criteria may cause false MIL illumination during 3<sup>rd</sup> Oxygen Sensor Monitoring (P0145).

This TSB provides a field fix procedure to address false MIL illumination with DTC P0145 (Heated oxygen sensor (3<sup>rd</sup>) circuit slow response) stored in the ECM. This software update optimizes the judgement criteria to minimize false MIL illumination.

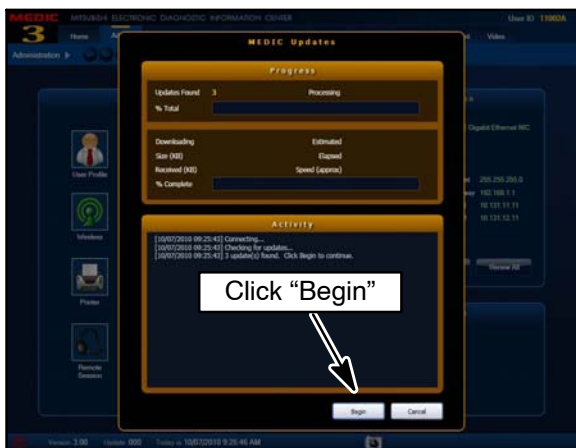
4. If the Medic Update screen advises updates are available, click the “Begin” button. After the updates are complete, **GO TO THE REPROGRAMMING PROCEDURE ON PAGE 4.**

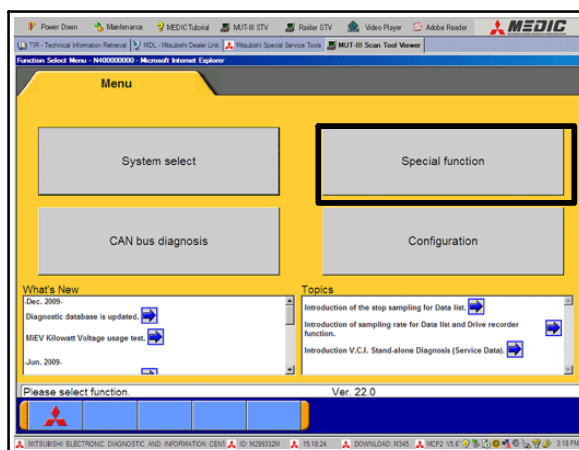
1. Conduct the following steps to reprogram the ECM.
  - a. Turn the ignition switch to the ON position.

- b. If using MEDIC 3, from the main page, click the MUT-III STV icon at the top center of the screen.
- c. Select "Special Function."
- d. Select "ECU reprogramming."

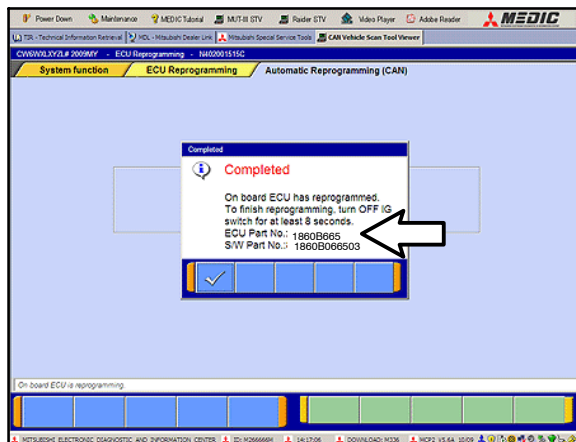
o. This message will display when ECM reprogramming is successfully completed. Confirm the “New S/W P/N” displayed matches the table on page 1 of this TSB.
