# Technical Service Bulletin

SUBJECT:			No: <b>TSB-13-13-005</b>
<b>ECM REPROGRAMMING FOR FALSE MIL (P2100) OR HARD TO START WITH ENGINE COLD</b>			DATE: <b>March, 2013</b>
			MODEL: <b>2010-2012 Outlander</b>
CIRCULATE TO:	<input type="checkbox"/> GENERAL MANAGER	<input checked="" type="checkbox"/> PARTS MANAGER	<input checked="" type="checkbox"/> TECHNICIAN
<input checked="" type="checkbox"/> SERVICE ADVISOR	<input checked="" type="checkbox"/> SERVICE MANAGER	<input checked="" type="checkbox"/> WARRANTY PROCESSOR	<input type="checkbox"/> SALES MANAGER

2010-2012 Outlander w/6G31 3.0L, AT, 2WD/4WD

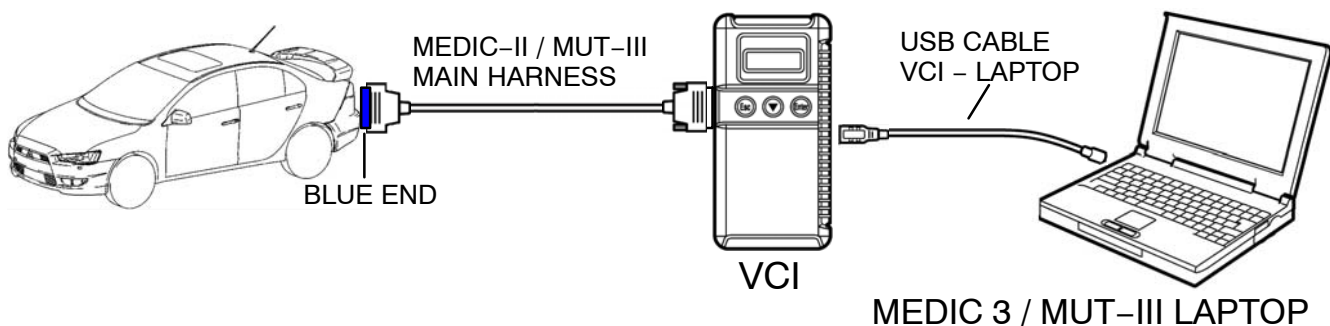
Connect the equipment as follows:

- Turn the laptop computer on. If you're running on battery power and the charge indicator in the lower right hand corner of the screen does not show a full charge, it is recommended that either the laptop battery be charged prior to beginning, or that reprogramming be completed with the A/C power adaptor connected to the laptop.
- Connect the USB cable to the VCI.
- When the laptop displays the MUT-III main screen, connect the USB cable to the laptop.
- Connect the MUT-III main harness (blue DLC connector) to the VCI.
- Connect the blue connector of the MUT-III main harness to the vehicle's data link connector.
- Turn the VCI power switch ON. Verify the indicator lamp in the upper right corner of the screen is green.

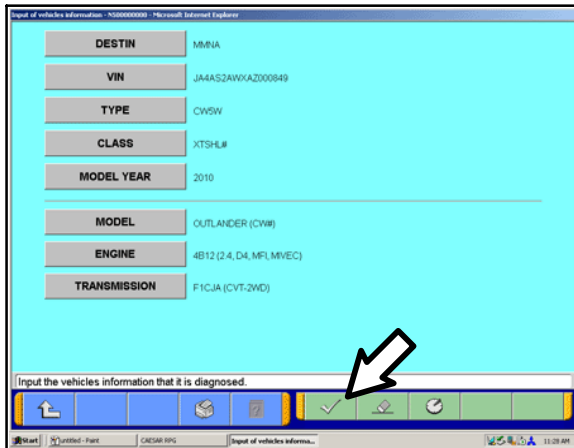
h. Click on the icon in the lower RH corner of the screen to have MUT-III automatically read the VIN. If a message appears saying that the VIN cannot be input automatically, manually type the 17 digit VIN into the VIN field at the top of the page.

Make sure the VIN is correct and click on the check mark.

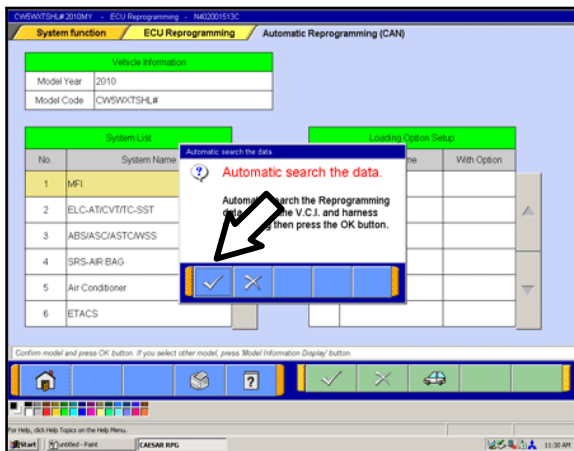
j. MFI should be highlighted as the default. If not, click on it to highlight it.

Click on the check mark at the bottom of the page.

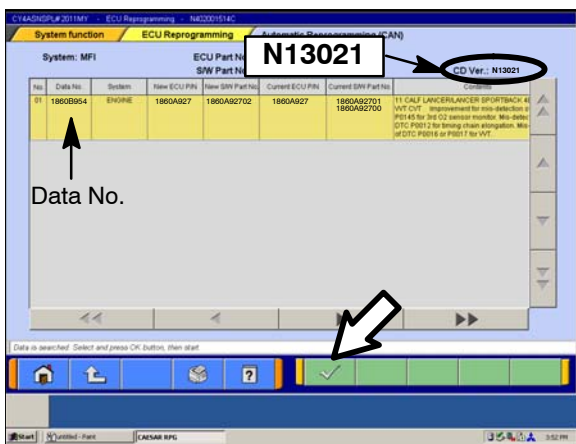
- l. The Automatic Reprogramming(CAN) database screen will display.

Confirm the database number at the top right of the table is **N13021** or higher.

If more than one row is displayed in the table, refer to the ECM Reprogramming Chart on page 2 to select the proper Data No. for this procedure and select the appropriate row.

Click on the correct row to highlight it.

Click on the check mark to continue.

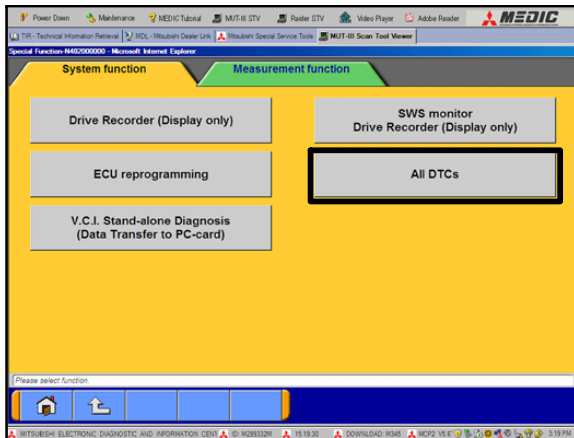
3. Using the MUT-III, check and erase ALL DTCs from all systems as follows.
- a. Select “Special Function.”
