Technical Service Bulletin

SUBJECT: ECM REPROGRAMMING FOR MIL ILLUMINATES, DTC P1235 OR P0068 STORED IN ECM			No: TSB-13-13-009
			DATE: December, 2013
			MODEL: See below
CIRCULATE TO:	<input type="checkbox"/> GENERAL MANAGER	<input checked="" type="checkbox"/> PARTS MANAGER	<input checked="" type="checkbox"/> TECHNICIAN
<input checked="" type="checkbox"/> SERVICE ADVISOR	<input checked="" type="checkbox"/> SERVICE MANAGER	<input checked="" type="checkbox"/> WARRANTY PROCESSOR	<input type="checkbox"/> SALES MANAGER

This TSB provides field fix procedures to reprogram the ECM with new software to address false MIL illumination with boost/air flow plausibility monitor DTCs P1235 (2008–2010 models) or P0068 (2011–2014 models) stored in memory.

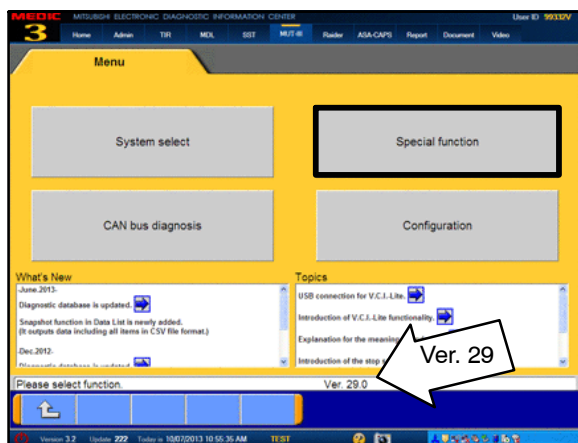
1. Conduct the following steps to reprogram the ECM.
 - a. Turn the ignition switch to the ON position. If the vehicle is equipped with the F.A.S.T. System, the transmitter must remain in the vehicle for the entire procedure.

- b. If using MEDIC 3, from the main page, click the MUT-III STV icon at the top center of the screen.
 - c. From the MUT-III Main Menu, select "Special Function."
 - d. Select "ECU Reprogramming."

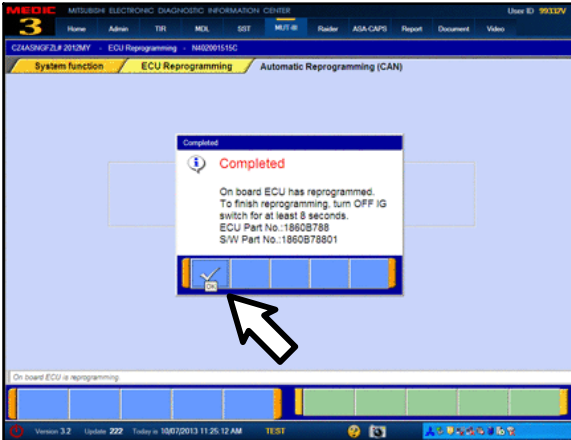
- o. This message will display when ECM reprogramming is successfully completed. Confirm the “New S/W P/N” displayed matches the table at the beginning of this TSB. Then click the check mark to clear the message.
2. Click the home icon at the lower left corner of the page to return to the MUT-III main page.
