SERVICE CAMPAIGN BULLETIN

CAMPAIGN REF: 01W
TITLE: Vehicle software platform update from 10.1 to 10.2
DOCUMENT #: 11 M 049
AFFECTED VEHICLES: 12C Coupe

SITUATION: Quality Engineering at McLaren Automotive have released a new software platform for the Model Year 13 12C.

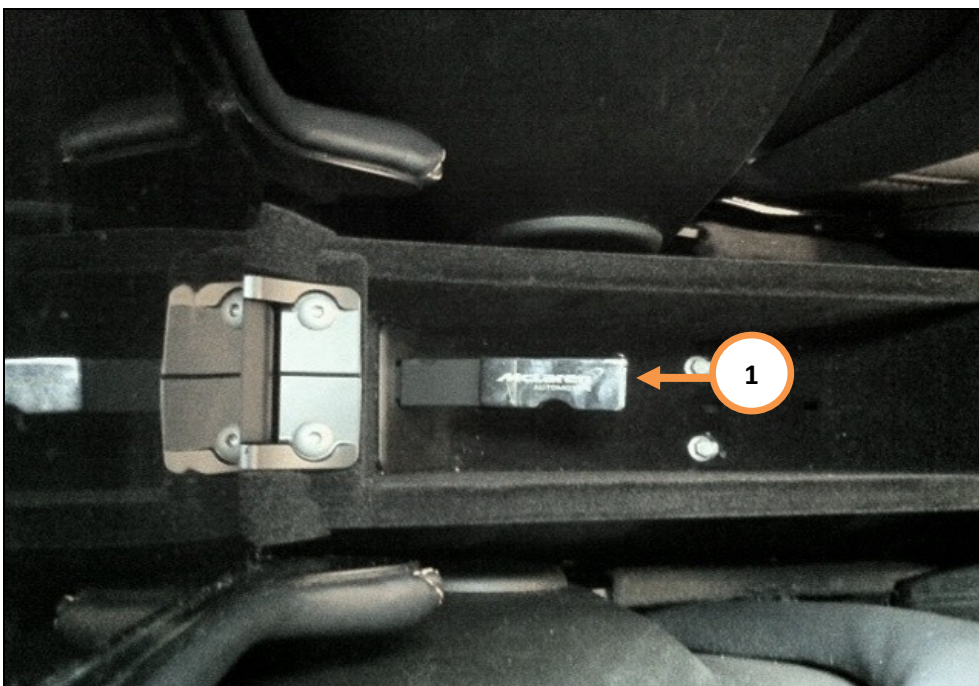
28. Insert the USB drive 11M2518CP.08 into the USB socket (1), then press and hold the centre IRIS button for approximately five seconds until the McLaren logo screen appears. This will trigger the software download process.

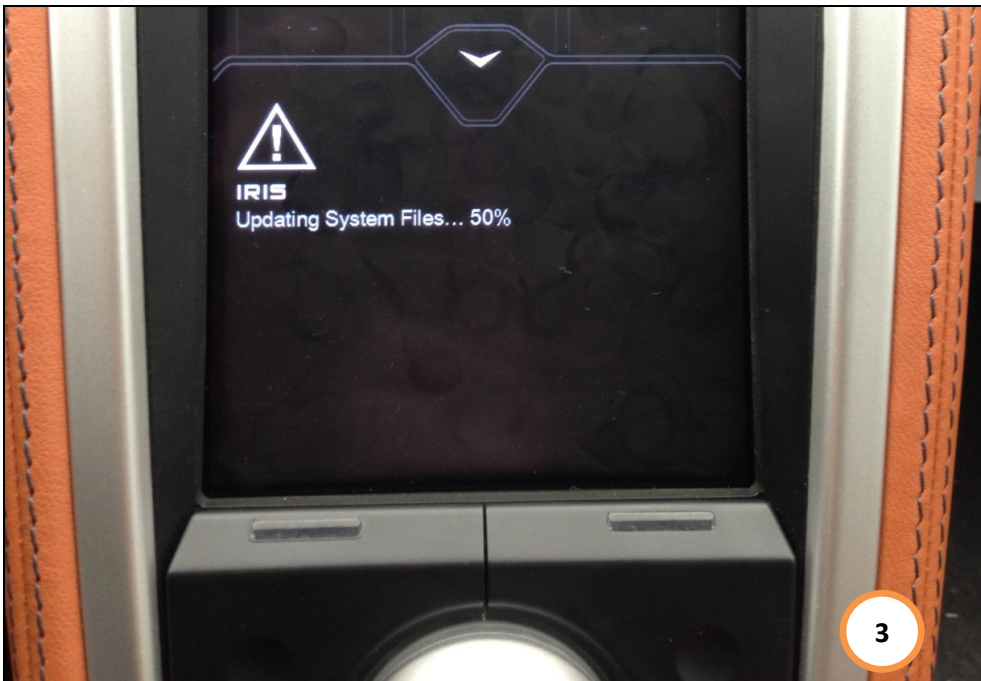
30. The following software download screen will be displayed whilst the update is proceeding (3).

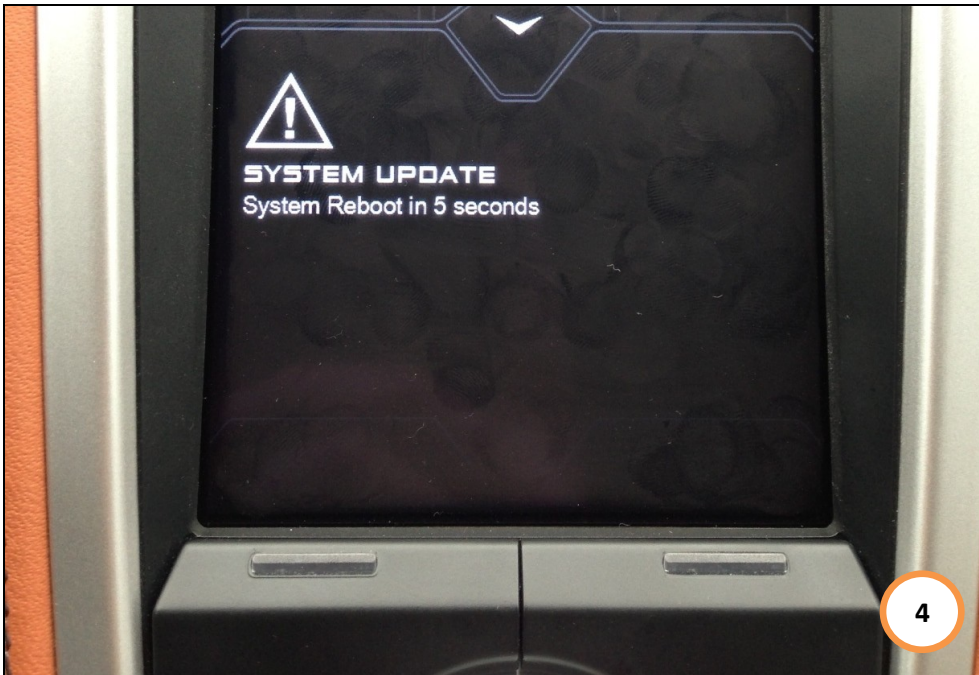
31. Once the update has completed the following screen will be displayed (4), remove the USB drive.

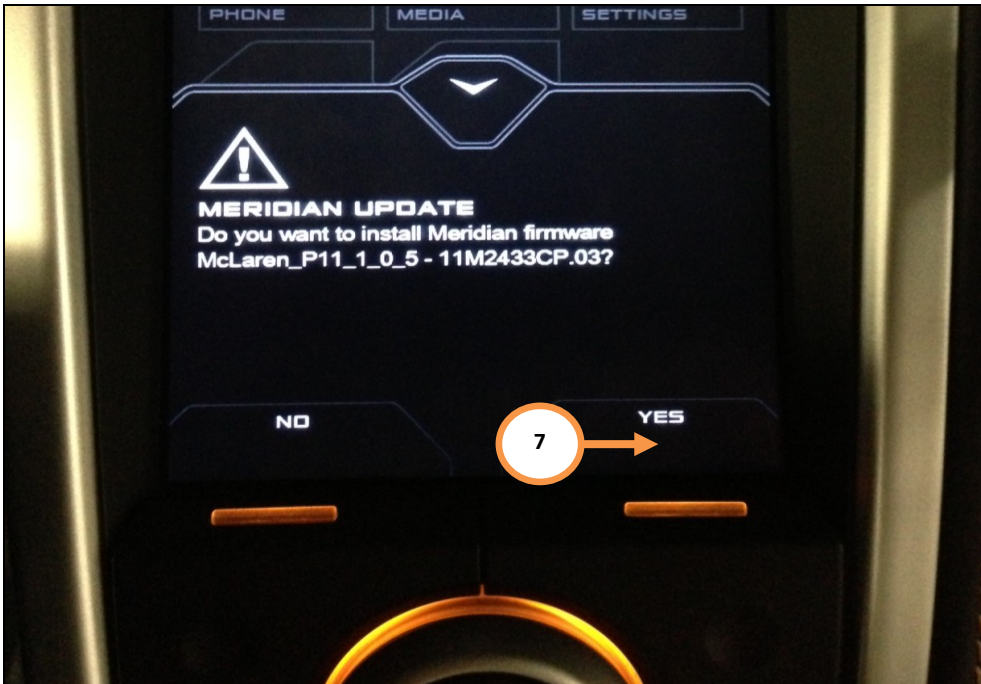
34. Insert USB drive 11M2433CP.03 into the USB socket and the following screen will then appear, select Yes (7).

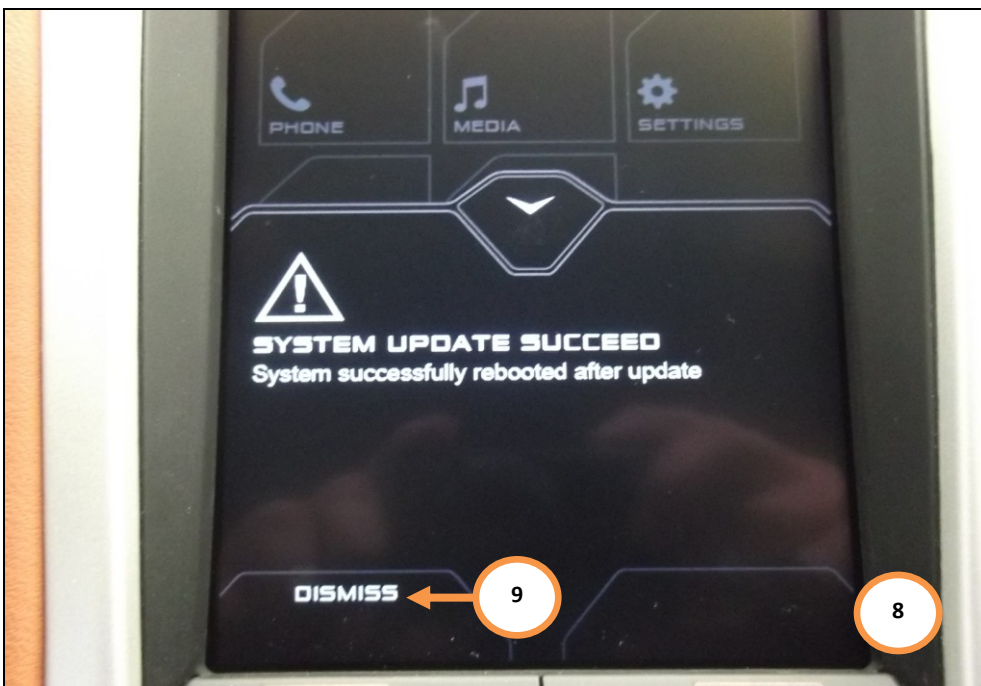
35. Once the update has completed and the unit has rebooted, the following screen will be displayed (8), select Dismiss (9) and remove the USB drive.

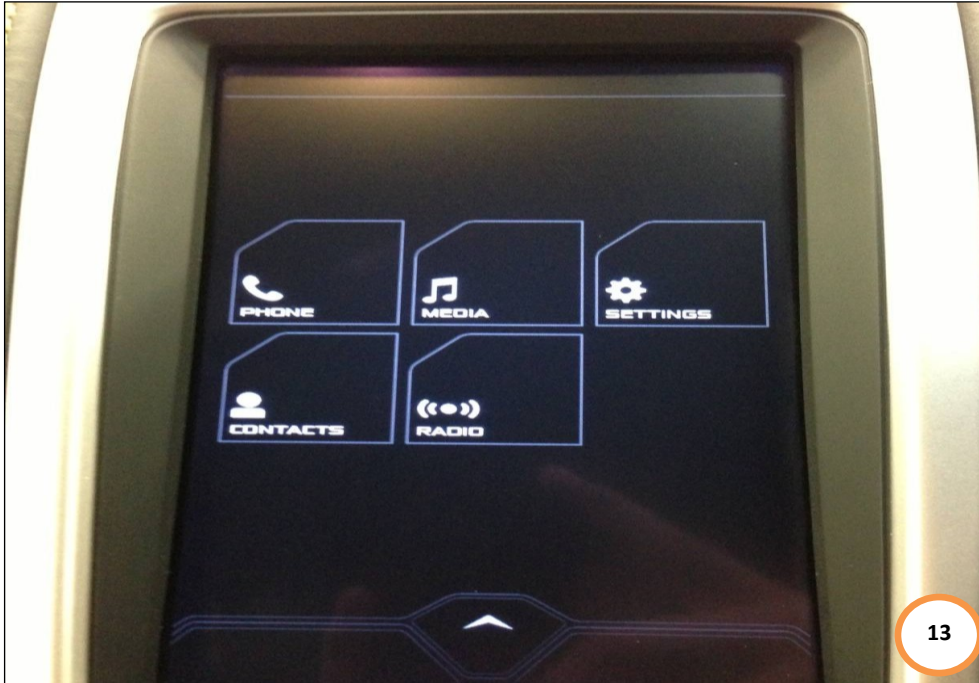
38. Select the "SETTINGS" icon on the home screen to enter the settings menu (13).

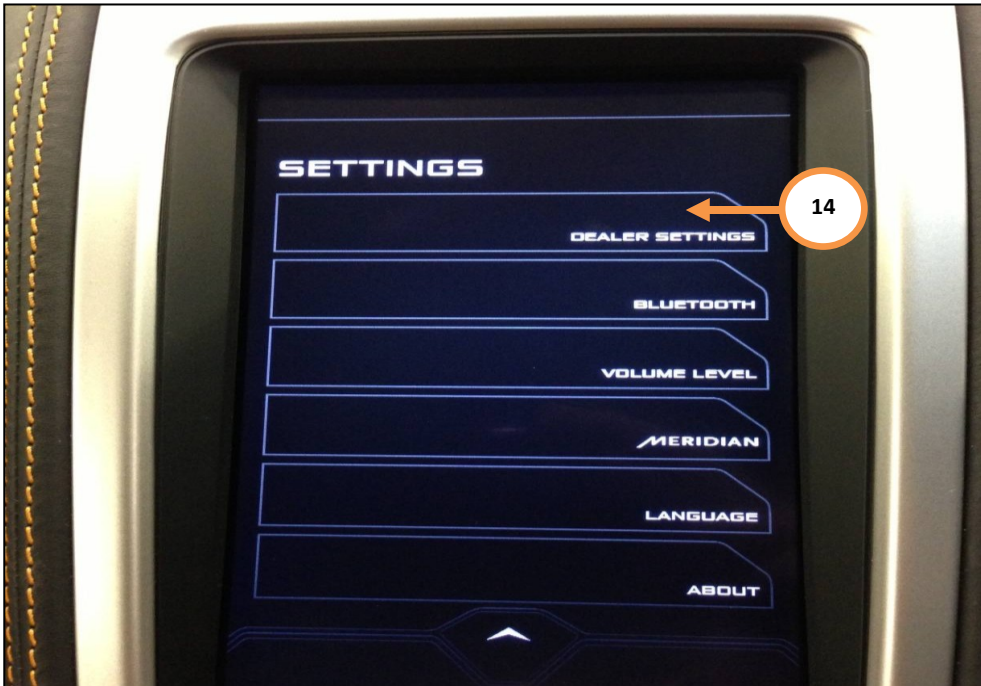
40. An additional option "DEALER SETTINGS" will appear (14) select this option to enter the dealer settings menu.

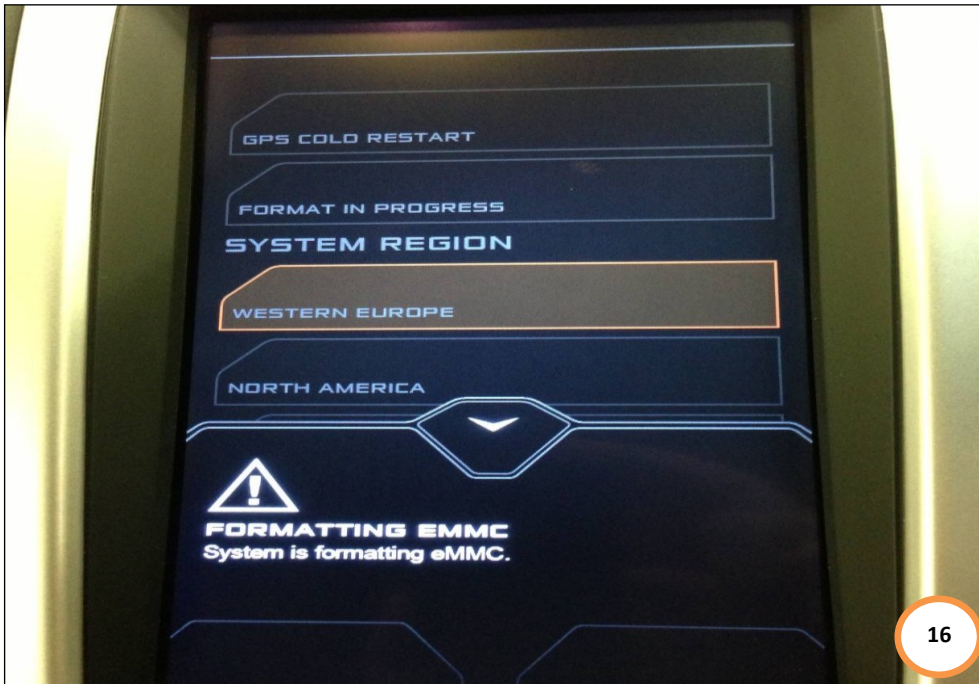
42. EMMC Formatting in progress will be displayed (16).

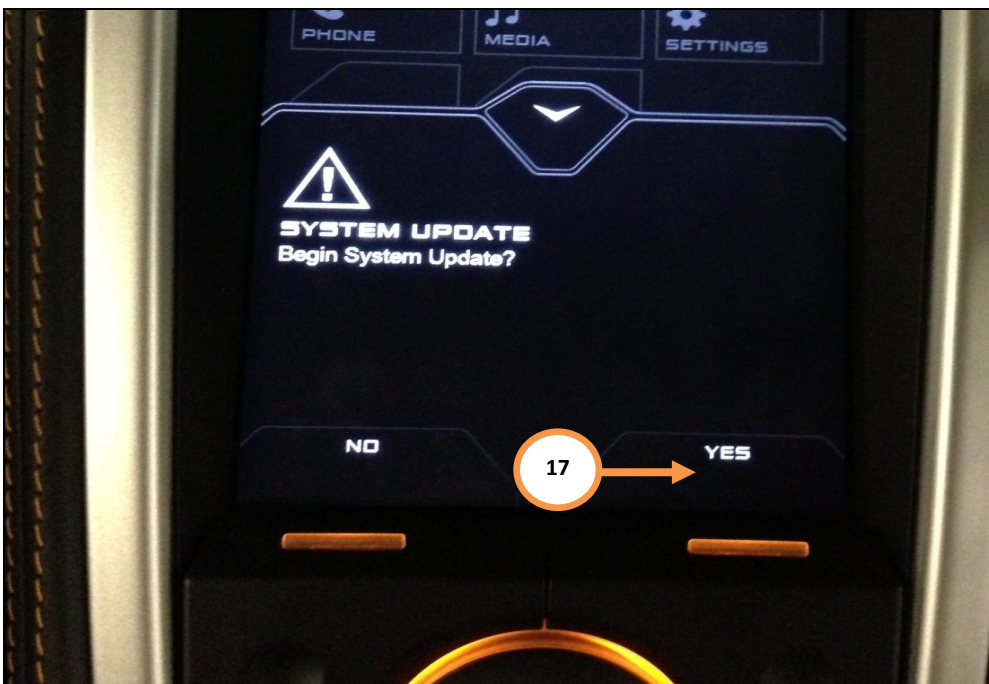
45. Insert the USB drive that contains the Satellite Navigation software variant applicable to your market (by referring to the software table on page 1), select Yes,(17)

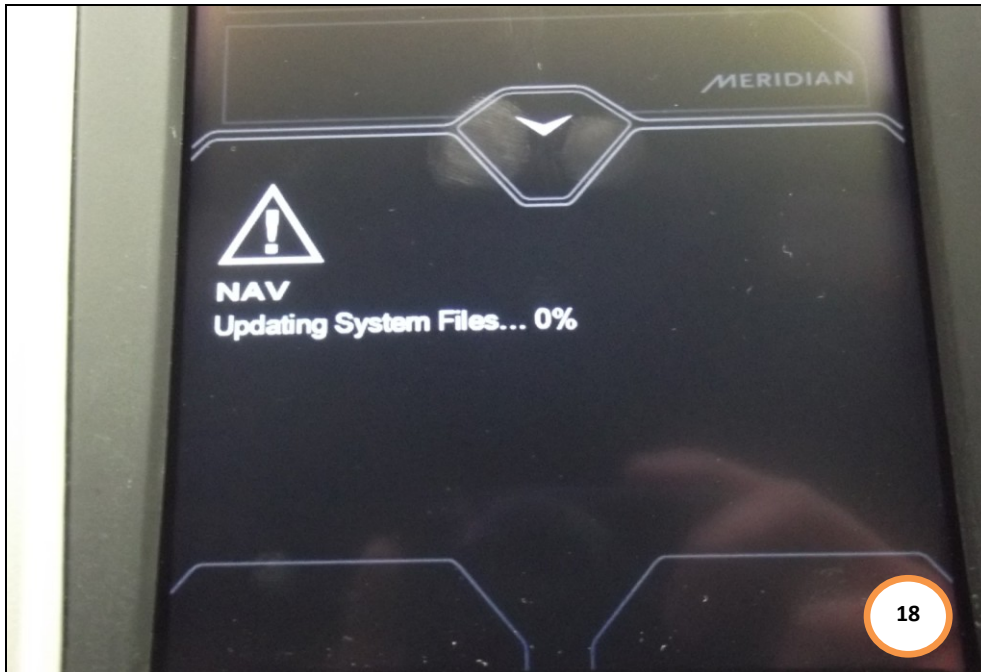
46. The following screen will be displayed (18).
