SERVICE CAMPAIGN BULLETIN

CAMPAIGN REF: 01Z
TITLE : Federal Engine control module (ECM) software update
DOCUMENT # : 11 M 058
AFFECTED VEHICLES : 12C Coupe and Spider

SITUATION : Quality Engineering at McLaren Automotive have identified an issue with the last release of ECM software calibration.

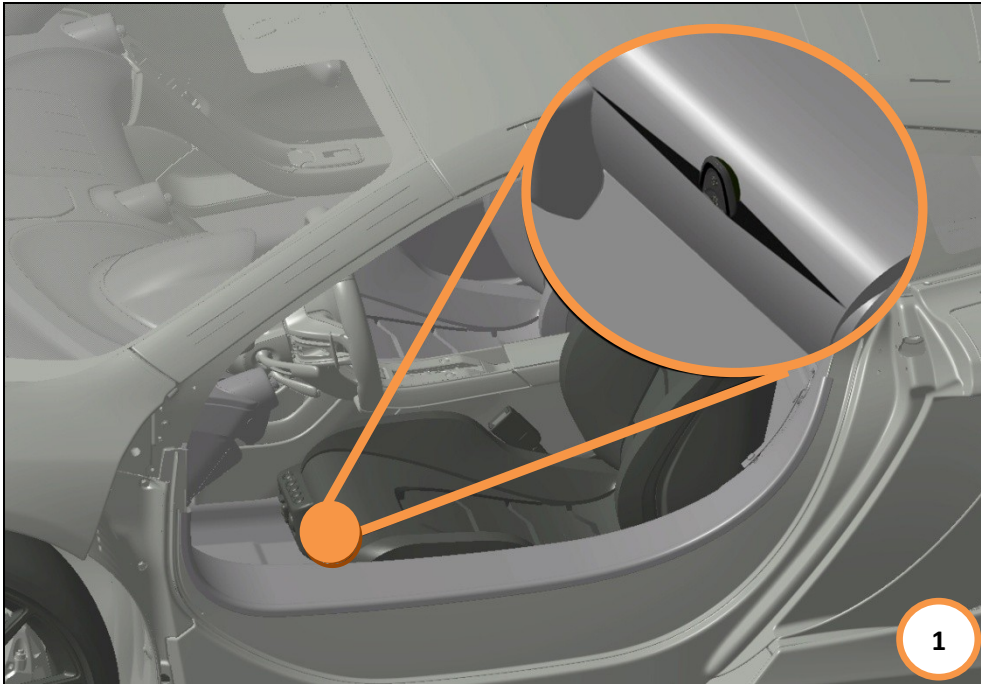
Care point: The key must be positioned in the driver's seat front pocket, picture below (1).

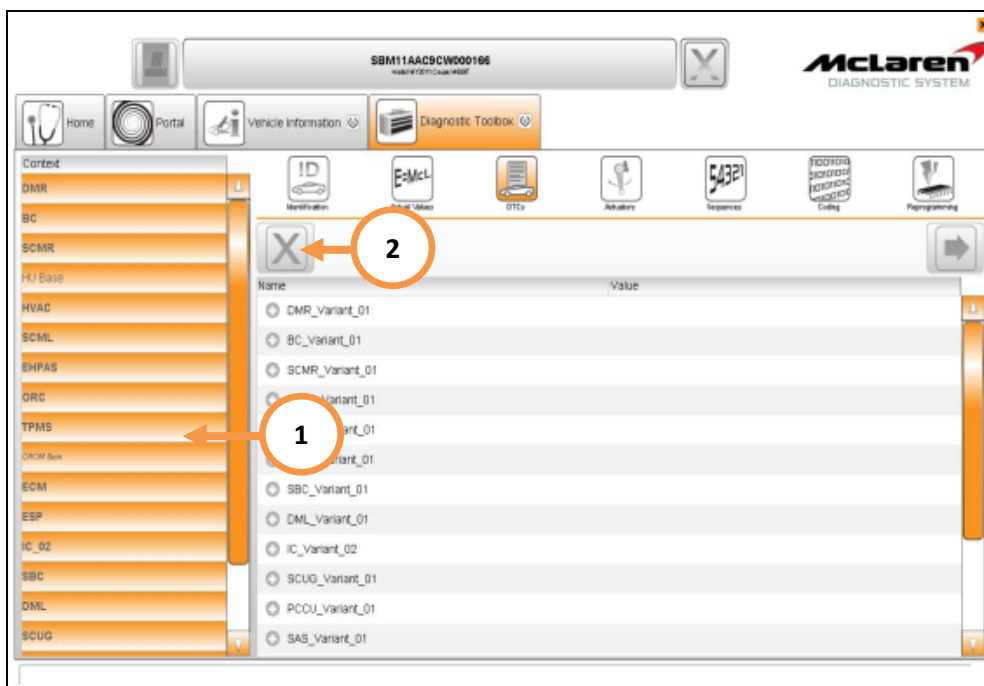
- Select and highlight all items within the context fields (1) and perform a global clear of all DTC's (2).

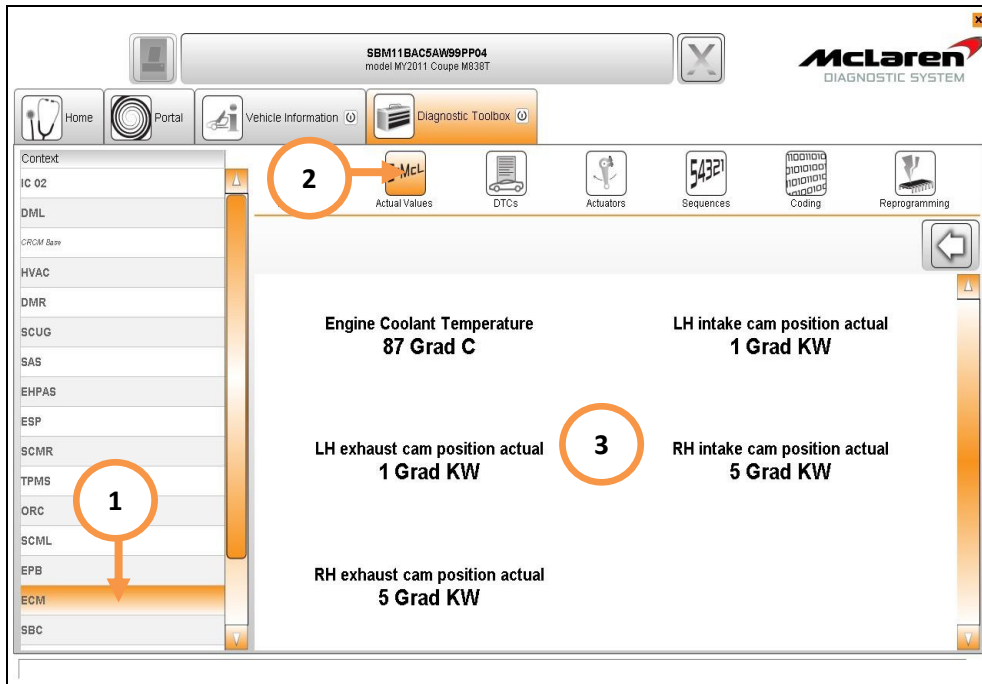
8. Select ECM (1), then Actual Values (2), select the following values as per the screenshot below (3), then select the play button to access the required data screen.
9. The inlet and exhaust camshaft values should be between 1 and 4, both values will fluctuate slightly. If all values are correct no further action is required proceed to step 11. If any values are incorrect proceed to step 10 to carry out the camshaft adaption.

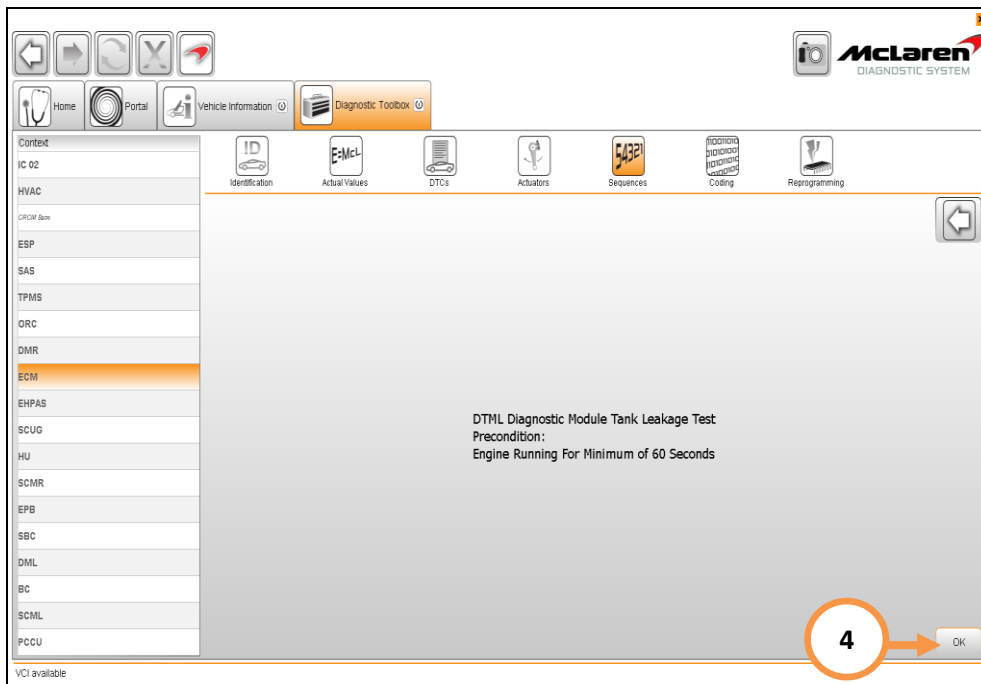
12. Follow the preconditions and run the engine for 60 seconds and then select Ok (4).

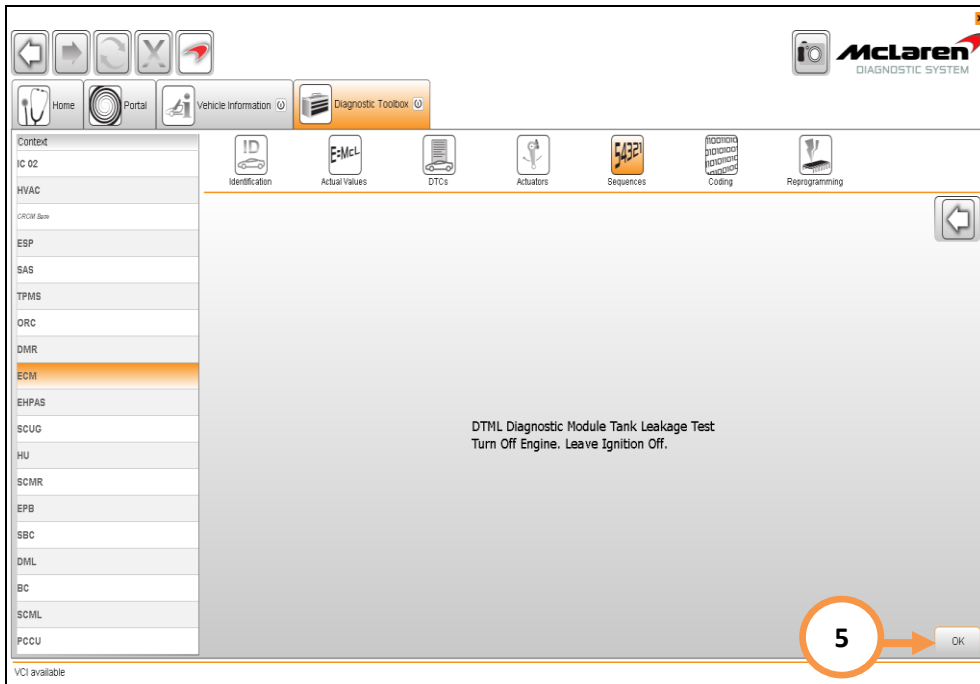
13. Follow the instructions on the next screen and then select Ok (5).
