NUMBER: 08-034-13

RA3 And RA4 Radio Enhancements

This bulletin involves upgrading the software on the SMART TOUCH 3 AM/FM/SAT/BT/VOICE and the SMART TOUCH 4 AM/FM/SAT/BT/NAV/VOICE Radio's.

2013 (DX) 1500 Ram Pickup (Mexico Market Only)

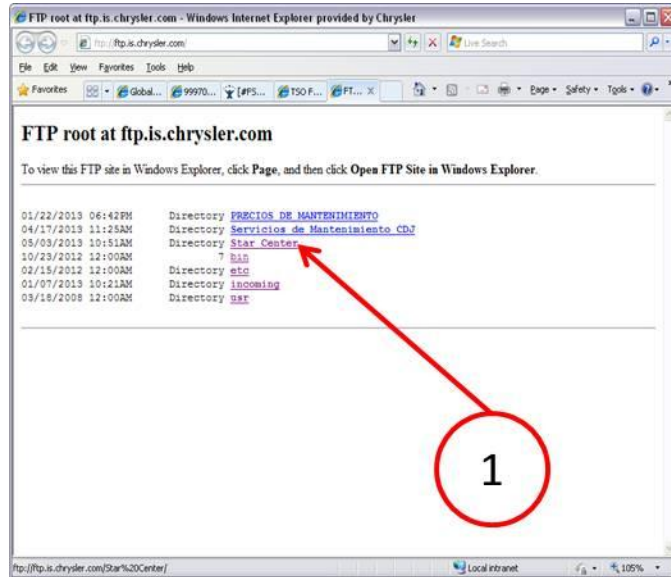
Fig. 1 FTP Site

- Click on the Star Center directory (Fig. 1).

1 - Star Center

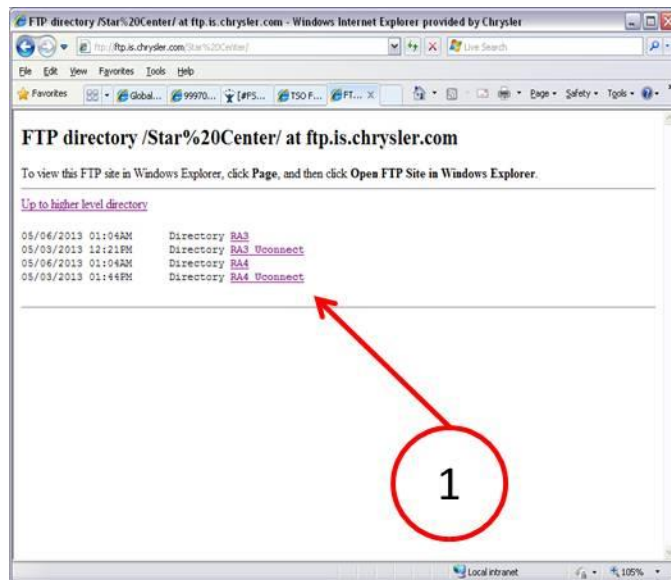
Fig. 2 FTP Site

- Select Radio Directory (Fig. 2).

1 - Radio Directory

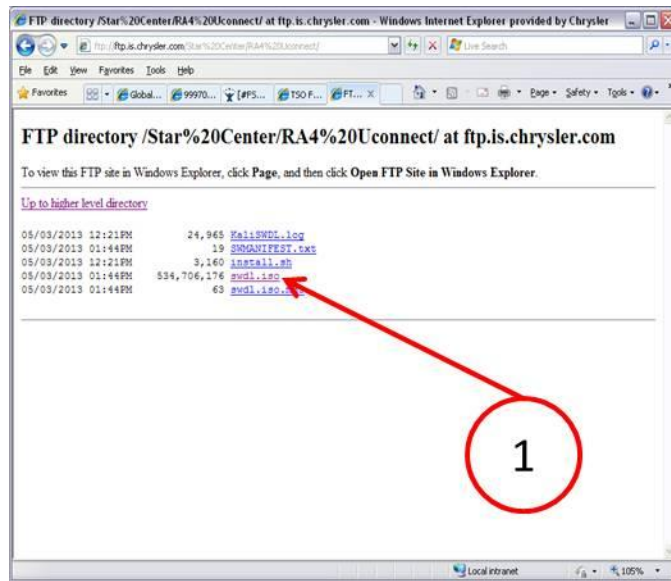
Fig. 3 FTP Site

- Select "swdl.iso" flash file (Fig. 3).

1 - Flash File "swdl.iso"
