SERVICE CAMPAIGN BULLETIN

NTB13-002

VOLUNTARY SERVICE CAMPAIGN 2013 PATHFINDER TCM REPROGRAM

APPLIED VEHICLES: 2013 Pathfinder (R52)

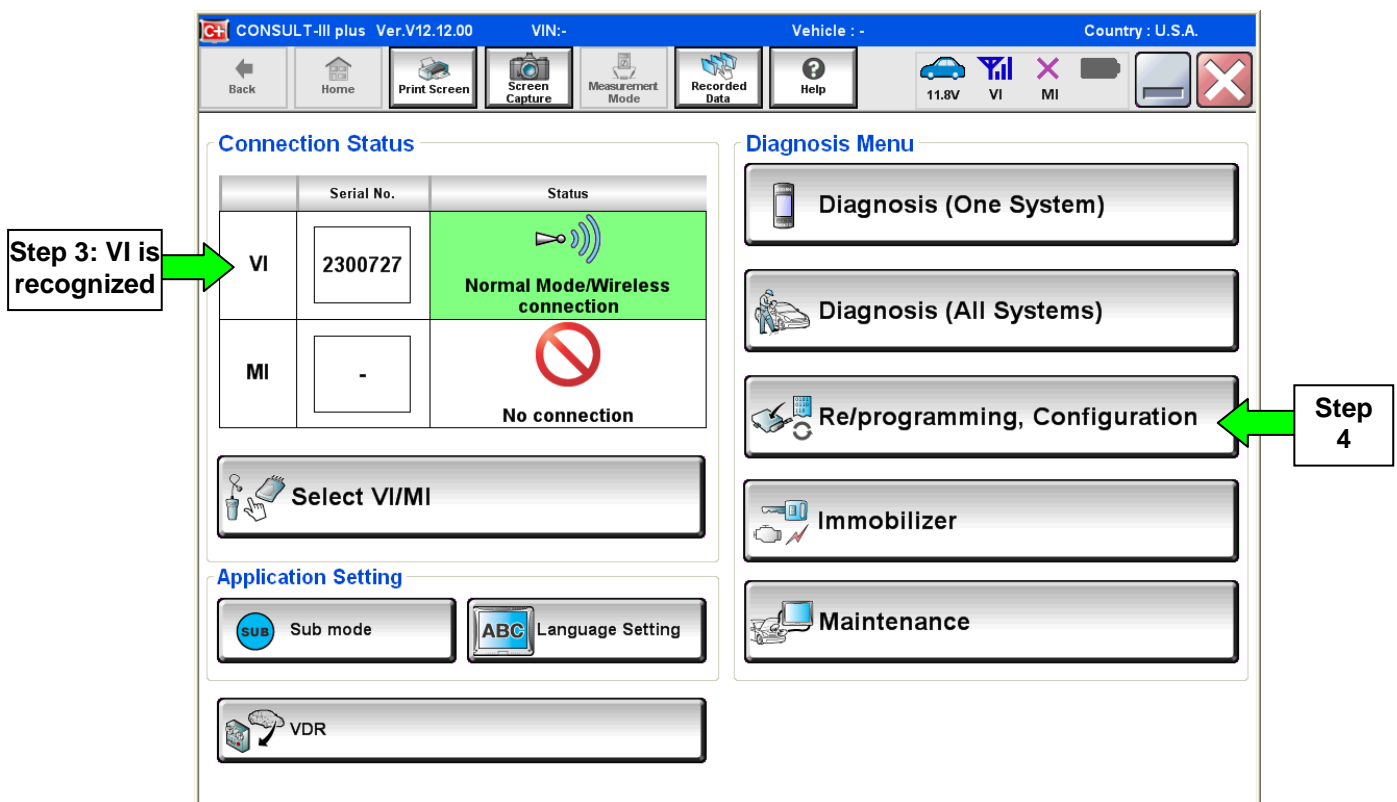
Figure 1

1. **Connect the CONSULT PC** to the vehicle to begin the reprogramming procedure.
2. Open ASIST on the CONSULT PC and start C-III plus.
3. Wait for the plus VI to be recognized / connected.
 - Serial number will display when the plus VI is recognized / connected.
4. Select **Re/programming, Configuration**.

During the initial “Reprogramming Confirmation” set-up, if you get this screen (Figure 1A):
