EC11-005b

January 28, 2013

## 2007 – 2008 G35, 2008 EX35 AND 2009 – 2010 FX35; ENGINE HESITATION OR STOPS RUNNING AT IDLE OR VERY LOW SPEEDS

**APPLIED VEHICLES:** 2007 – 2008 G35 Sedan (V36)  
                                   2007 G35 Coupe (CV35)  
                                   2008 EX35 (J50)  
                                   2009 – 2010 FX35 (S51)

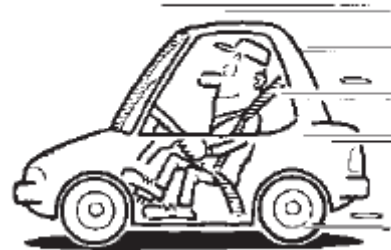
Figure A

- Most instructions for reprogramming with CONSULT-III plus (C-III plus) are displayed on the CONSULT PC screen.
- If you are not familiar with the reprogramming procedure, [click here](#). This will link you to the "CONSULT- III plus (C-III plus) ECM Reprogramming" general procedure.
- Take the vehicle for a 10 minute drive in order to meet the following Idle Air Volume Learn (IAVL) conditions:
  - Engine coolant temperature: 70 -100°C (158 - 212°F)
  - Battery voltage: More than 12.9V (At idle)
  - Transmission: Warmed up

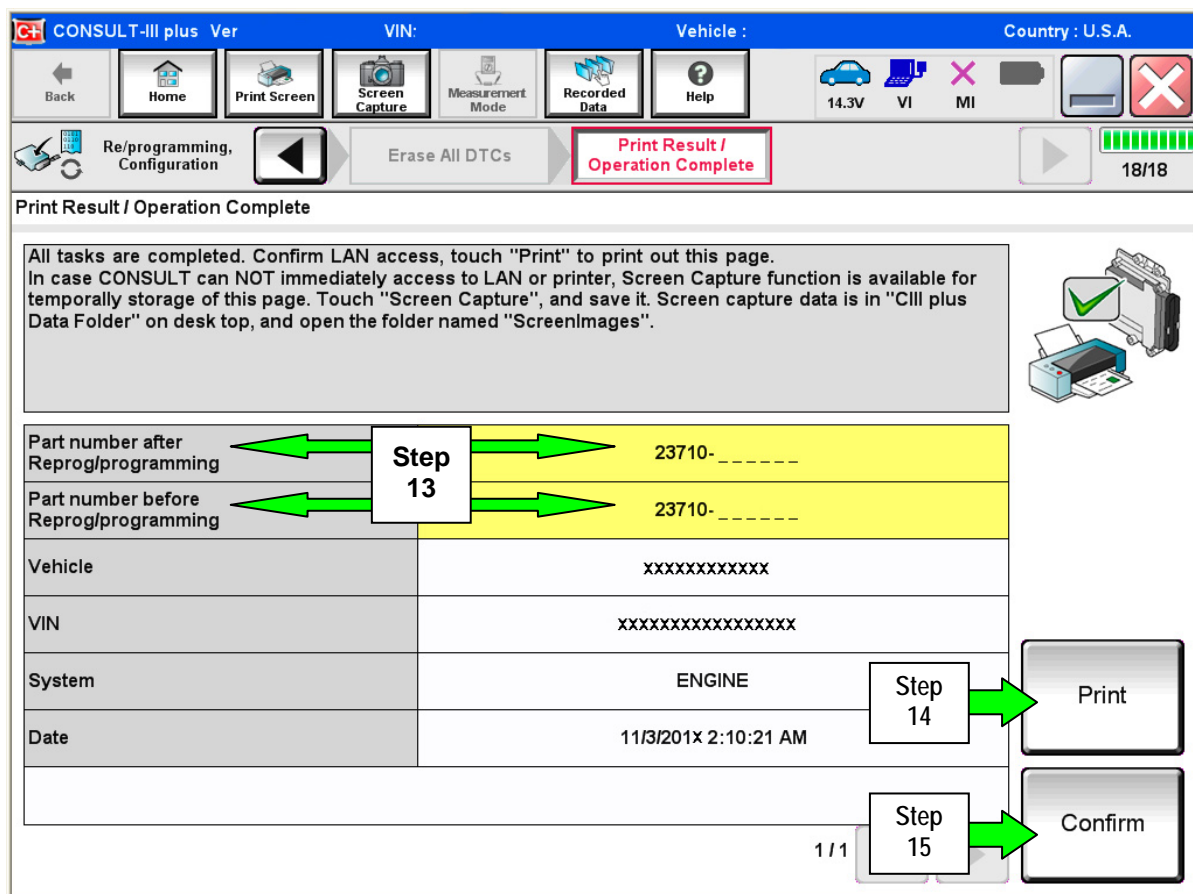
12. When the entire reprogramming process is complete, the screen in Figure 7 will display.
13. Verify the before and after part numbers are different.
14. Print a copy of this screen (Figure 7) and attach it to the repair order for warranty documentation.
15. Select **Confirm**.
