SERVICE BULLETIN

Classification: EC12-024b	Reference: NTB12-085b	Date: April 4, 2013
------------------------------	--------------------------	------------------------

2013 ALTIMA SEDAN WITH 4 CYL ENGINE; MIL ON WITH A/F SENSOR DTC STORED

APPLIED VEHICLES: 2013 Altima Sedan (L33) with 4 cylinder engine **ONLY**

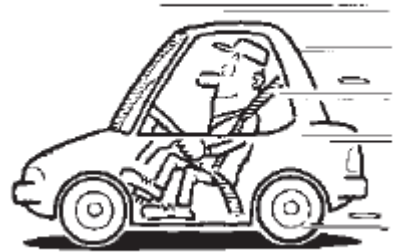
Figure A

- Take the vehicle for a 10 minute drive in order to meet the following Idle Air Volume Learn (IAVL) conditions:
 - Engine coolant temperature: 70 -100°C (158 -212°F)
 - Battery voltage: More than 12.9V (At idle)
 - Transmission: Warmed up
