SERVICE CAMPAIGN BULLETIN

NTB13-098

VOLUNTARY SERVICE CAMPAIGN 2013 LEAF PDM SOFTWARE UPDATE

APPLIED VEHICLES: 2013 LEAF® (ZE0)

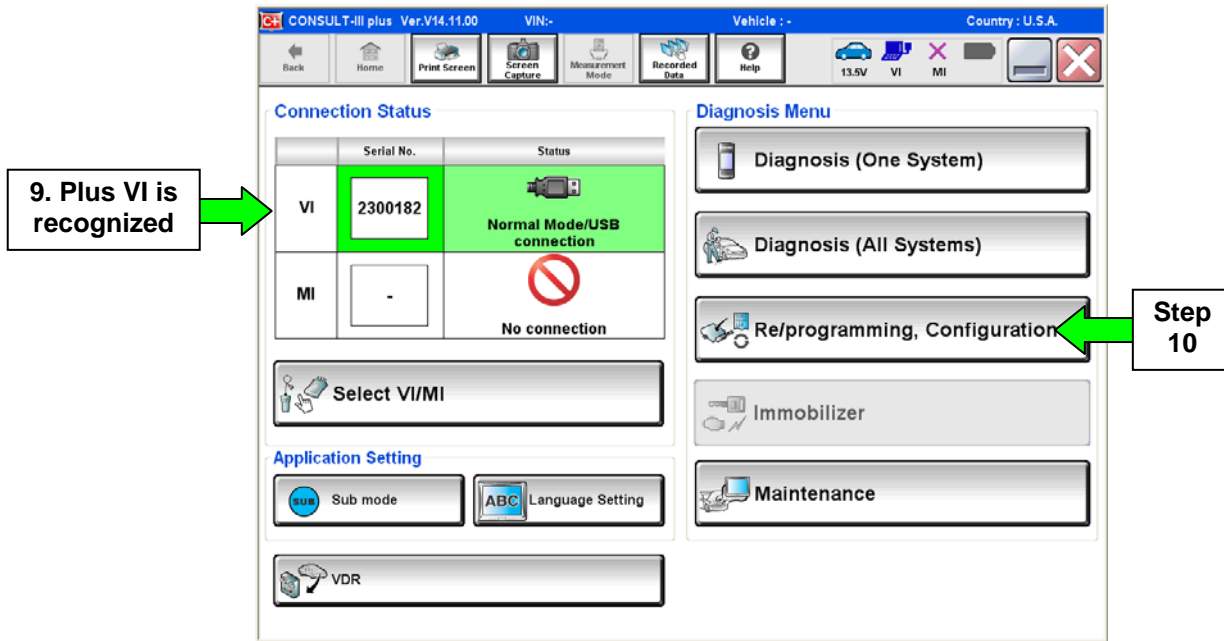
Figure 1

10. Select **Re/programming, Configuration**.

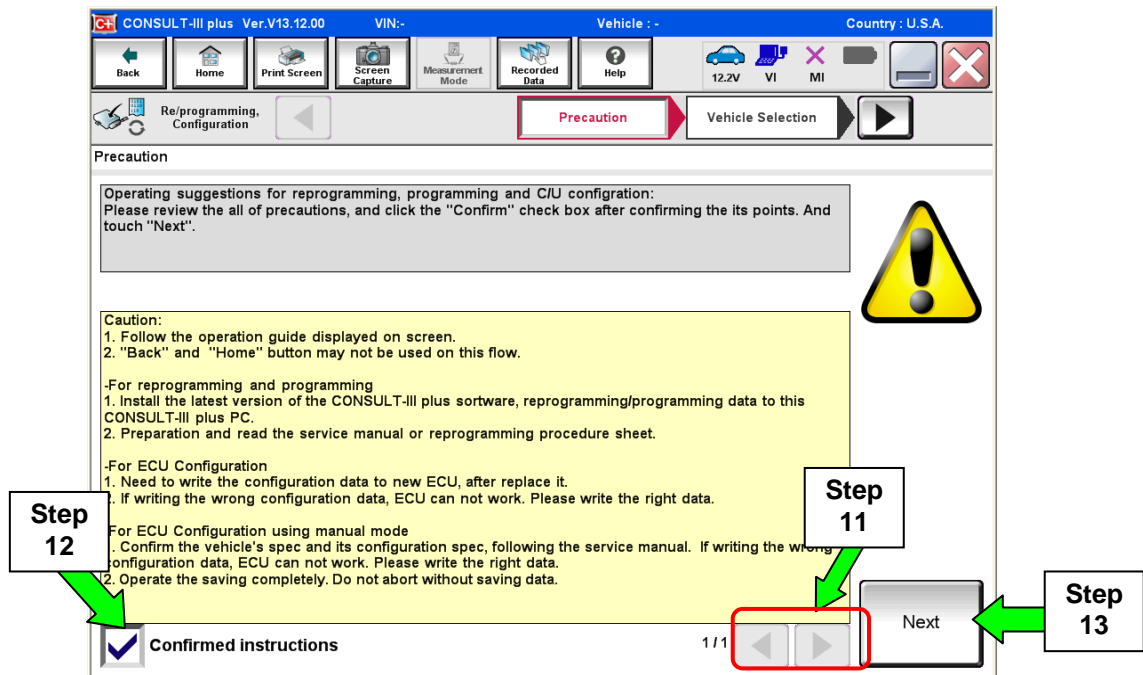
Figure 2

11. Use arrows (if needed) to view and read all precautions.

12. Check the box confirming the precautions have been read.

13. Select **Next**.

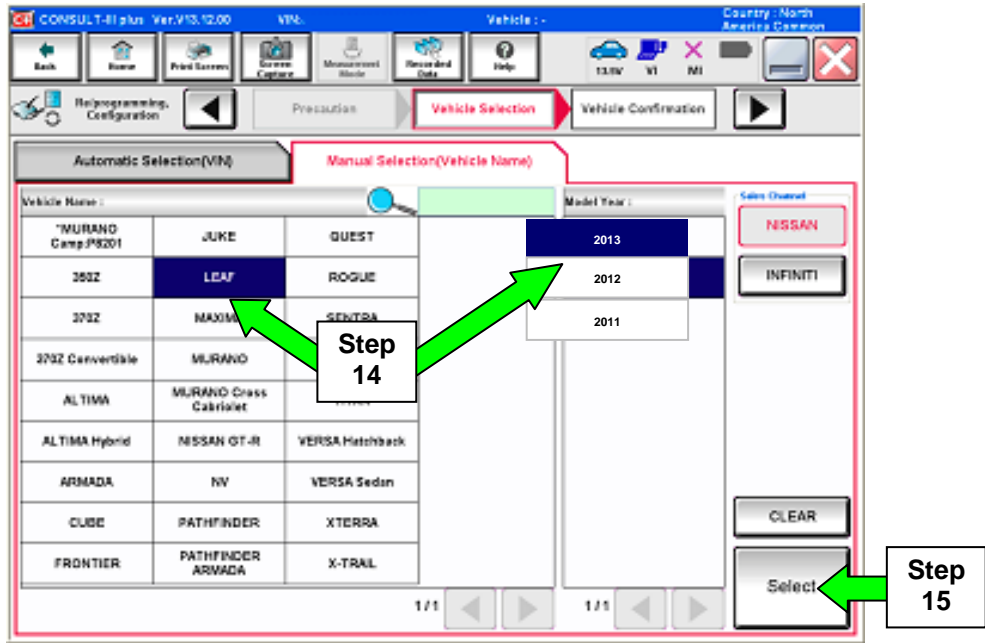
14. Select **LEAF** and **2013**, or **Automatic Selection (VIN)**.

- If **Automatic Selection (VIN)** is selected, wait for the **Reading VIN** screen to complete.
- If the screen in Figure 3 does not display, skip to step 16.

15. Select **Select**.

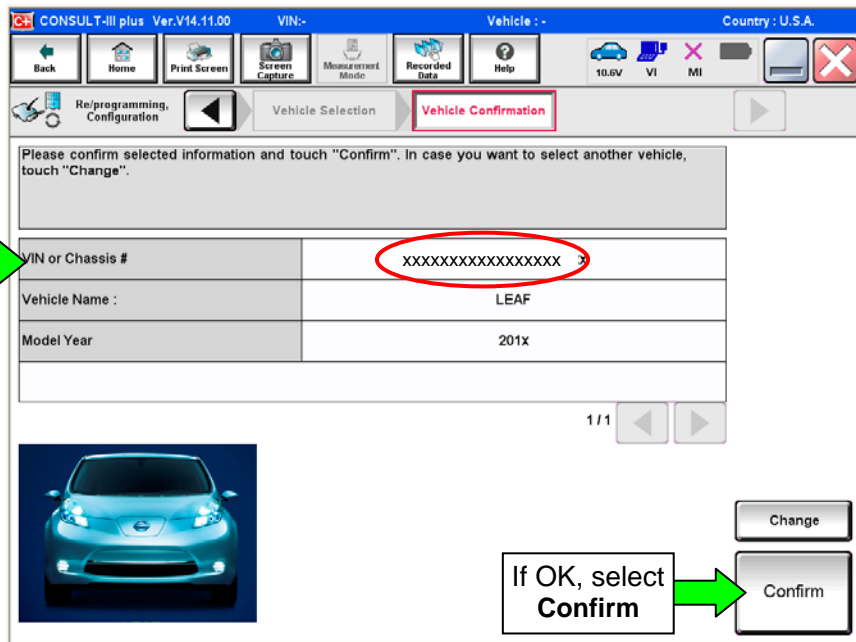
Figure 4

16. Verify the VIN in **VIN** or **Chassis #** matches the vehicle being reprogrammed.

- If the correct VIN is displayed, select **Confirm**.

Verify here

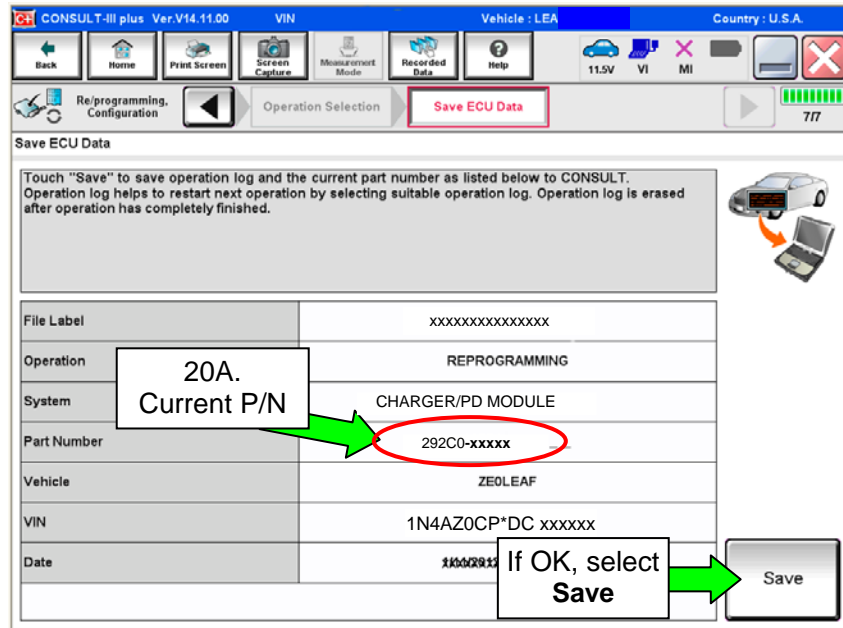
Figure 8

20. When you get to the screen shown in Figure 8, confirm this bulletin applies as follows.

A. Find the **CHARGER/PD MODULE Part Number** and write it on the repair order.

NOTE: This is the current CHARGER/PD MODULE Part Number (P/N).

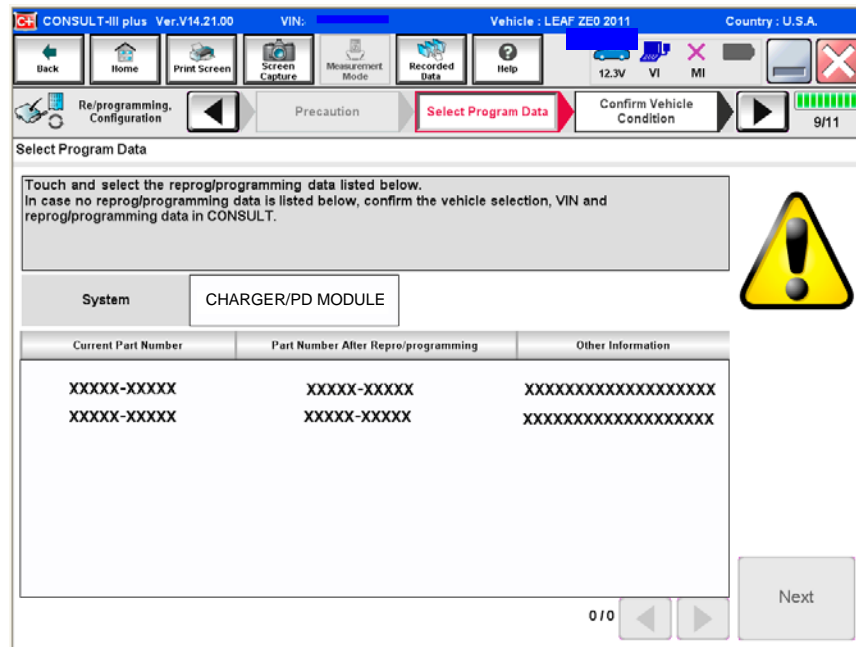
- In some cases, more than one new P/N for reprogramming is available.
 - If more than one P/N is available, the screen in Figure 11 will display. Select and use the reprogramming option that **does not** have the message “Caution! Use ONLY with NTBXX-XXX”.
- If you get this screen and it is blank (no reprogramming listed), it means there is no reprogramming available for this vehicle.

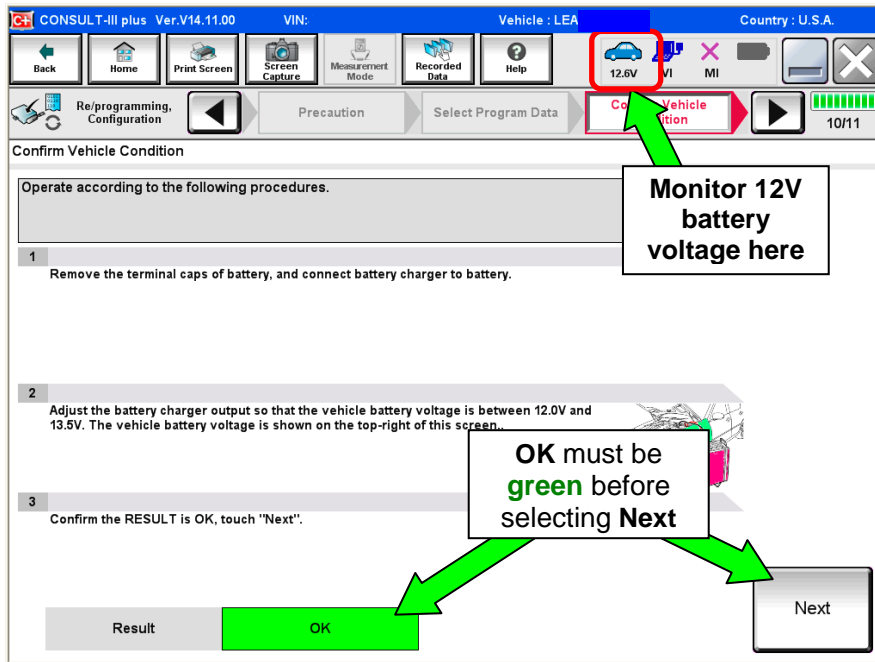
Figure 13

26. Confirm battery voltage is correct, and then select Next.

NOTE: Battery voltage must stay within specified range to make the indicator turn **green**.

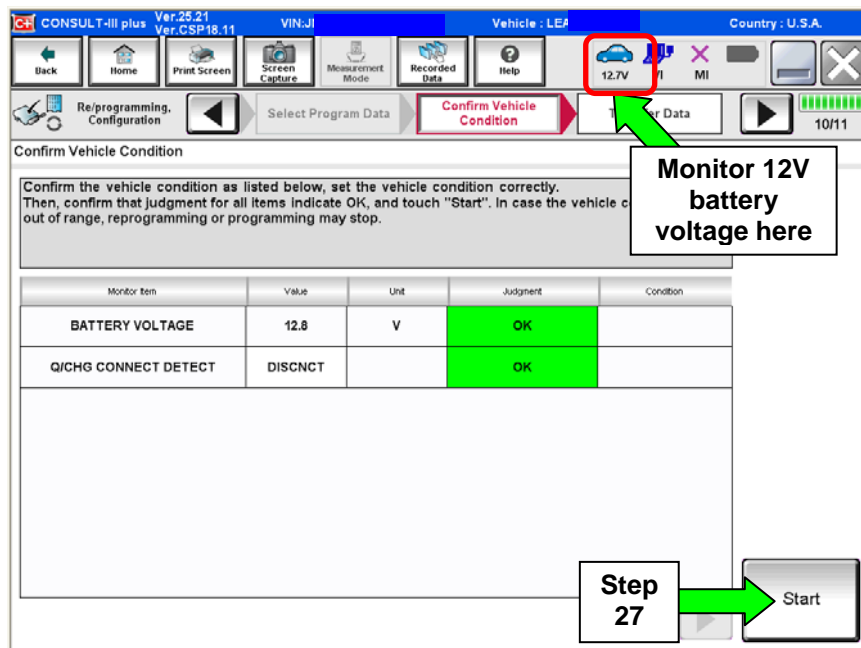
Figure 14

27. With battery voltage in the green, select **Start**.

- The reprogramming process begins when **Start** has been selected.

NOTE: For reprogramming to continue, vehicle 12V battery voltage must stay within 12 volts and 13.5 volts. Make sure the voltage level is sufficient.

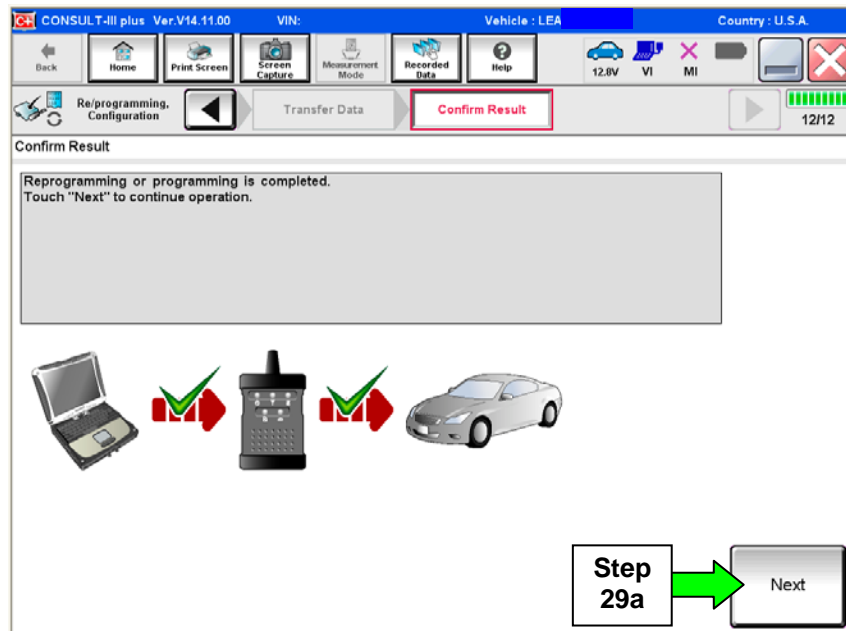
29. When the screen in Figure 16 displays, reprogramming is complete.

- a. Select **Next**, and then wait for System Call to complete.
- b. Proceed to step 30 on page 16.

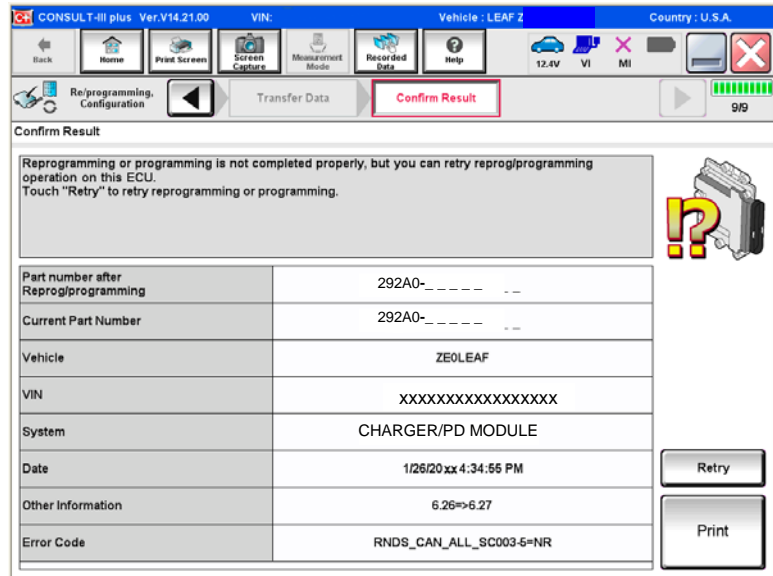
Figure 17

NOTE: If reprogramming does not complete and the **!?** displays as shown in Figure 17:

- Check battery voltage (12.0 - 13.5V).
- Ignition is ON, Ready Mode is OFF.
- External Bluetooth® devices are OFF.
- All electrical loads are OFF.
- **Select Retry and follow the on screen instructions.**
- Retry may not go through on the first attempt and can be selected more than once.

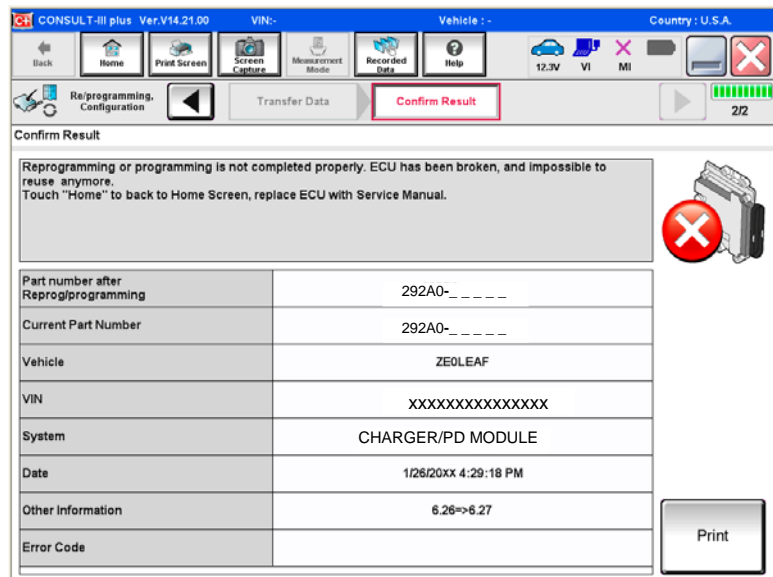
Figure 18

OR: If reprogramming does not complete and the **X** displays as shown in Figure 18:

Do not disconnect plus VI or shut down Consult III plus if reprogramming does not complete.

- Check battery voltage (12.0 - 13.5V).
- CONSULT A/C adapter is plugged in.
- Ignition is ON, Ready Mode is OFF.
- Transmission in Park.
- All C-III plus / plus VI cables are securely connected.
- All C-III plus updates are installed.
- **Select Home, and then restart the reprogram procedure from the beginning.**

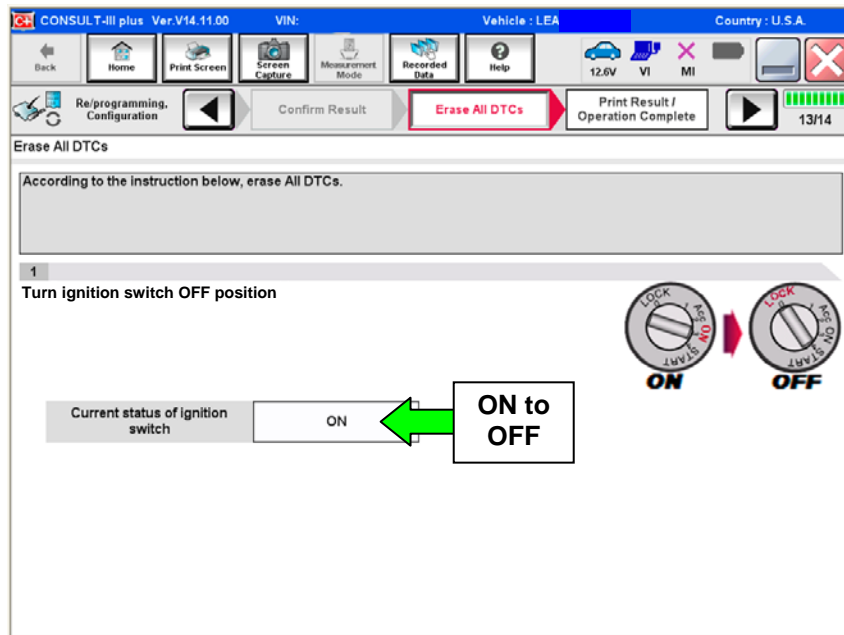
- a. Turn the “ignition” off by depressing the power switch once.
 - The screen in Figure 19 will read **OFF** after pressing the power switch once.

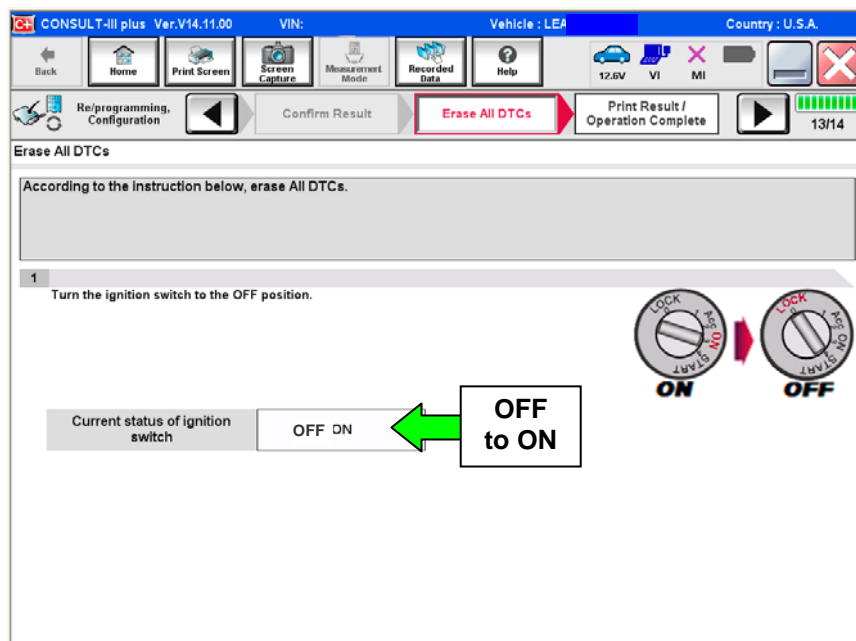
- b. Wait 1 minute with the ignition OFF.
- c. Turn the “ignition” on by depressing the power switch twice (not Ready mode).
 - Do not step on the brake pedal when depressing the power switch.
 - The screen in Figure 20 will read **ON** after pressing the power switch twice.

NOTE: Do not be confused by any screen messages. At this point, simply turn the “ignition” on.

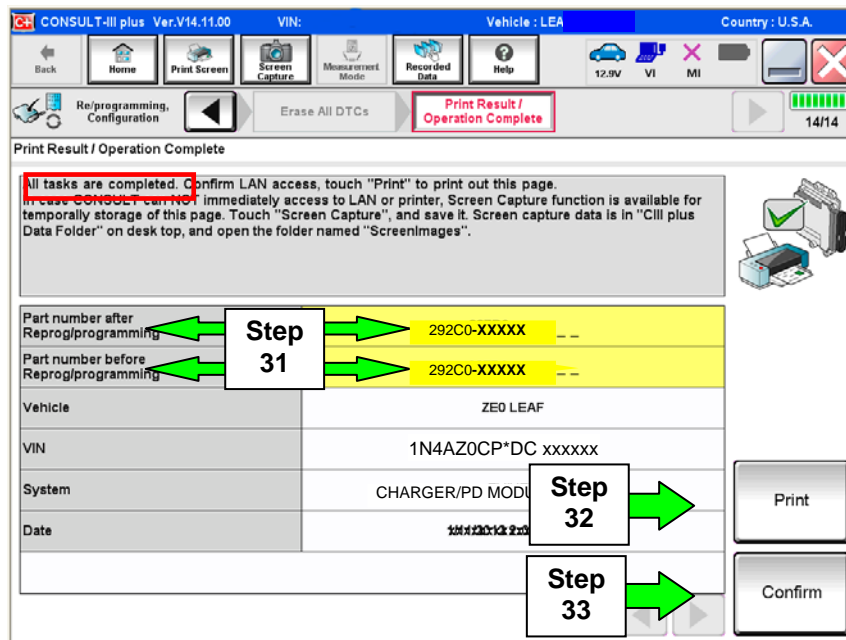
Figure 22

31 Verify the before and after part numbers are different.

32. Print a copy of this screen (Figure 22) and attach it to the repair order.

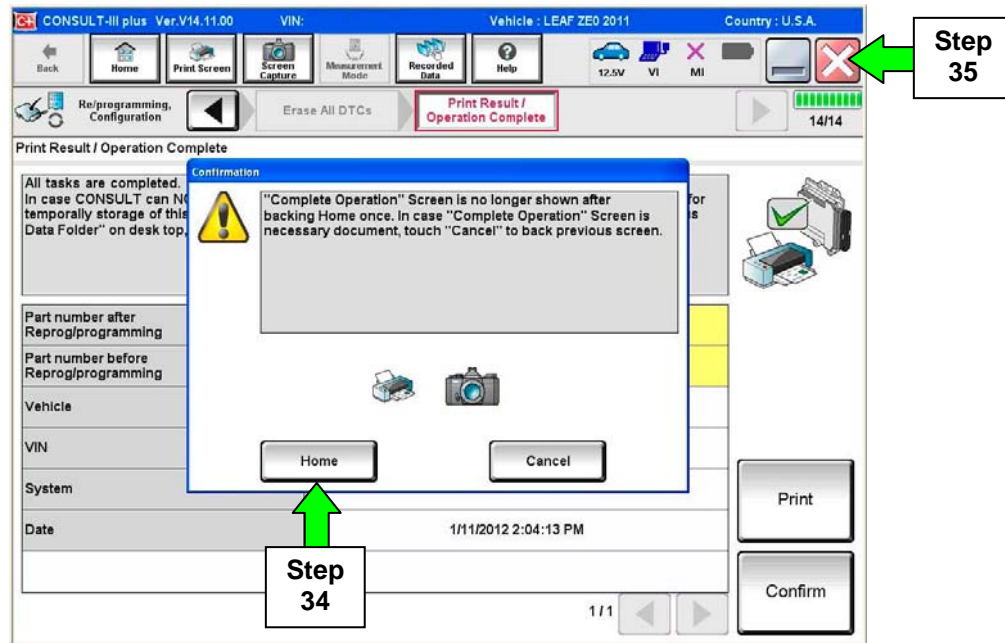
Figure 23

35. Close C-III plus by selecting “X” (see Figure 23).

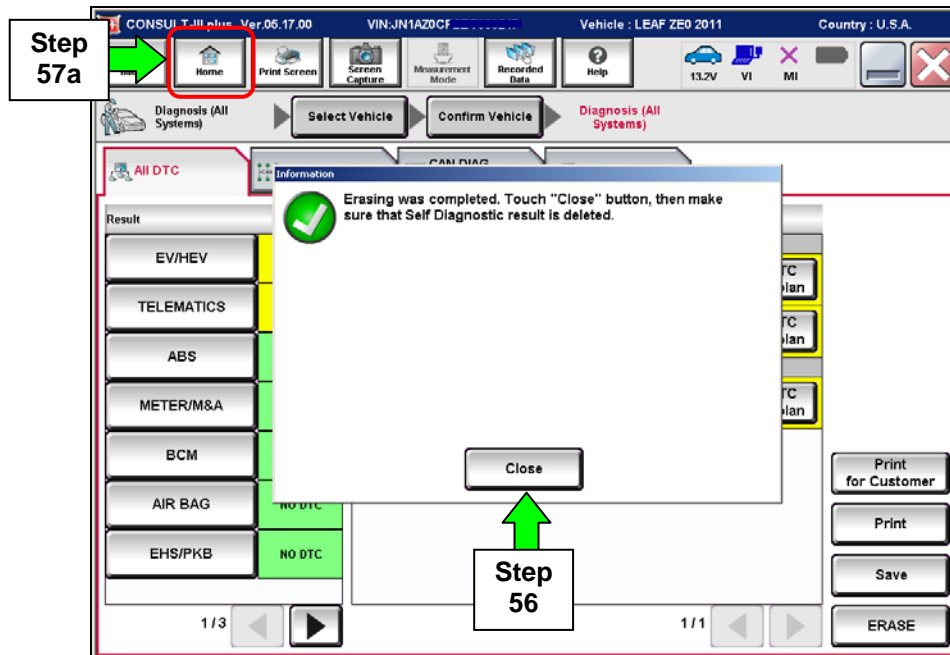
Figure 41

56. Select **Close**.
