Navigation System Firmware Update

Service Category Audio/Visual/Telematics

Section Navigation/Multi Info Display

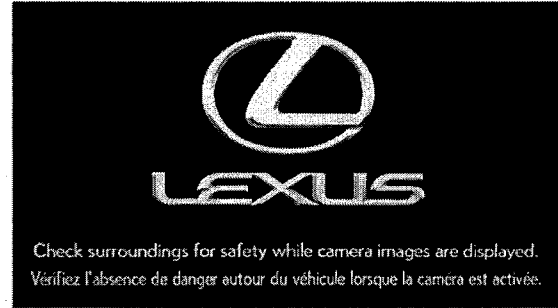
Figure 1.

1. Confirm the software version.
 - A. Cycle ignition to ACC. The *LEXUS* emblem will be displayed on the navigation screen.
 - B. Wait for the display to switch to the *Caution* screen, and then select *Continue*. The map screen will display.
 - C. Enter the *Service Menu* by cycling the headlight switch ON/OFF 3 times while holding down the MENU button.

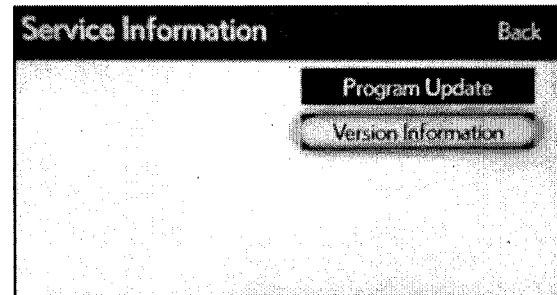
Figure 5.

E. Select *Version Information*.

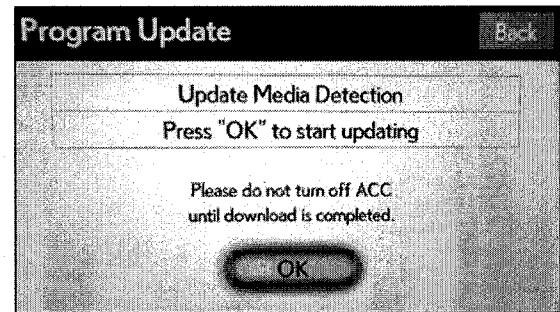
Figure 11.

E. Select OK.

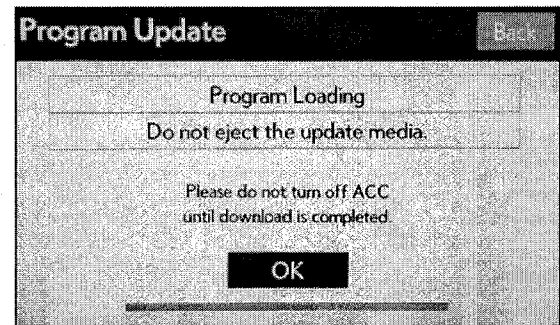
Figure 12.

F. Wait for the upload to finish. This should take about 2 – 3 minutes.

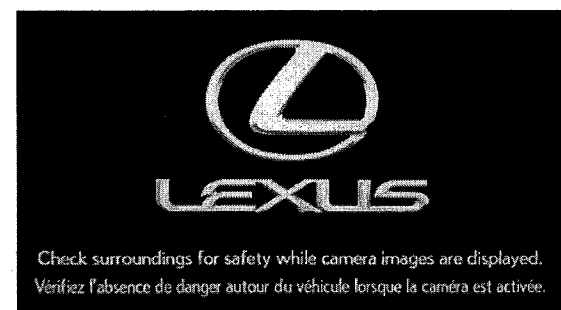
Figure 20.

- M. Following the update, the system should boot up as usual with the *LEXUS* emblem.

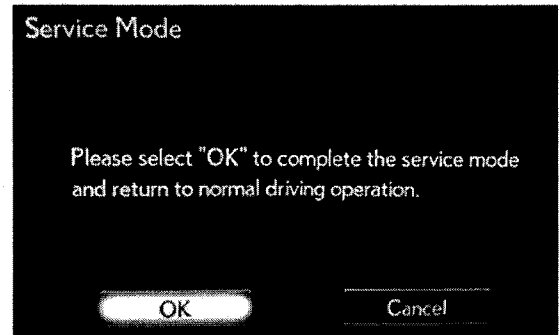
Figure 22.

- C. Exit *Service Mode* by cycling ignition OFF or holding down the HOME button for at least 5 seconds.

If the screen shown appears after start-up, following the update, select **OK**.
