Technical Service Bulletin

01 MIL on, DTC P112800 and/or P113000 or P008700 or P244000 and/or P244200 in ECM

01 13 07 2029340/6 June 21, 2013. Supersedes Technical Service Bulletin Group 01 number 12-62 dated December 12, 2012 for reasons listed below.

Model(s)	Year	VIN Range	Vehicle-Specific Equipment
A6/A7	2012	All	3.0 FSI Engine

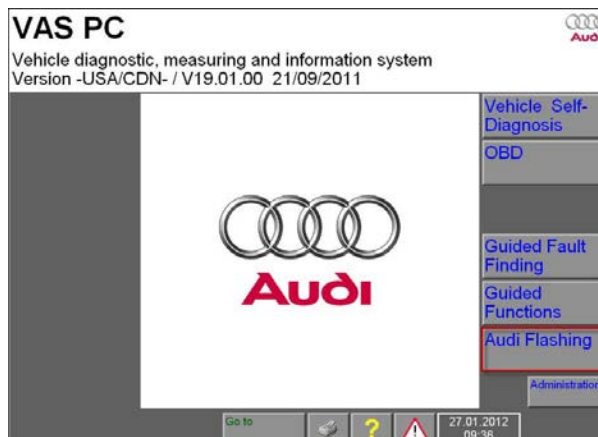
Figure 2. Audi Flashing.

- Turn off any appliances with high electromagnetic radiation (such as mobile phones).
 - If communication with a module cannot be properly established, appropriate repairs must be made before attempting SVM. If the tester cannot communicate with a module, the tester cannot flash software onto the module.
5. Enter the SVM code into the User Test Plan by selecting the **Audi Flashing** option at the main tester screen, unless otherwise directed by the TSB or TAC Helpline.
