# Emissions Service Action

Code: 24Y7

**Subject: 2011-2012 Routan with 3.6L engine  
PCM Software Update**

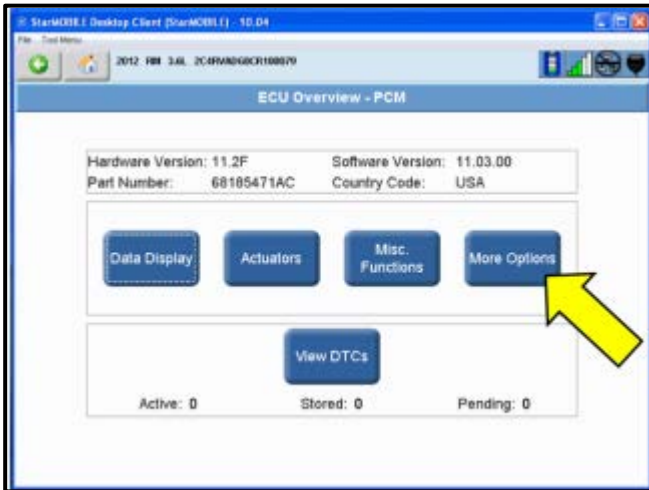
⇐ Select “More Options” <arrow>.

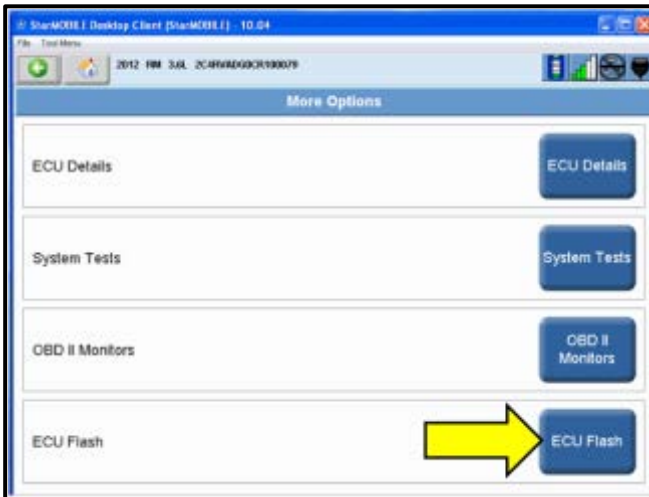
⇐ Select “ECU Flash” <arrow>.

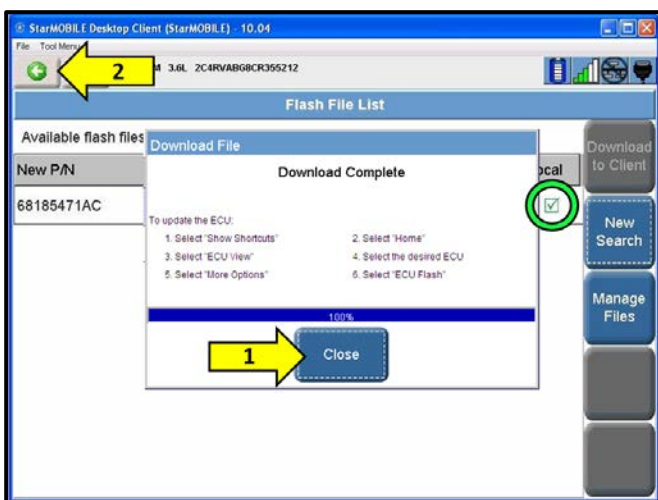
← When "Download Complete" message is displayed, select "Close" <arrow 1>.

← The red "X" in the "Local" column will change to a green check <circle>, showing the file has been saved to the StarMobile Desktop Client.

← Select the back arrow <arrow 2>.

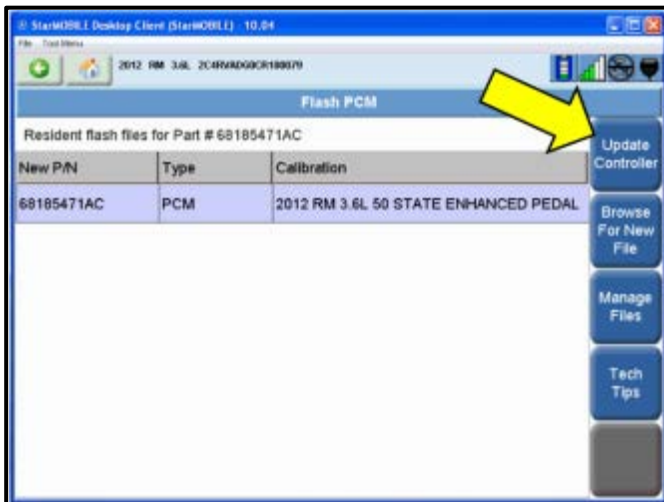
### Section C – Flashing PCM software

← From the “Flash PCM” screen, click on the flash file to select it, then select “Update Controller” <arrow>.

**Note:** If the flash process is interrupted or aborted, the flash should be restarted.

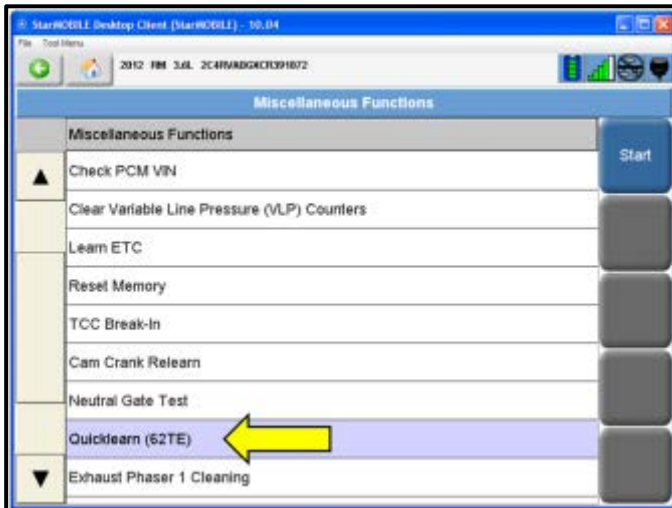
- Start the engine.
- ⇐ Select “Quicklearn (62TE)” <arrow> and press the “Start” button.
- Follow the screen prompts to complete the Quicklearn procedure.

**Note:** The Quicklearn procedure must be performed while sitting in the vehicle.

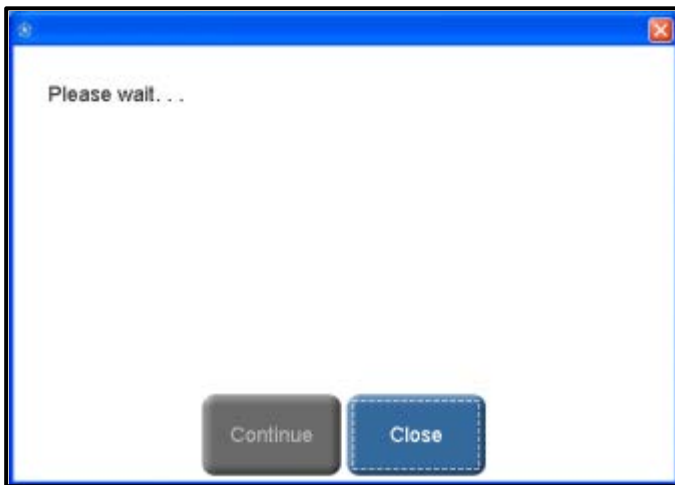
**Note:** The test plan may not properly display the confirmation message.

- If this screen is displayed (left) for more than 60 seconds with no change, Quicklearn procedure is complete.
- Select "Close".

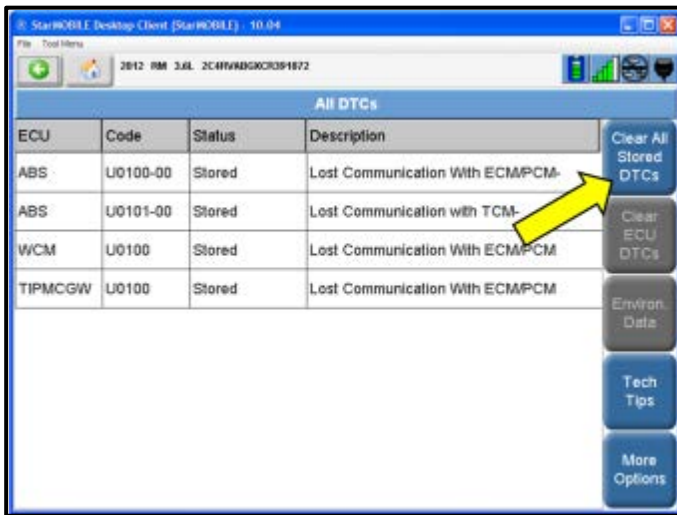
⇐ Select “Clear All Stored DTCs” <arrow>.
