Service Action

Code: 64C9

Subject: 2012 – 2013 MY Volkswagen Beetle
Front Window Motors

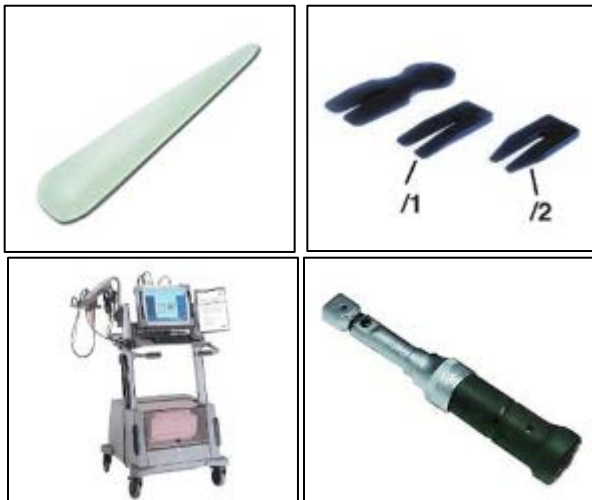
Required Tools:

- 3409 – Trim Removal Wedge
- T10383 – Wedges
- VAS 5051 – Vehicle Diagnosis, Testing & Info. System (or equivalent)
- VAG1783 - Torque Wrench, 2-10 Nm (or equivalent)

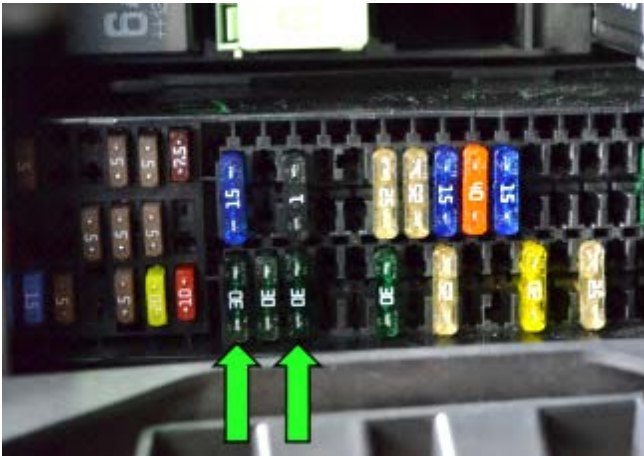
Follow these steps in order to ensure windows are in the proper service position **PRIOR** to removing fuses.

- Close both front doors
- With both front doors closed, fully raise both front windows.
- Open both doors to allow automatic slight drop of windows.
- Leave both doors **OPEN**.

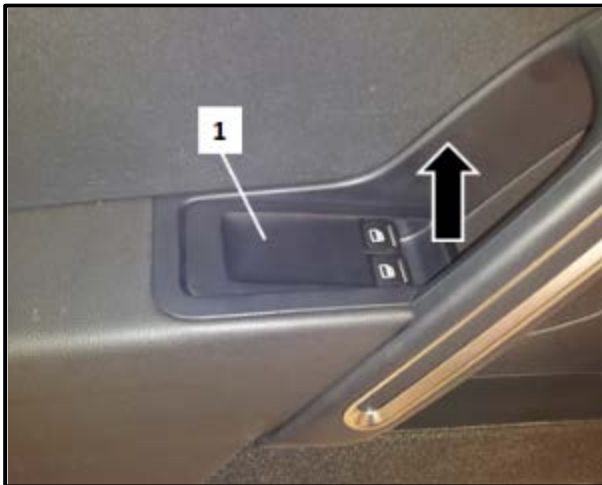
- ⇐ Release the window switch trim <1> by gently prying upward on the front edge with trim removal tool (3409) <arrow> and remove it from the door trim panel.

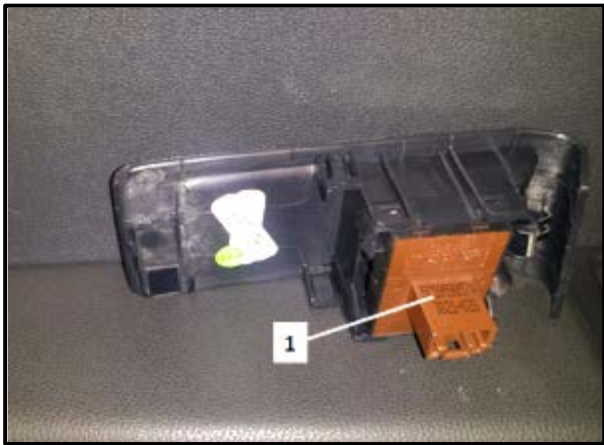
⇐ Disconnect connector <1> and remove the handle trim.

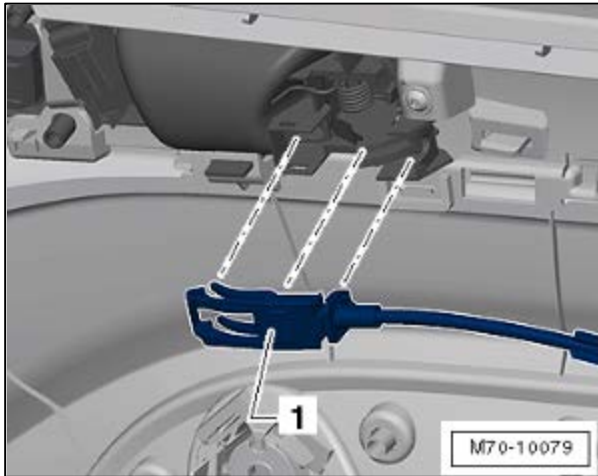
⇐ Disconnect the cable <1> from the interior door mechanism.

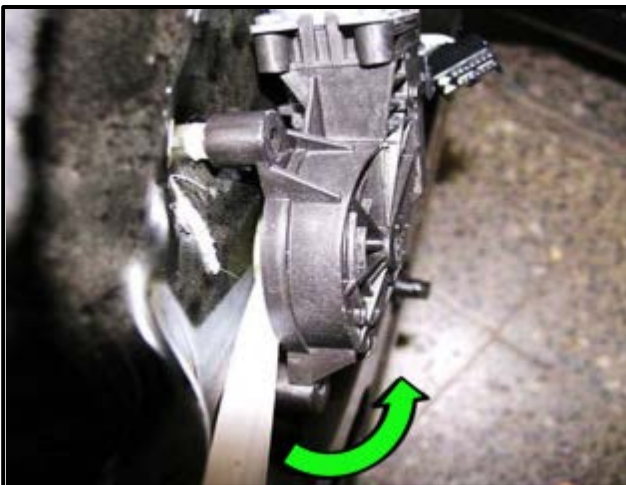
⇐ With the aid of trim removal wedge <3409> or equivalent, carefully remove the window regulator motor straight out (not at an angle) from the mounts of the cable reel so that the regulator gear drum does not unseat from its housing.

If regulator gear drum unseats or comes out too far, damage to regulator may occur.

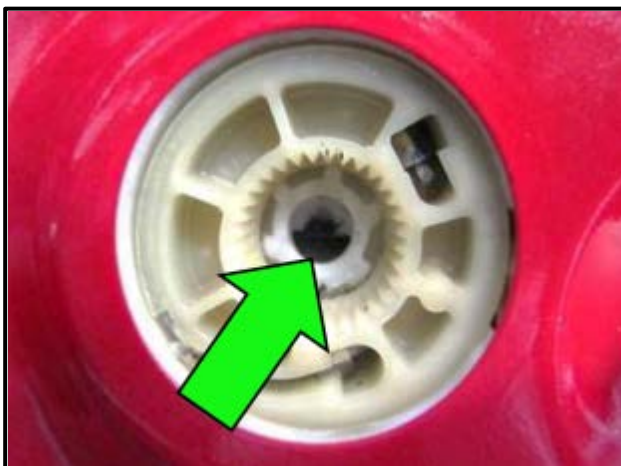
Tip: Prior to applying the adhesive, it is important to have the parts ready for immediate installation. This adhesive will begin to set up in as quickly as 30 seconds.

⇐ Place a large drop of adhesive part number (D 195 800 A1) as shown <arrow> into the lower corner of the regulator bore.

CAUTION: It is important that the adhesive remains only in the regulator bore and does not leak out onto the gear splines. Do not allow adhesive to come in contact with the regulator gear splines.

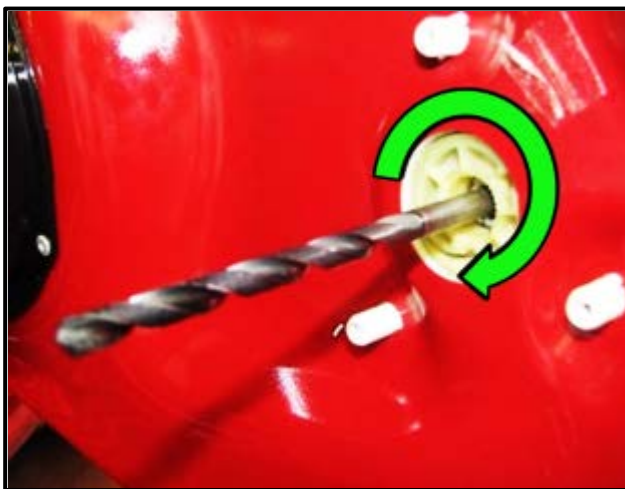
⇐ Using the back side of an 8mm drill bit, lightly insert and rotate drill bit in order to evenly spread the adhesive in the regulator bore inner wall.

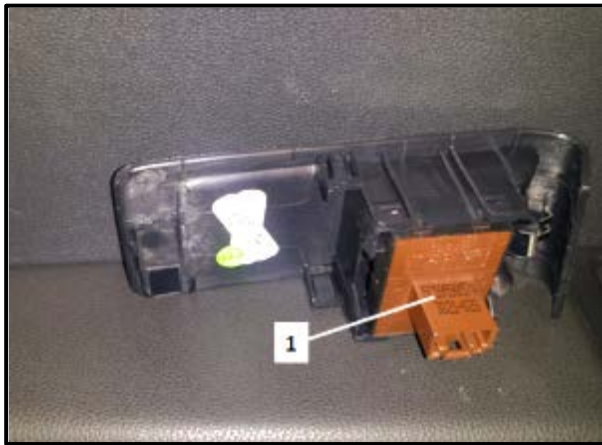
- Reconnect the connector <1> and reinstall handle trim.
- ⇐ Once installation of new motor(s) is complete allow minimum of three (3) hours cure time of adhesive before restoring electrical power to windows. Vehicle may be moved but do not reinstall fuses until cure time is complete.

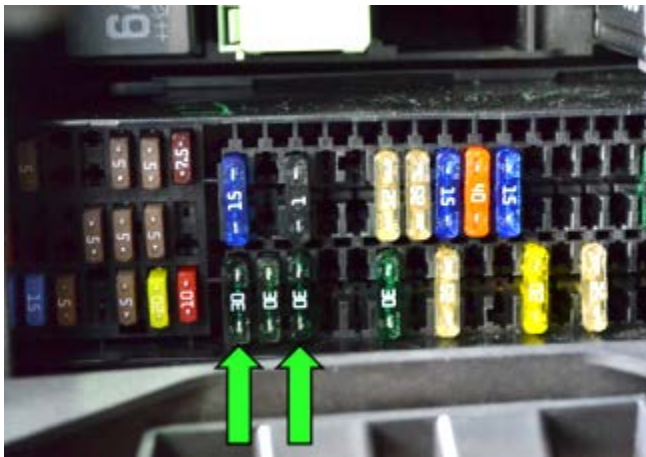
- ⇐ Once minimum 3 hour cure time is complete, reinstall the two fuses SC43 and SC45 <arrows> for door control units (window motors).
- Using the VAS tester, clear all DTC's from the vehicle.
