**GRAND VITARA**

# Technical Bulletin

Section Title: Restraints  
 TSB No. TS 05 01140

**SUBJECT:** COUNTER-MEASURE PROCEDURE FOR DTC B1318  
**MODEL(S):** GRAND VITARA (JB424W/JB632W)  
**YEAR:** 2009  
**VIN BREAKS:** JB424W: ~JS3TD042494101207 May 26, 2009  
 JB632W: ~JS3TD148494100441 May 28, 2009

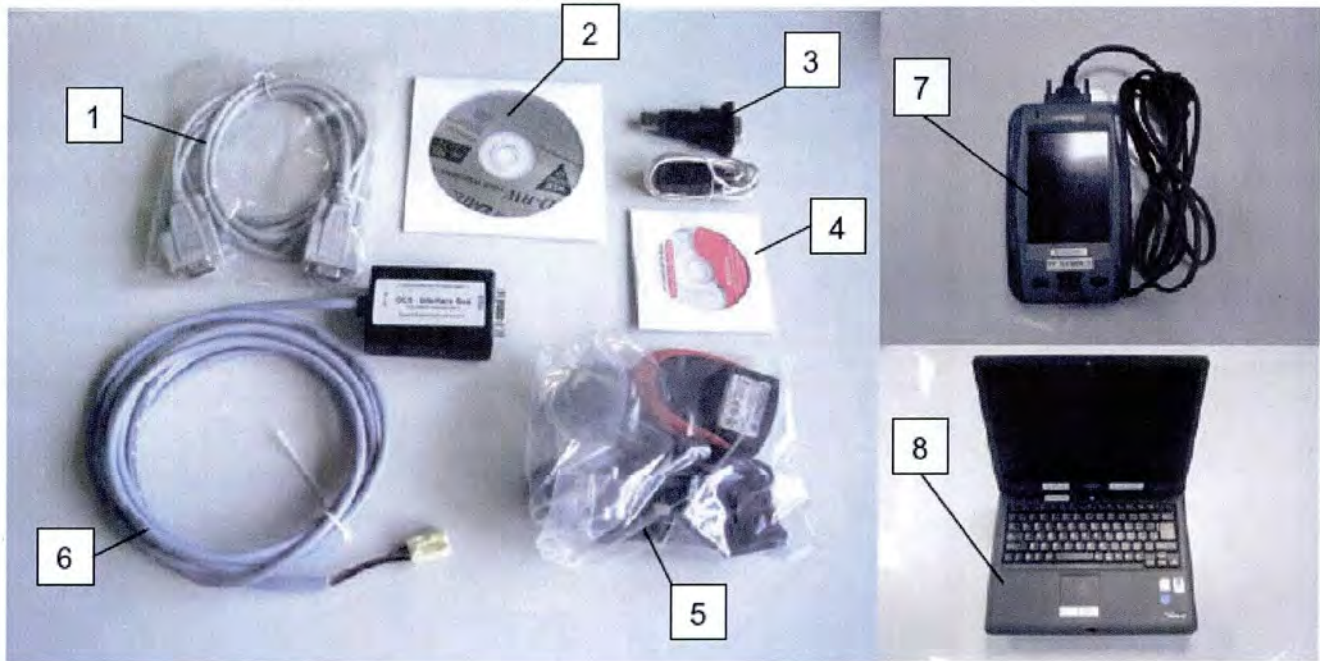
Note: Tools 1 through 6 are included in the OCM Reflash Kit, the Suzuki SDT (7) and the PC/Laptop (8) are available at the dealership.

Part Name	Qty	Remark
1	RS232C Interface cable	1	
2	Reprogramming CD-ROM	1	
3	RS232C-USB converter	1	
4	Converter Driver software CD-ROM	1	
5	Power supply 100-240V AC	1	Includes four different type of power plugs
6	K-Line interface cable	1	
7	Suzuki SDT scan tool	1	Software version 3.5 or newer
8	PC or Laptop	1	Refer to "Minimum system requirement"

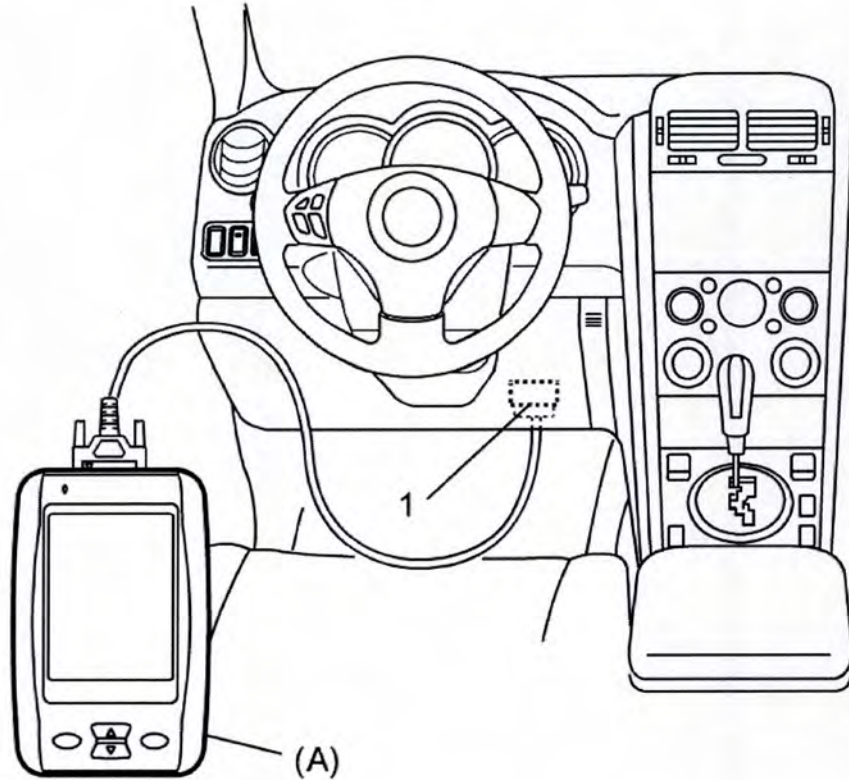
1. Turn ignition switch to OFF position.
2. Connect the SUZUKI SDT (A) to the data link connector (DLC)(1), located on underside of instrument panel to the right of the steering column.

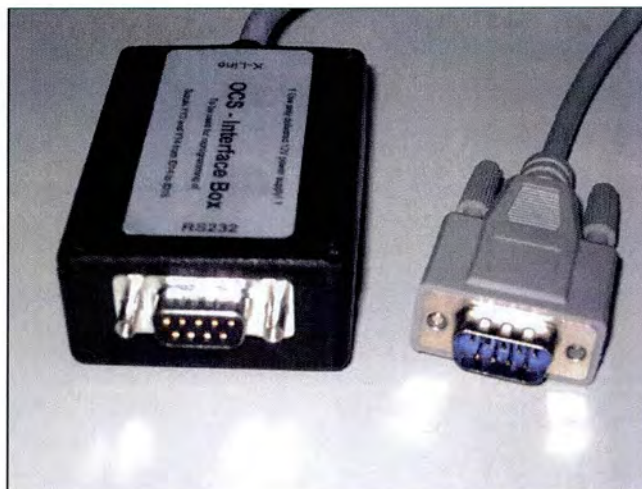
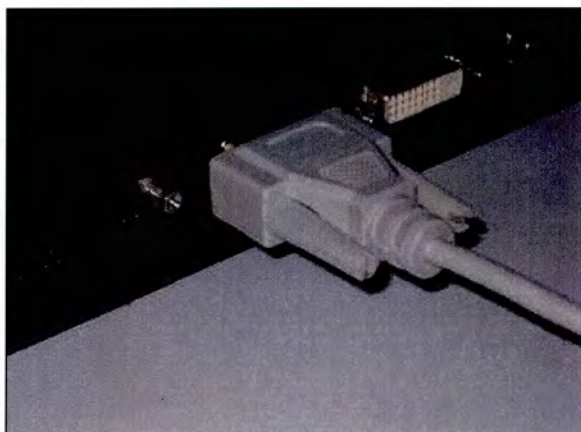
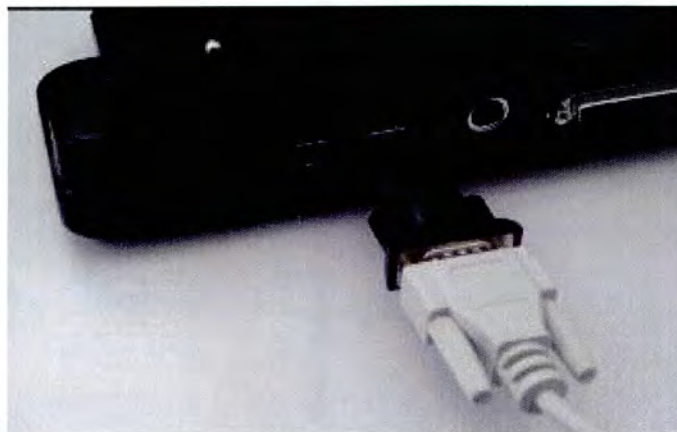
7. Connect the OCS- Interface Box to the PC using the RS232C serial interface cable (and the USB TO RS232 adapter, if needed).

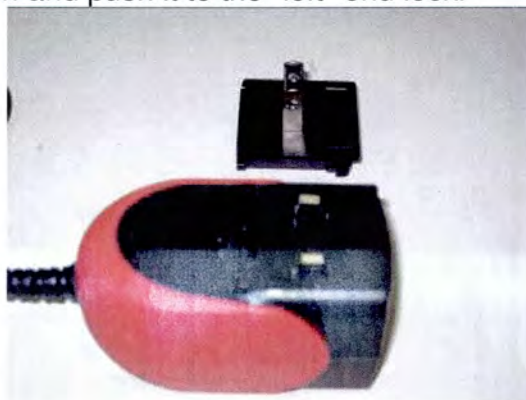
8. Connect Power supply 100-240V AC to power connector (for U.S. application) referring to the figure.

- Note the direction of the connector based on the pin size.
- Push the connector down and push it to the "left" end lock.

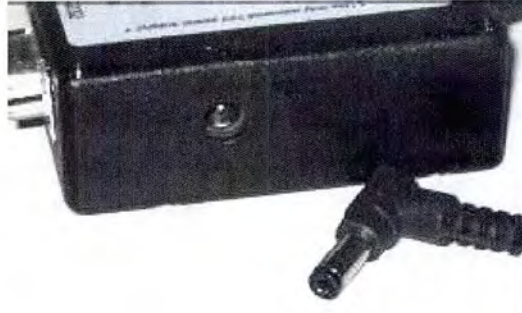
9. Connect the Power Supply to the OCS – Interface Box, and plug into a 120V AC power source.

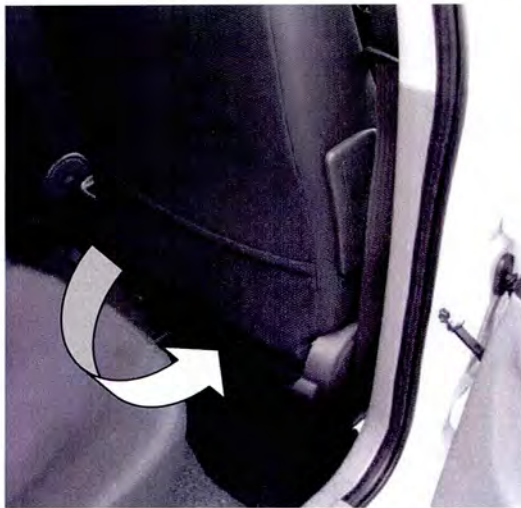
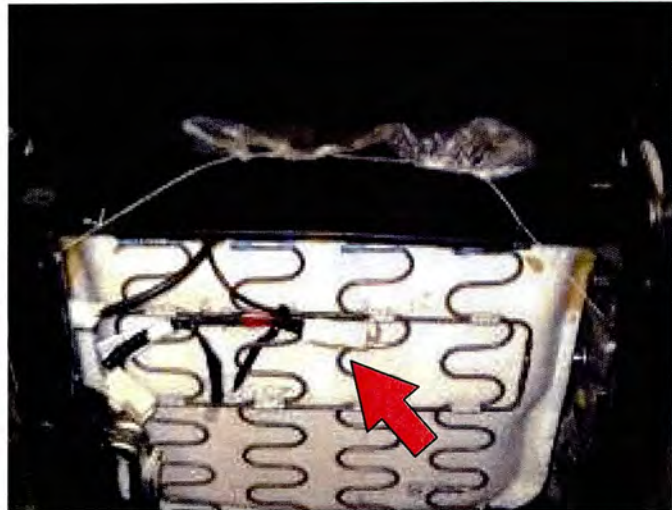
11. Find the OCS connector, located under the Passenger Seat Cushion, and disconnect it.  
Note: You should not need to remove the strap securing the harness.

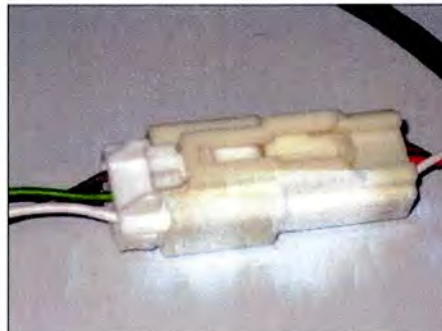
12. Connect OCS male connector of the vehicle and OCS female connector of K-Line interface cable.

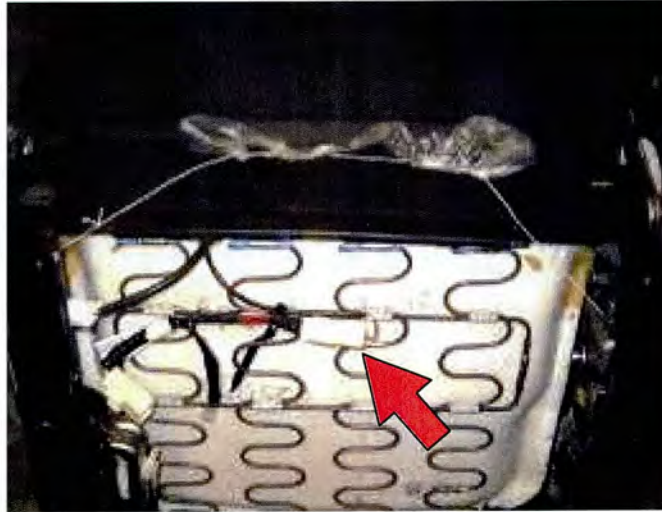
20. Disconnect the reprogramming tools from the vehicle starting with the female OCS connector under the seat cushion.
21. Reconnect the OCS female connector to the vehicle harness connector under the seat cushion.
