# SERVICE BULLETIN

Classification: AT10-010	Reference: NTB10-150	Date: December 22, 2010
-----------------------------	-------------------------	----------------------------

## 2010 ALTIMA, ROGUE, AND SENTRA MIL IS ON AND/OR SLOWER THAN NORMAL ACCELERATION

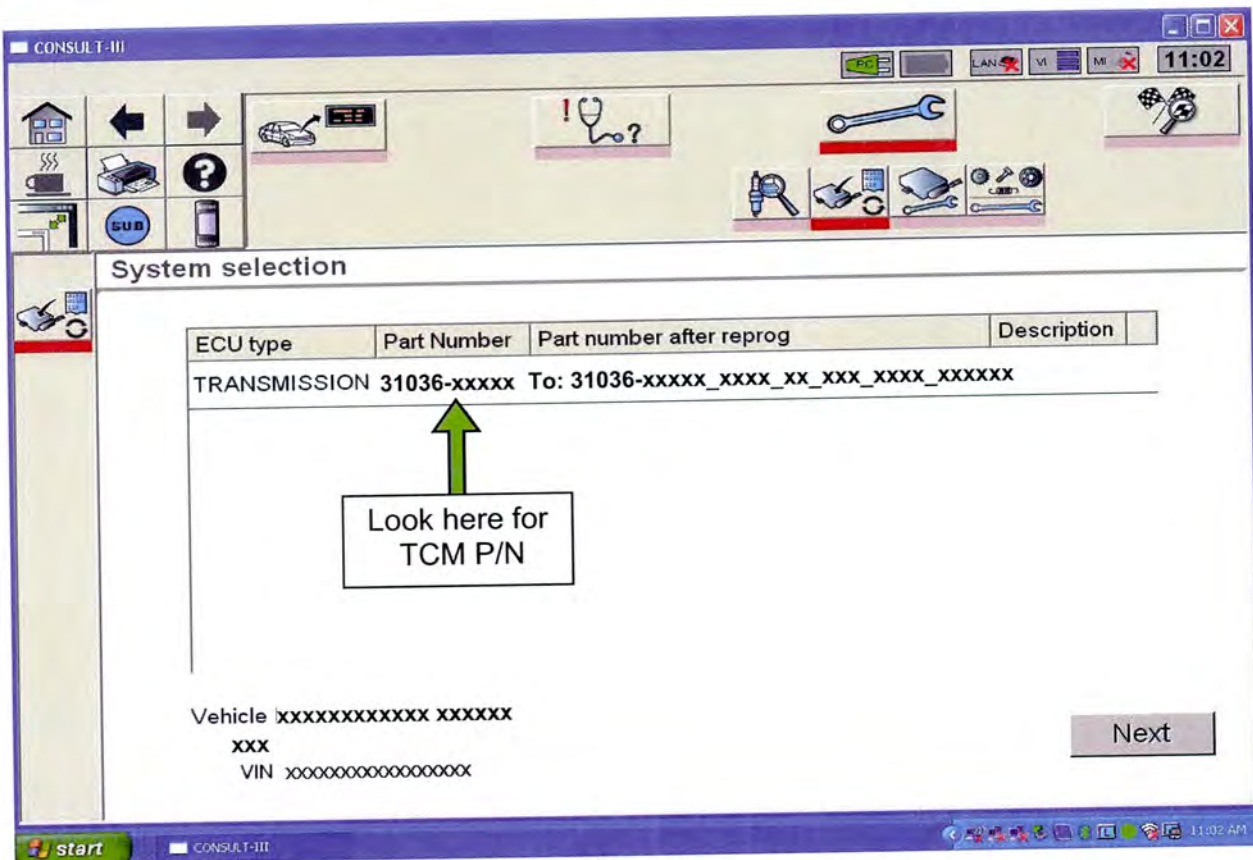
2. When you get to the TCM Reprogramming screen shown in Figure 1, confirm TCM reprogramming applies as follows:

A. On your C-III screen, look at the **Part Number** column (see Figure 1 example).

- If this column is **blank** (no part number listed), this **TCM reprogramming does not apply or has already been done**. Skip to page 7 and perform TCM initialization.
- If a part number (P/N) is listed, write it on the Repair Order and then go to Step B.
